# **Corroded RC columns repair and strengthening with high performance fiber reinforced concrete jacket**

Alberto Meda, University of Rome Tor Vergata, Italy

## **Abstract**

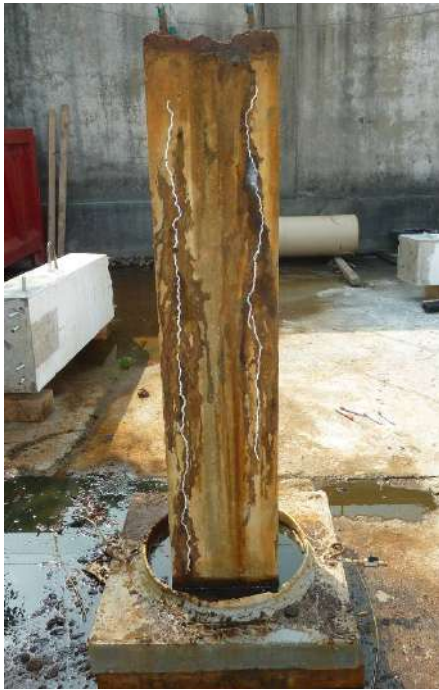
Figure 3. a) Dummy specimen after corrosion; b) state of the corroded rebar; c) Load-strain relationship of uncorroded and corroded rebars extracted from the specimen (corrosion expressed in % of mass loss marked next to each curve)

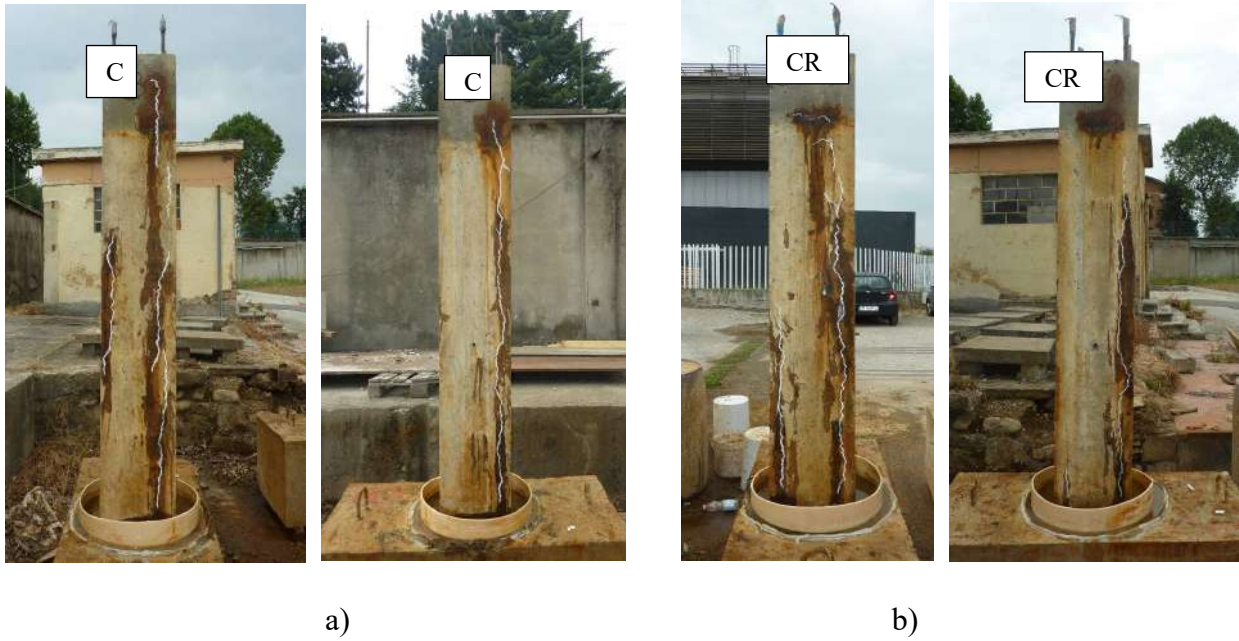
Finally, Figure 4 shows the columns C and CR after the corrosion. It can be noticed a typical crack pattern due to rust expansion, with longitudinal cracks close to the steel rebars, often involving the whole specimen length.

Figure 4. Specimen after corrosion process – crack pattern; a) specimen C; b) specimens CR

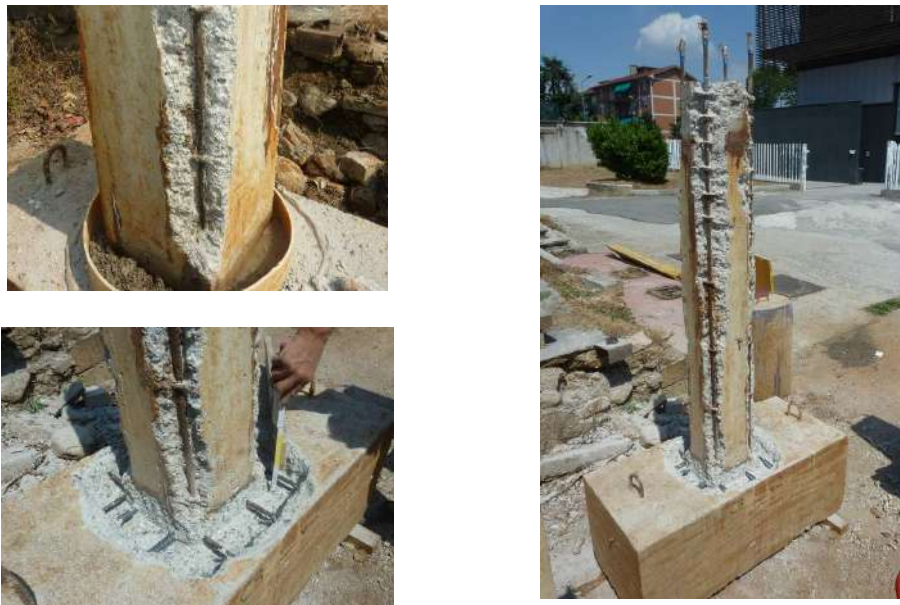
Figure 5. Specimen CR: Cover removal and foundation socket, before jacket cast

- the deteriorated cover in correspondence to the four longitudinal bars was removed and the reinforcement was manually brushed to eliminate the corrosion products;
- a 80 mm deep pocket was made in order to ensure the connection of the jacket with the foundation, as made in previous researches [12] (Fig. 5);
- the surface of the column was sandblasted in order to obtain a roughness of about 1 mm (Fig. 6) to ensure the adhesion between the old concrete and the HPFRC jacket (as investigated in [8]).

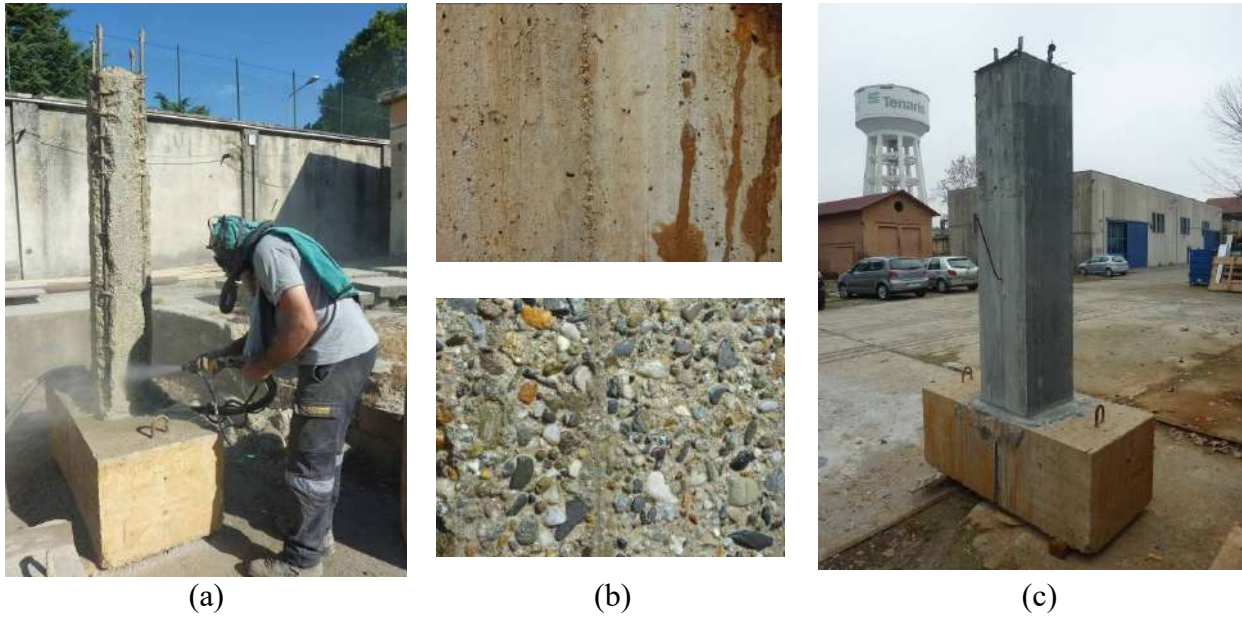
Figure 6. Specimen CR: a); b) sandblasting; c) HPFRC jacketed column

Finally, a jacket having a thickness of 40 mm has been cast with a self-levelling HPFRC (Fig. 6), having a maximum aggregate size of 1.3 mm and water/binder (cement + microsilica) ratio equal to 0.17 by weight. The concrete was reinforced with 1.2% (by volume) straight, 15mm long, steel micro-fibers with a diameter of 0.18 mm and an ultimate tensile strength of 2000 MPa. The average compressive strength of the material, measured on cubes after 28 days of curing, is about 130 MPa. The uniaxial tensile strength, measured on dog-bone specimen (Fig. 7a), is approximately equal to 6 MPa, while the flexural load, measured on four-point bending tests (Fig. 7b), is equal to 42 kN (nominal stress equal to 12.6MPa). As highlighted from the uniaxial tensile test (Fig. 7a), the material is characterized by a strain-hardening behaviour in tension up to 0.15% strain, followed by a stable and slightly degrading softening behaviour.

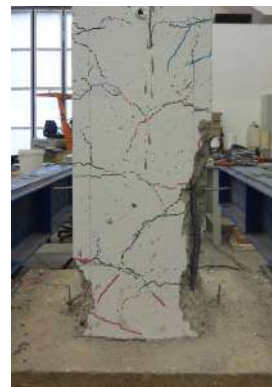
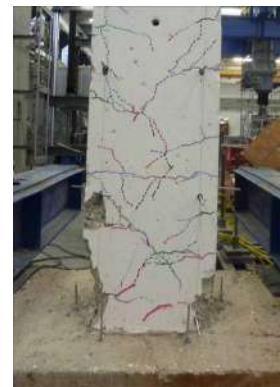
the cracked zone was about 700 mm from the column base. The maximum loads, measured for positive and negative cycles, were equal to 63 and 61 kN, respectively. The related drifts were equal to  $\pm 2\%$ . In the cycles beyond 2% drift, a progressive strength degradation was observed, up to a value of about 40 kN (approximately 64% of the maximum load), related to a 5% drift. At this point, the test was stopped, due to the cover spalling and concrete crushing observed at the column base, involving a zone with a height approximately equal to the section side. Moreover, the buckling of one of the reinforcing bars was observed. The final state of the specimen, for a drift equal to 5%, is shown in Figure 9b.

Figure 9. Reference uncorroded specimen UC: a) Horizontal load –drift; b) crack pattern at the end of the test

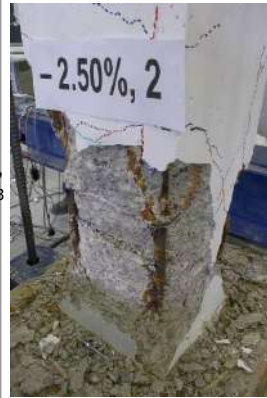
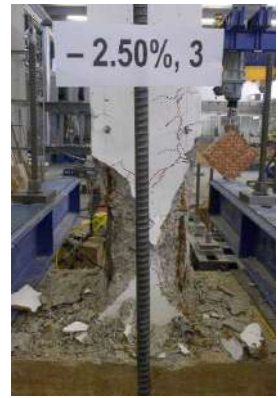
Horizontal cracks located at the column base, within an extension of about 700 mm from the foundation appeared for cycles ranging from a drift of 0.25% to 1.00%, growing in number and extension. The vertical cracks, due to corrosion, visibly opened for the cycle corresponding to 1% drift; while cover spalling occurred for a 2% drift. The test was stopped at a drift equal to 2.5%, after complete concrete crushing. Buckling of all the reinforcement bars was clearly noted. The final state of the specimens, for a drift equal to 2.5%, is shown in Figure 10b.

Figure 10. Corroded column (C): a) Horizontal load – drift; b) crack pattern at the end of the test.

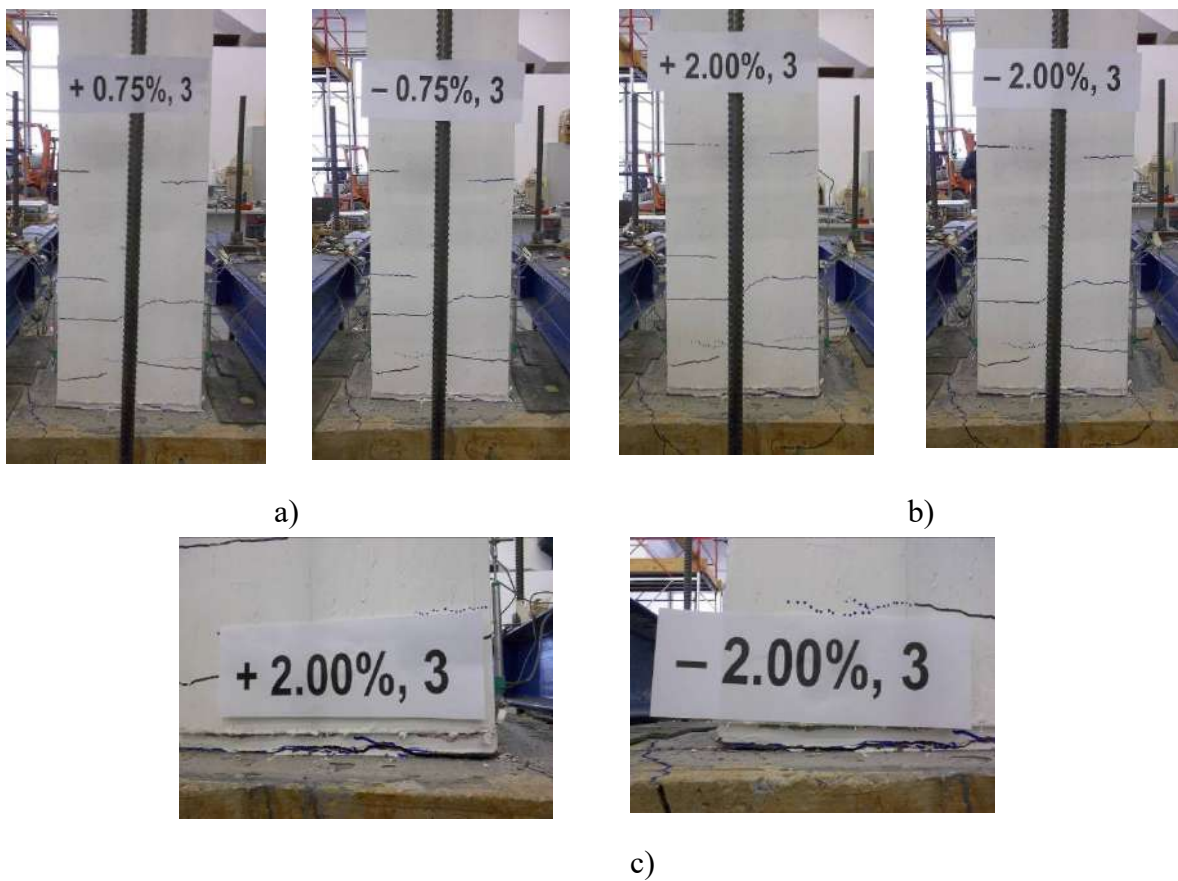
Horizontal cracks at the column base appeared for cycles ranging from a drift of 0.30% to 0.75%, within an extension of about 600 mm from the foundation (Fig. 12a). The crack patterns at drift levels of 0.75% and 2% are shown in Figure 12.

From a drift of 0.75%, the cracks development in the external jacket was stable (Figure 12a) while a local damage of the HPFRC jacket at the column-foundation interface took place at 2% drift (Figure 12b and 12c). In the case of positive drift, damage is not localized exclusively at the column-foundation interface, but there was a gradual detachment of the fiber reinforced jacket from the base foundation. The progressive pinching of the cycles for drift values higher than 1.5% is related to the detachment of the HPFRC layer at the base, whereby the contribution of the tensile strength of the jacket layer at the base is progressively lost, and a rocking mechanism takes place at the column base. The column has reached the collapse during the third cycle at 2% drift, due to the rupture of one of the longitudinal rebars during the positive drift cycle. In order to gain further knowledge of the specimen behaviour, it was decided to perform even the cycles at 2.5% drift, since for negative drifts the residual load was still high. The test was stopped at the second 2.5% drift cycle, when a second reinforcing bar failed. At the time, the load was equal to 82 kN, corresponding to 82% of the maximum strength reached for negative drift cycles.

Figure 12. Corroded Reinforced column (CR): Crack pattern at a drift of 0.75% (a) and 2% (b, c)
