*The paper was published in the proceedings of the 7<sup>th</sup> International Conference on Earthquake Geotechnical Engineering and was edited by Francesco Silvestri, Nicola Moraci and Susanna Antonielli. The conference was held in Rome, Italy, 17 - 20 June 2019.*

## Usability and damage assessment of public buildings and churches after the 2016 Central Italy earthquake: The ReLUIS experience

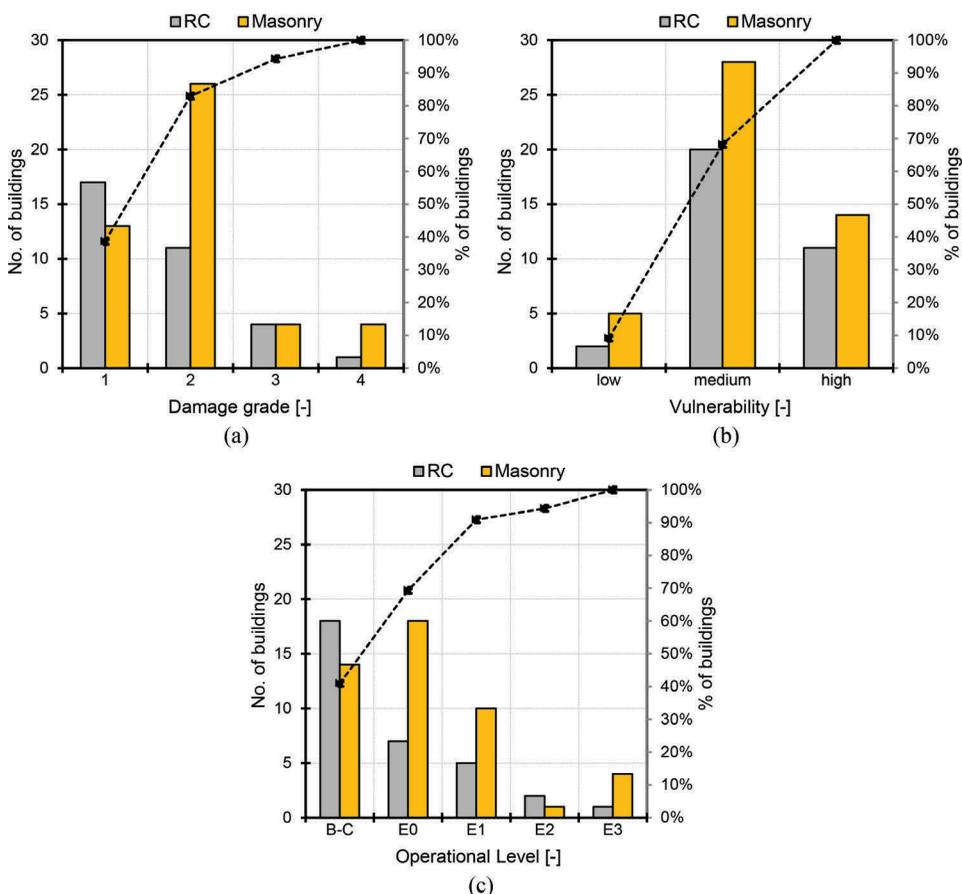
Figure 2. Damage grade (a), Vulnerability (b) and Operational Level (c) of unusable school buildings.

Figures 2a-c report the distribution of damage grade (Figure 2a), vulnerability (Figure 2b) and operating level (Figure 2c) of the unusable school buildings in each structural type (i.e. RC and masonry). Figure 2a shows that about 83% of the examined buildings were characterized by damage grade between 1 and 2. Figure 2b also shows that about 68% of the buildings were classified in the medium vulnerability category. Figure 2c shows that about 69% of the buildings are characterized by an operating level between B-C and E0, corresponding to a damage grade lower than the "very heavy" damage and a "medium-low" vulnerability.
