INTEGRATED SURVEY TECHNIQUES: PRELIMINARY STUDIES FOR THE CONSERVATION OF VILLA GALVAGNINA

KEY WORDS: Villa Galvagnina, integrated survey techniques, decay mapping, cultural heritage preservation

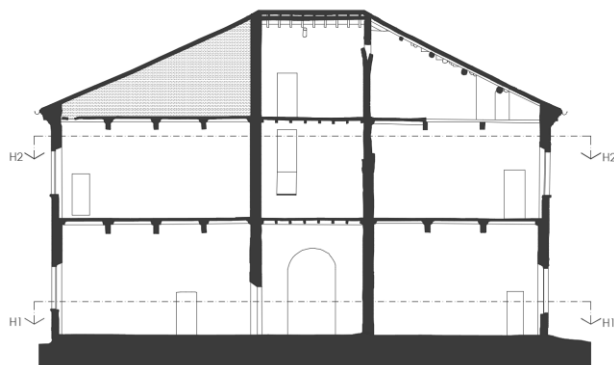
Figure 5: Vertical section V2 obtained from the points cloud (Municipality of Mantua).

The outer brick walls and the brick walls of the main rooms are characterized by a thickness between 45 centimetres and 50 centimetres and a height of about 10 meters. The entrance hall walls, as well as the dividing wall between the main hall and the entrance hall, reach a height of about 14 meters (Fig. 5), so they have a remarkable slenderness.

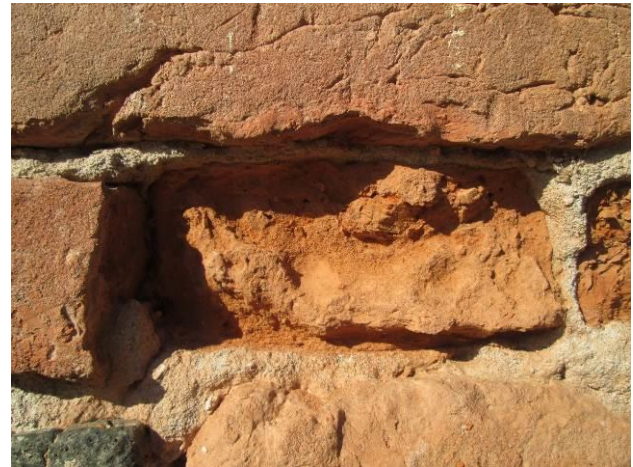
The masonry is in a very poor condition, due to the presence of many bricks subject to powdering, as well as to the deep disintegration of the mortar joints.

Figure 6: Powdering of the bricks.

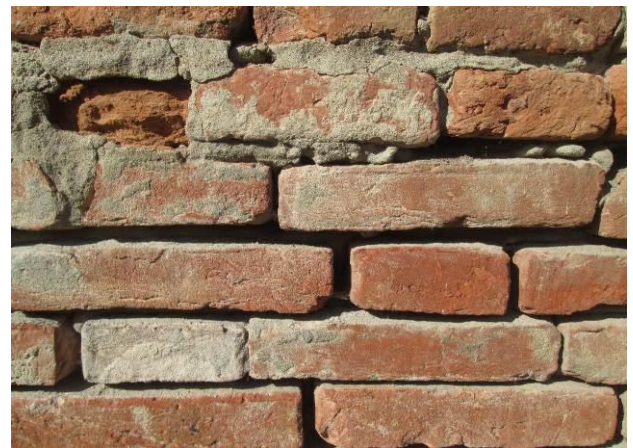
As mentioned before, the low-quality mortar has caused the deep disintegration of the joints.

Figure 7: Loss of the mortar.

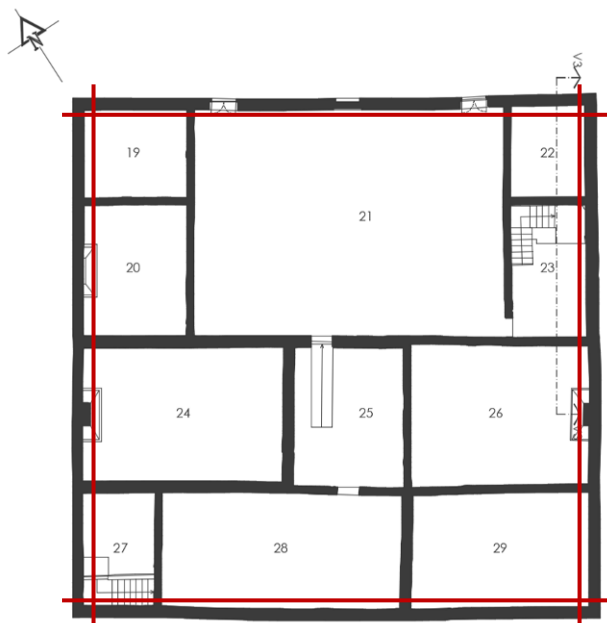
The horizontal sections obtained from the points cloud show two deformation mechanisms of the masonry walls. The south-eastern and the south-western walls show an out-of-plane

deformation that could be due to a horizontal bending (Fig. 8). This deformation may have been caused by the earthquake and aggravated by the action transmitted by the internal walls. The internal walls and the south-west and north-west external walls also show a little out-of-plan deformation.

Figure 8: First floor plan H2, out-of-plane deformation of the masonry walls (Municipality of Mantua).

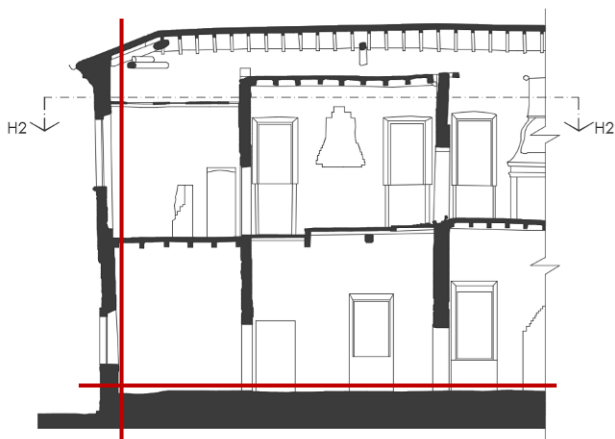
An outward rotation of the upper east corner of the building seem to be caused by the load of the roof, maybe exacerbated by a foundation subsidence, given a confined floor sinking (Fig. 9).

Figure 9: Vertical section V3, the overturning of the external walls and the floor sinking (Municipality of Mantua).

The vertical sections show the overturning of the external walls, particularly evident in the middle part of the wall, except for the north-eastern front, the maximum overturning of which is near the east corner.

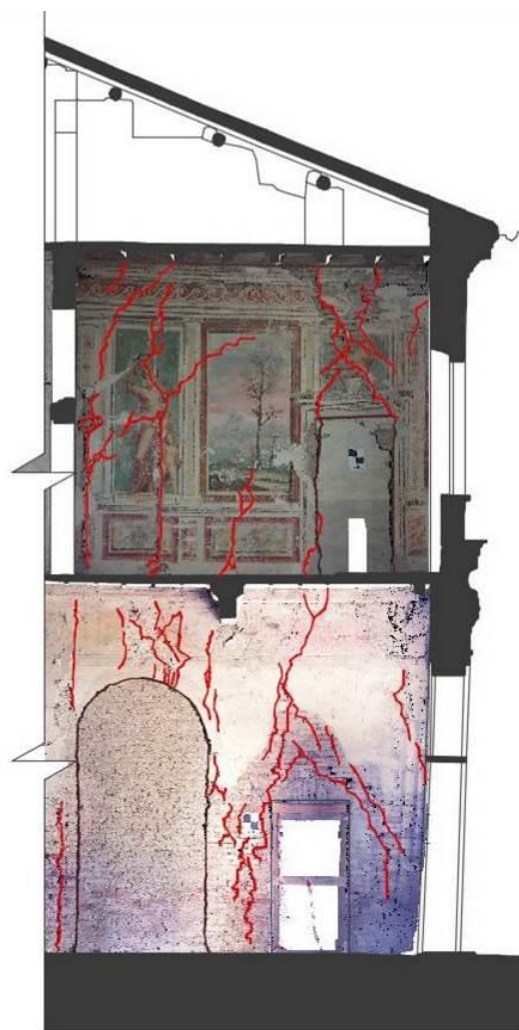
Figure 10: Details of the crack pattern.

The crack pattern appears in general to be due to static loads. It is from before the earthquake and the seismic event made him worse, as shown by the comparison between the photos taken before and after 2012.

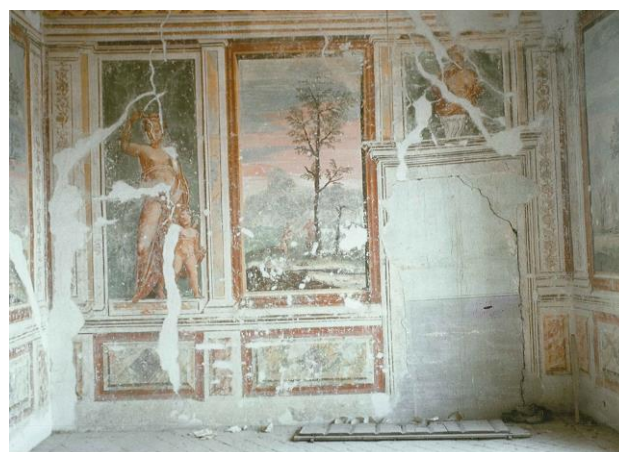
Figure 11: Crack pattern, room 28, 1990 (Private archive Federico Merli).

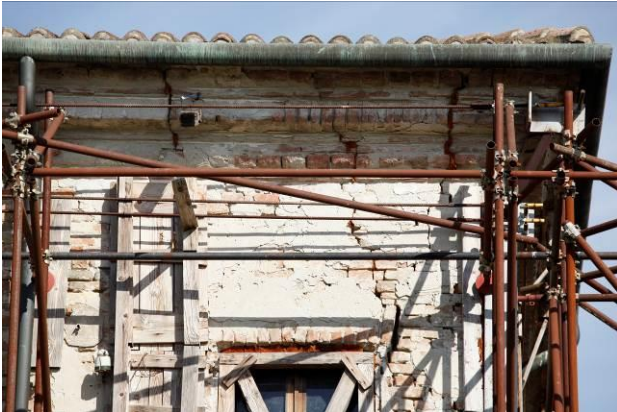
The cracks at the top of the external walls, in particular, appear to have been caused by the outward thrust of the roof (Figure 12 and 13). This problem, as already mentioned, does not seem to

have been effectively solved by the replacement of the wooden structure.

Figure 12: Cracks due to the outward thrust exerted by the roof.

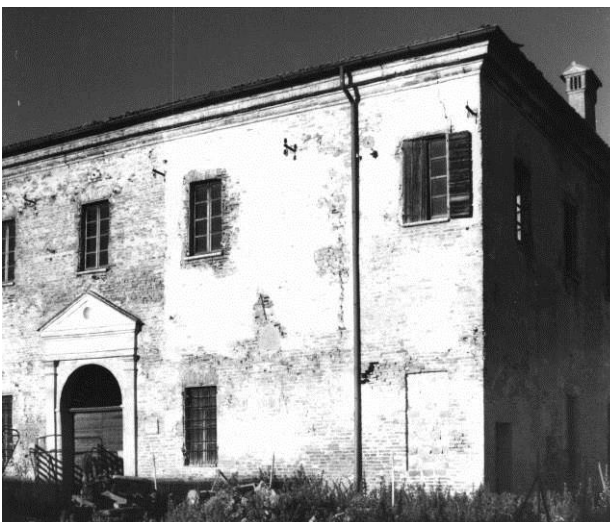
Figure 13: The main front of the villa in the 1960's. The crack due to the outward thrust exerted by the roof can be seen in the upper right corner (Private archive Alberto Ferrari).

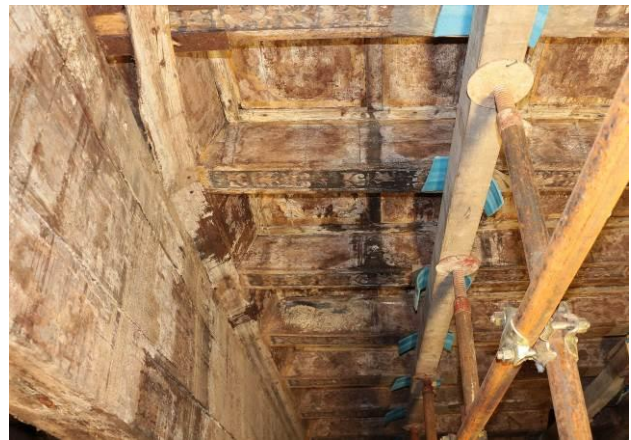
Another obvious problem concerns the severe damage suffered by the painted wooden floors that show localised rotteness and collapses. The structural behaviour of all the wooden elements will have to be thoroughly investigated in order to develop an

Particular attention should be given to the built beams of the main hall, one of which was replaced by a glulam beam. The ends of the built beams were repaired using steel plates.

Figure 14: Wood decay, main hall.

effective strengthening action. The wooden floors behaviour under static and seismic loads can be improved by means of a thin collaborating steel slab or collaborating multilayer panels. Both of these techniques, while giving up the intactness of the pavement, make it possible to build anti-seismic shear-resisting, even if the multilayer panels lead to worst results in terms of flexural response.

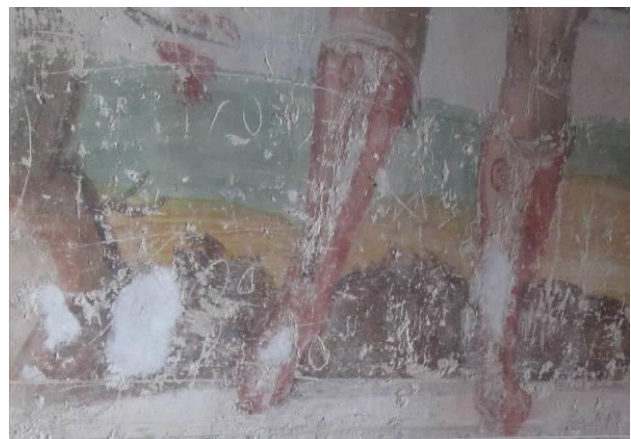
Figure 15: Wall paintings decay, room 4.

On the decorations, in fact, in addition to the cracks, the gaps and the detachments determined by the structural problems of the building, significantly aggravated by the earthquake, the presence of deposits, cuts, scratches, impact damages and graffiti was observed.
