Seismic performance of precast industrial facilities following major earthquakes in the Italian territory

Abstract

On the basis of detailed field observations on a relevant number of buildings, collected just after the earthquakes, seven representative industrial facilities are examined to outline the main vulnerabilities of one-storey precast concrete structures not designed and detailed for seismic loads.

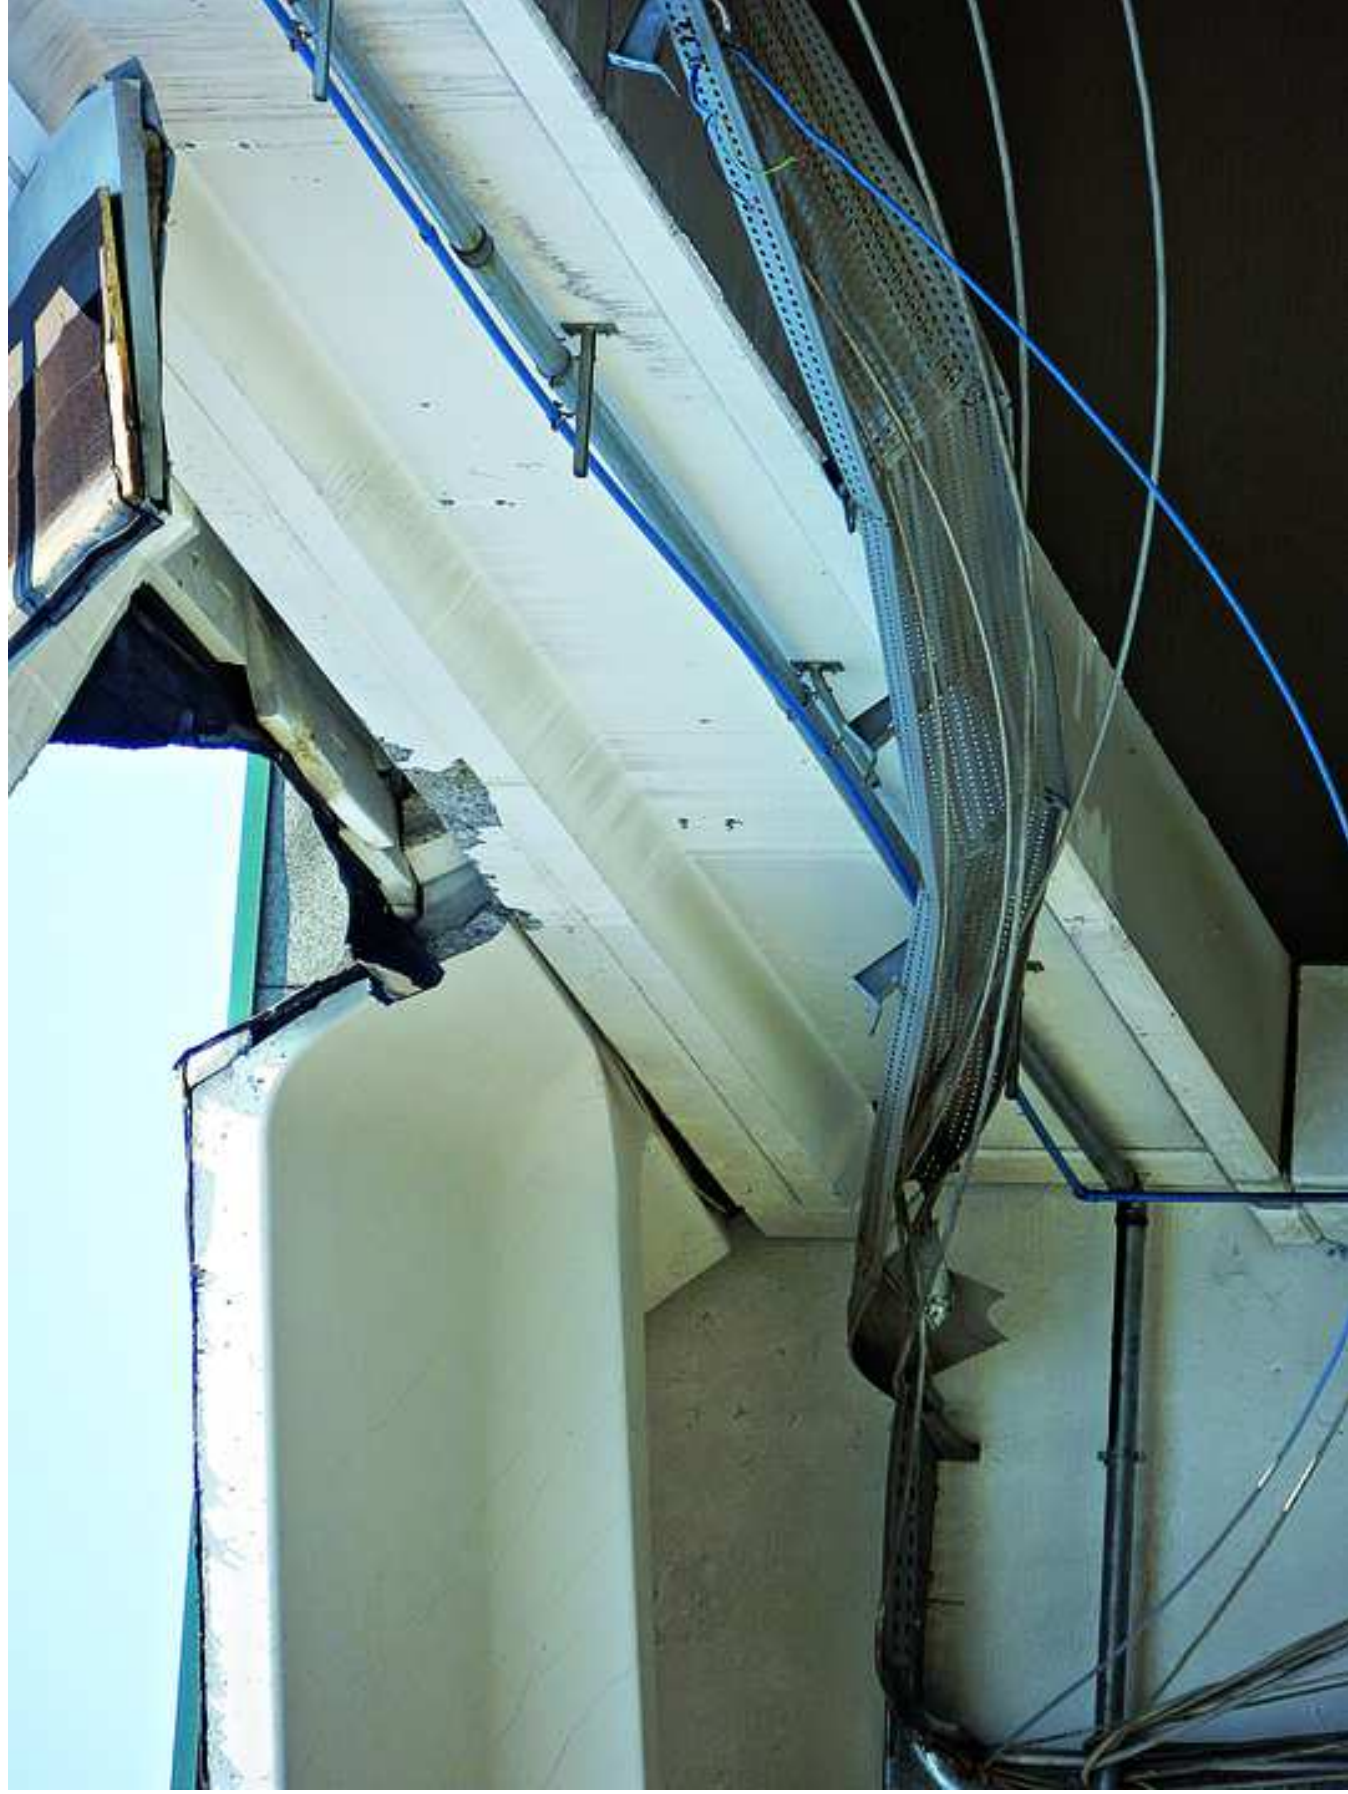
Figure 5
[Click here to download high resolution image](#)

As mentioned before, the most severe damage observed during the Emilia earthquakes is associated to the structural element loss of support and consequent falling, since the beam-to-column and roof-to-beam connections lacked mechanical devices as a seismic load transfer mechanism. Such type of collapse affected more significantly structures belonging to category A. Fig. 5 shows the loss of support of roof elements from the supporting beam, while Fig. 6 depicts the failure mode of a

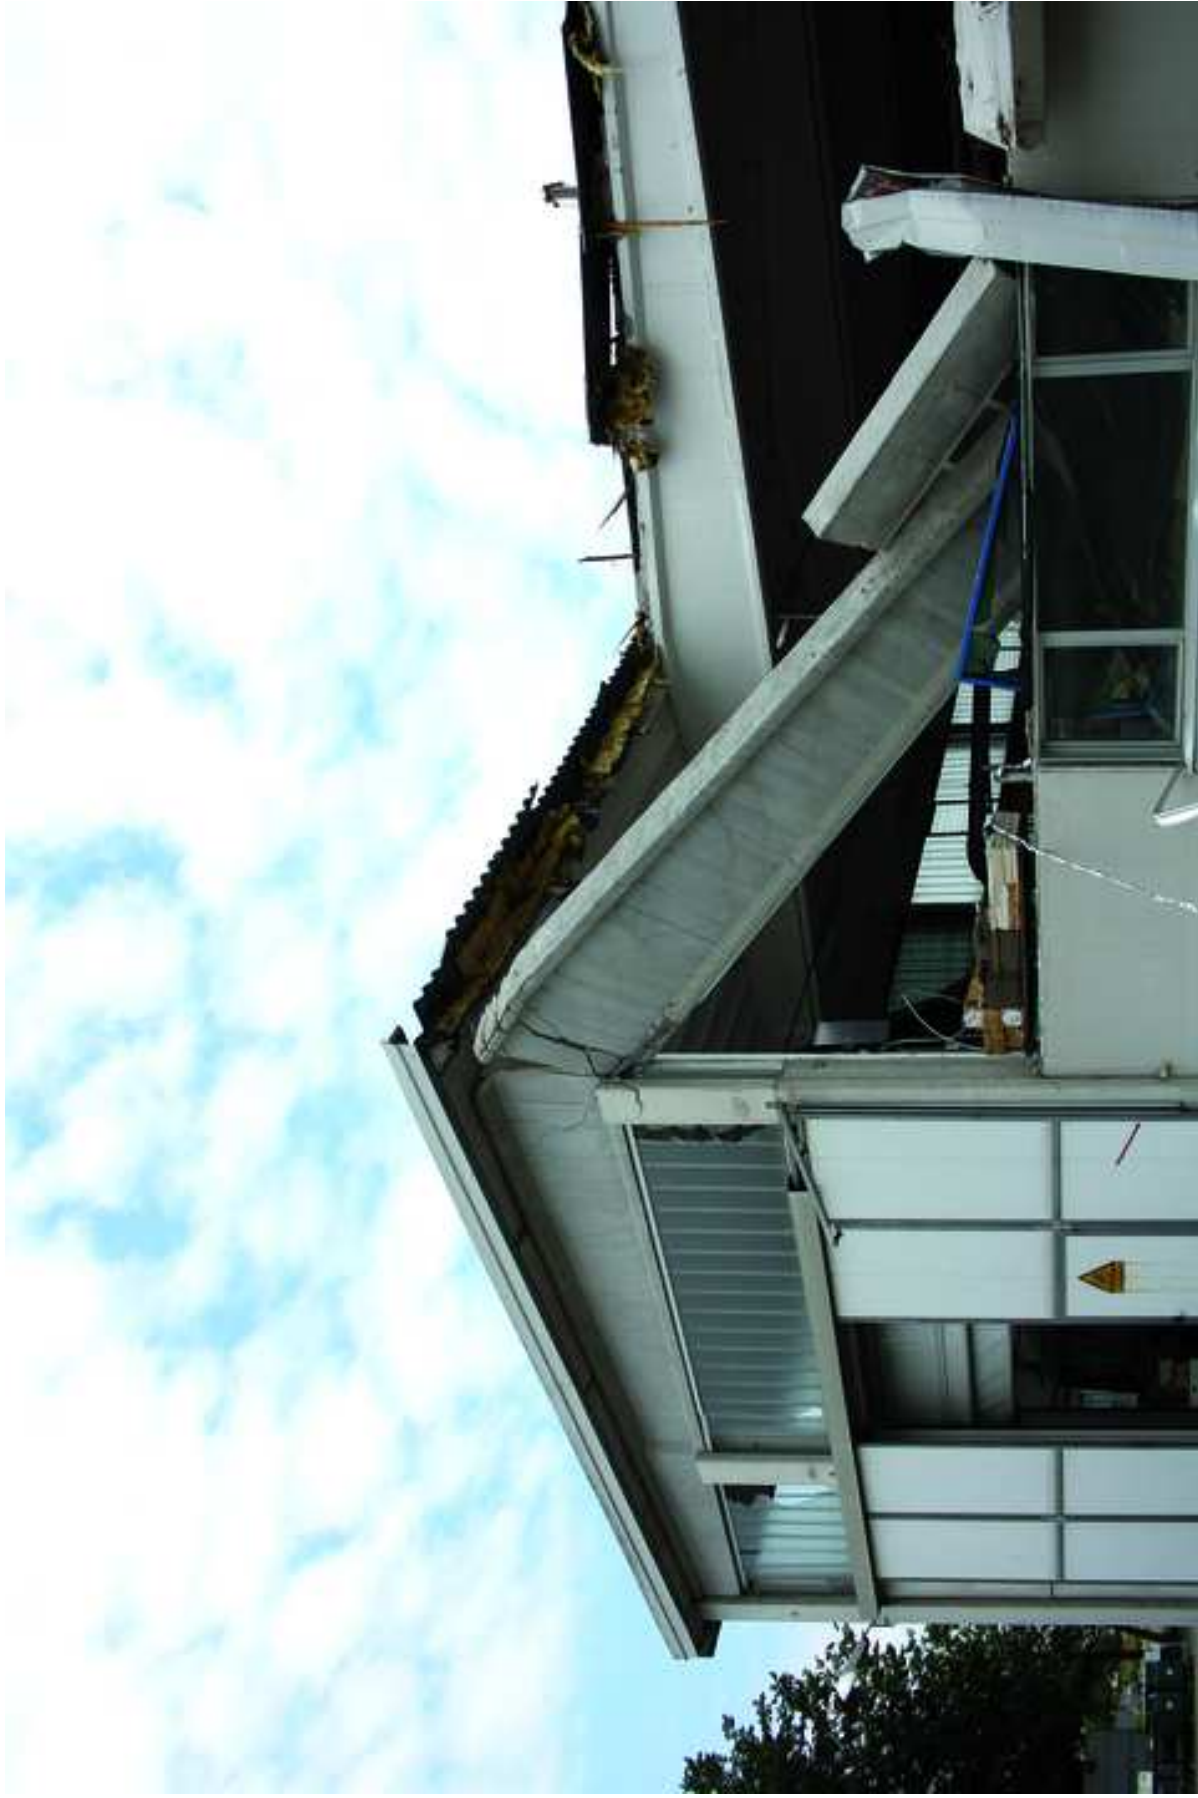
Figure 6

precast tapered I-beam due to its interaction with a column placed at the mid-span of the facade portal frame: designed as an element simply supported at its ends, the beam lost one of its supports during the earthquake and failed in flexure at mid-span, in accordance with a cantilevered static scheme not considered during design.

14 **Fig. 6. Precast tapered I-beam failure due to the loss of support**

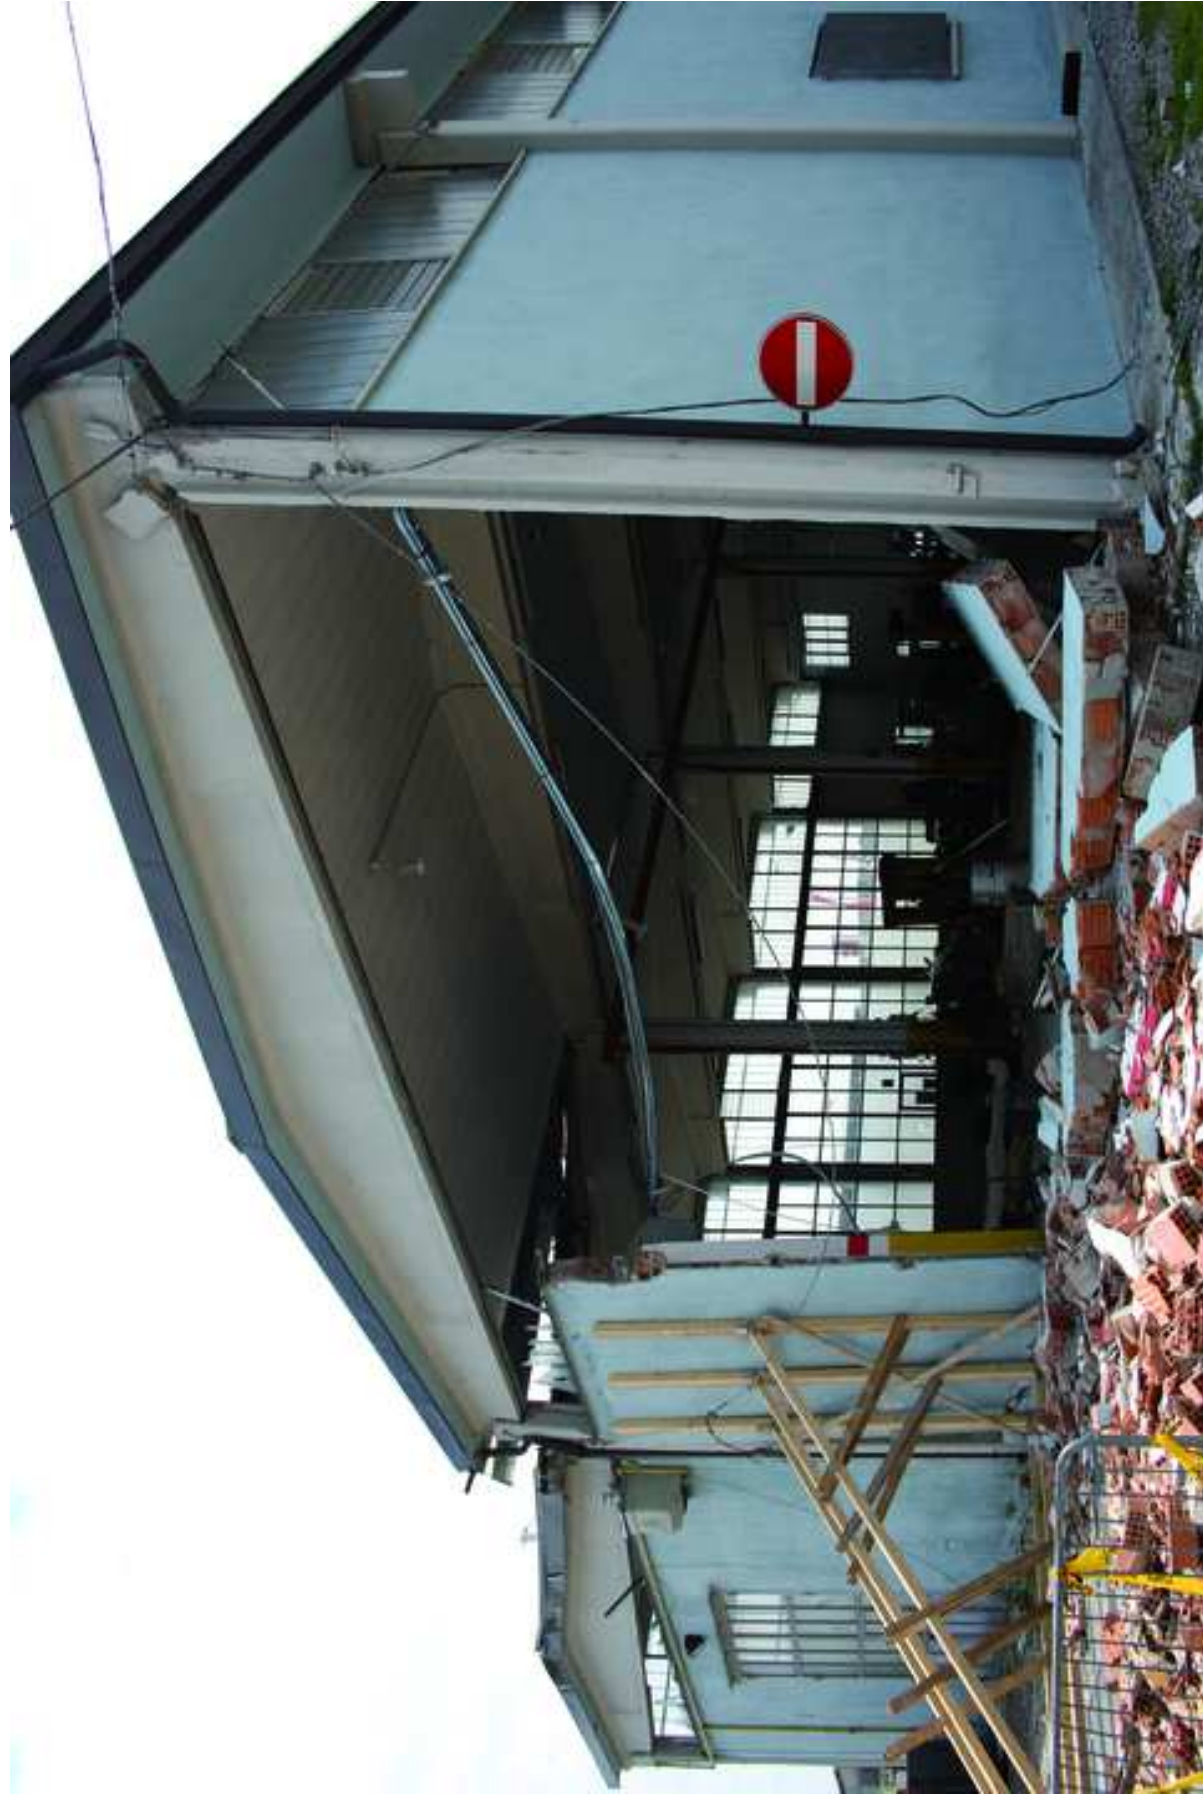
Figure 9

Another frequent failure typology observed is the collapse of the cladding panels, consisting both of brick masonry and precast RC elements. For what concerns the former, traditionally used in buildings of category A, the incipient collapse was observed to be associated with the high out-of-plane slenderness, as no lateral restraint was provided in correspondence to columns and RC spandrels (Fig. 9).

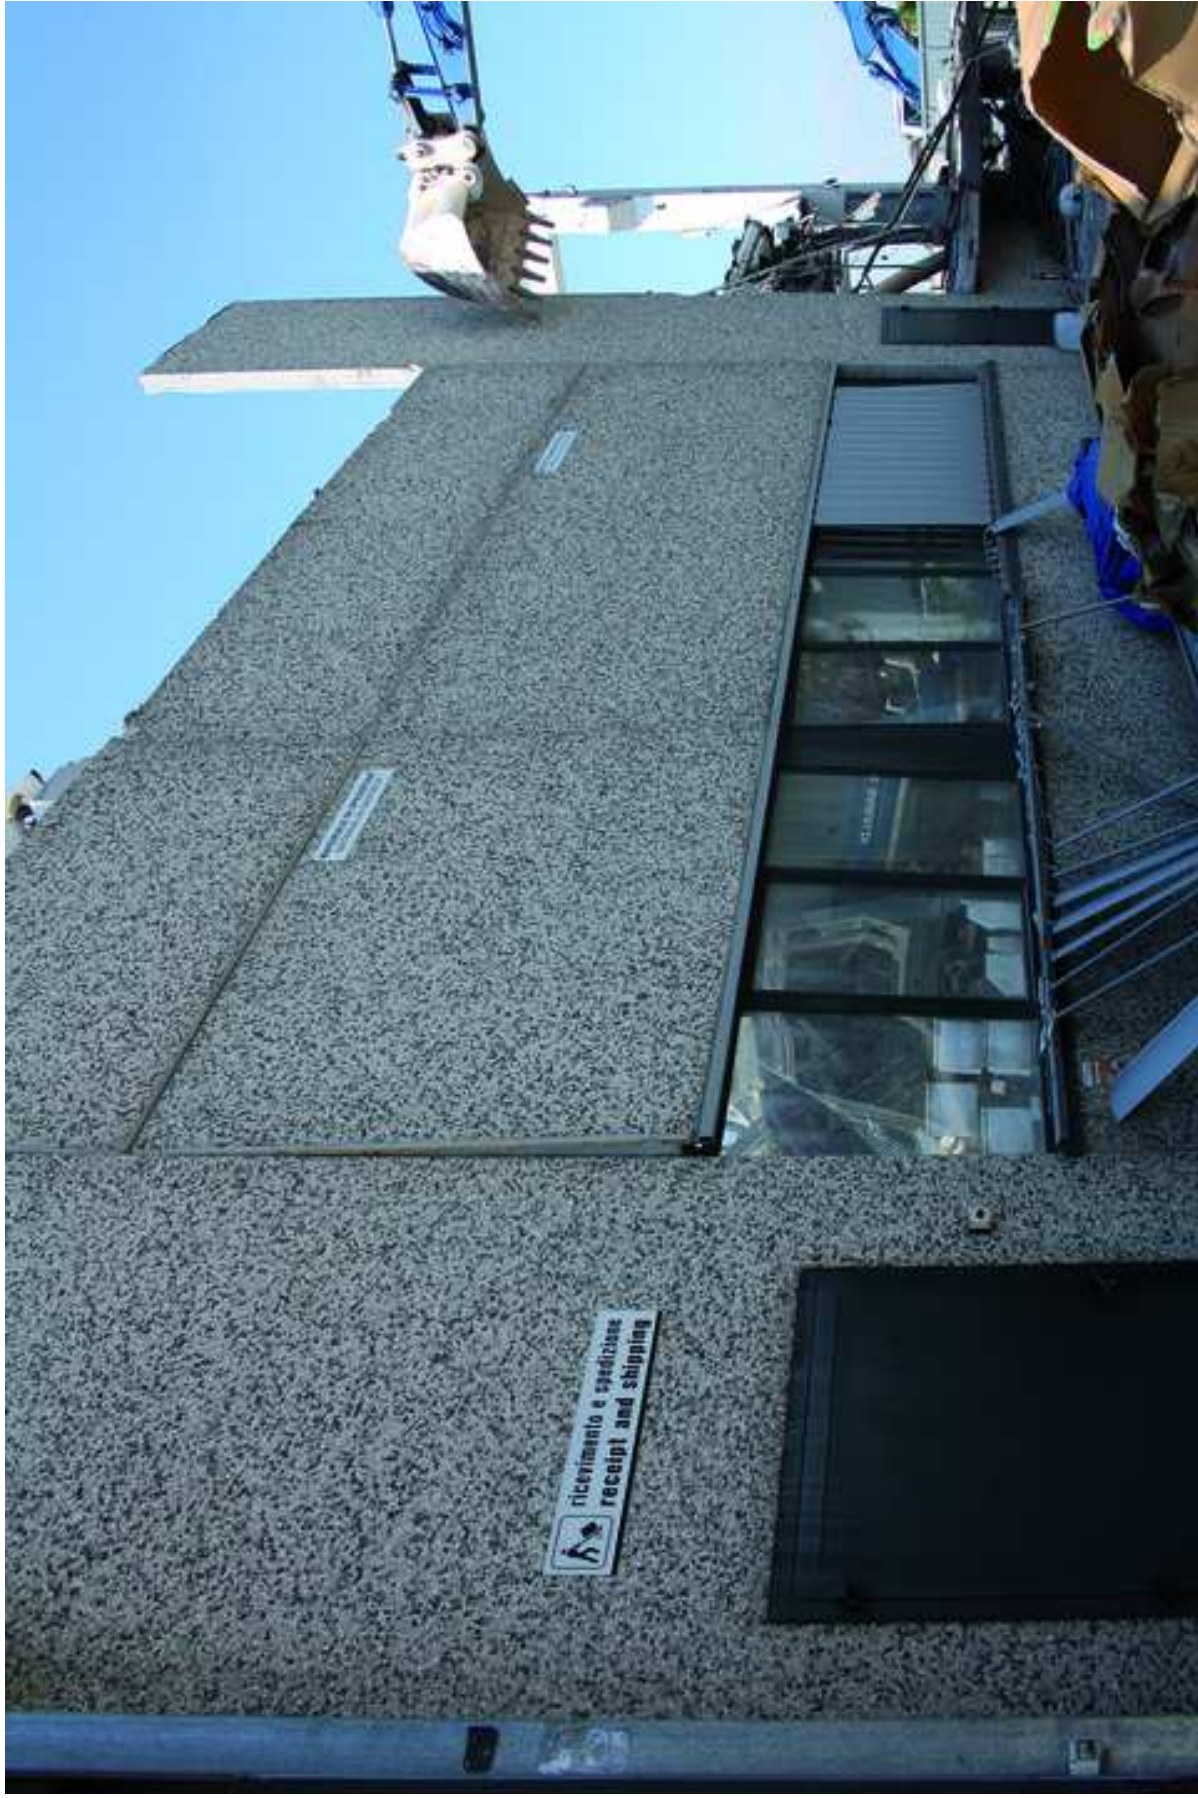
Figure 10
[Click here to download high resolution image](#)

Conversely, in structures of category B, the observed falling of horizontal (Fig. 10) and vertical (Fig. 11) RC precast cladding panels was clearly related to failure in the mechanical connections, typically anchor channels and C-shape or L-shape steel profiles, to the supporting columns and/or beams. In fact, these devices were designed to sustain mainly vertical gravity loads and to avoid the panel overturning as a consequence of low out of plane horizontal actions, such as wind loads. During an earthquake these connections need to accommodate high relative displacements and rotations, being the displacement and rotation demand concentrated at the connection level owing its lower stiffness compared to the connected precast elements.

The complex panel-structure interaction caused many collapses particularly in the case of irregularities along the height of the structure. Many horizontal panels dropped down, as anchor channels were absolutely not adequate to allow for large seismic displacement demands and, consequently, their plasticization induced the expulsion of the retaining bolts by prying action, particularly in the upper panels. On the contrary, vertical panels behaved slightly better; if properly fixed to their foundation beam or drowned into the industrial pavement, they stiffened and strengthened the building, however without inhibiting the previously observed vulnerabilities. By contrast, collapses were observed in the case of vertical sandwich panels, adopted for thermal insulation issues, characterized by lower stiffness and strength.

24 **Fig. 10. Horizontal precast cladding panels collapse due to connection failure**

Although retrofit solutions are beyond the purpose of the present paper, this seismic event seems to reaffirm the need of rationally conceived mechanical connectors to properly allow for displacement demand rather than try to make them work for unfeasible strain and load levels.

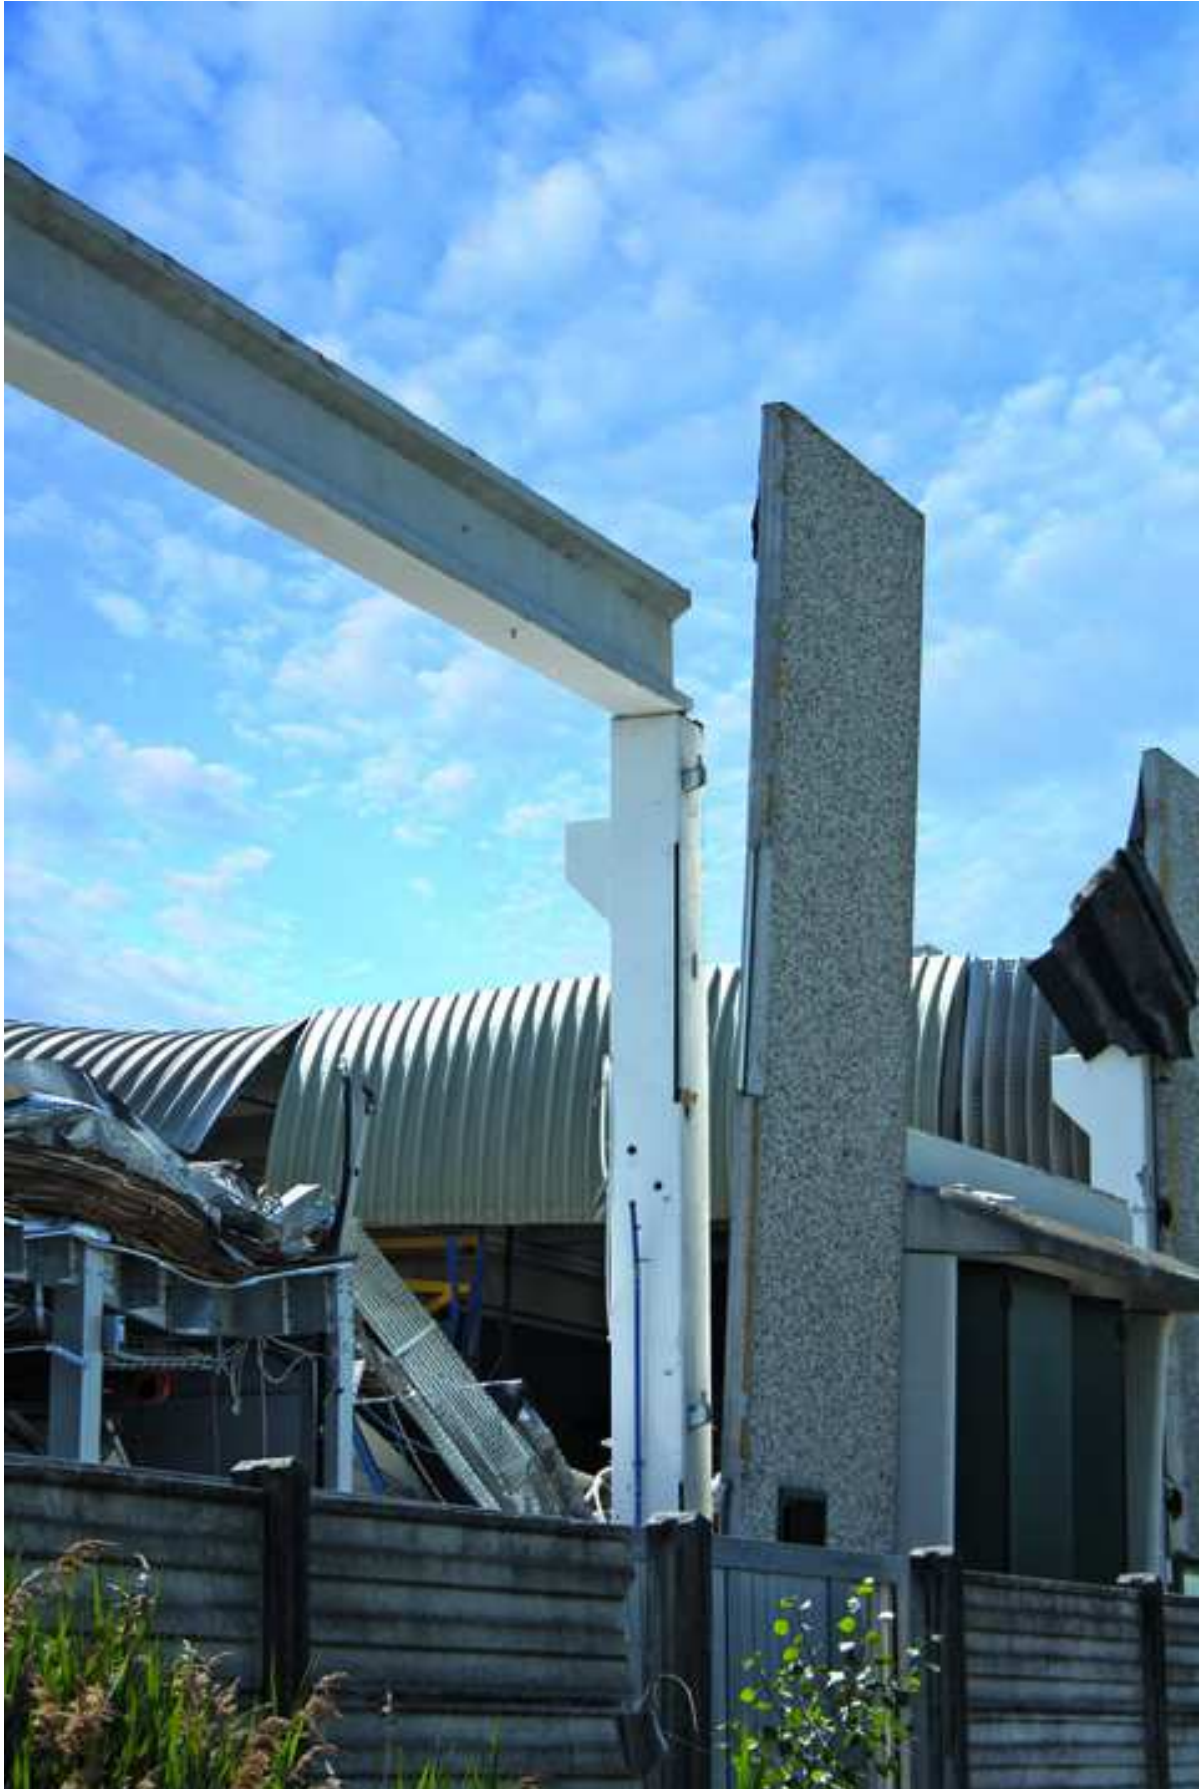
Figure 11
[Click here to download high resolution image](#)

26 **Fig. 11. Vertical precast cladding panels collapse due to connection failure**

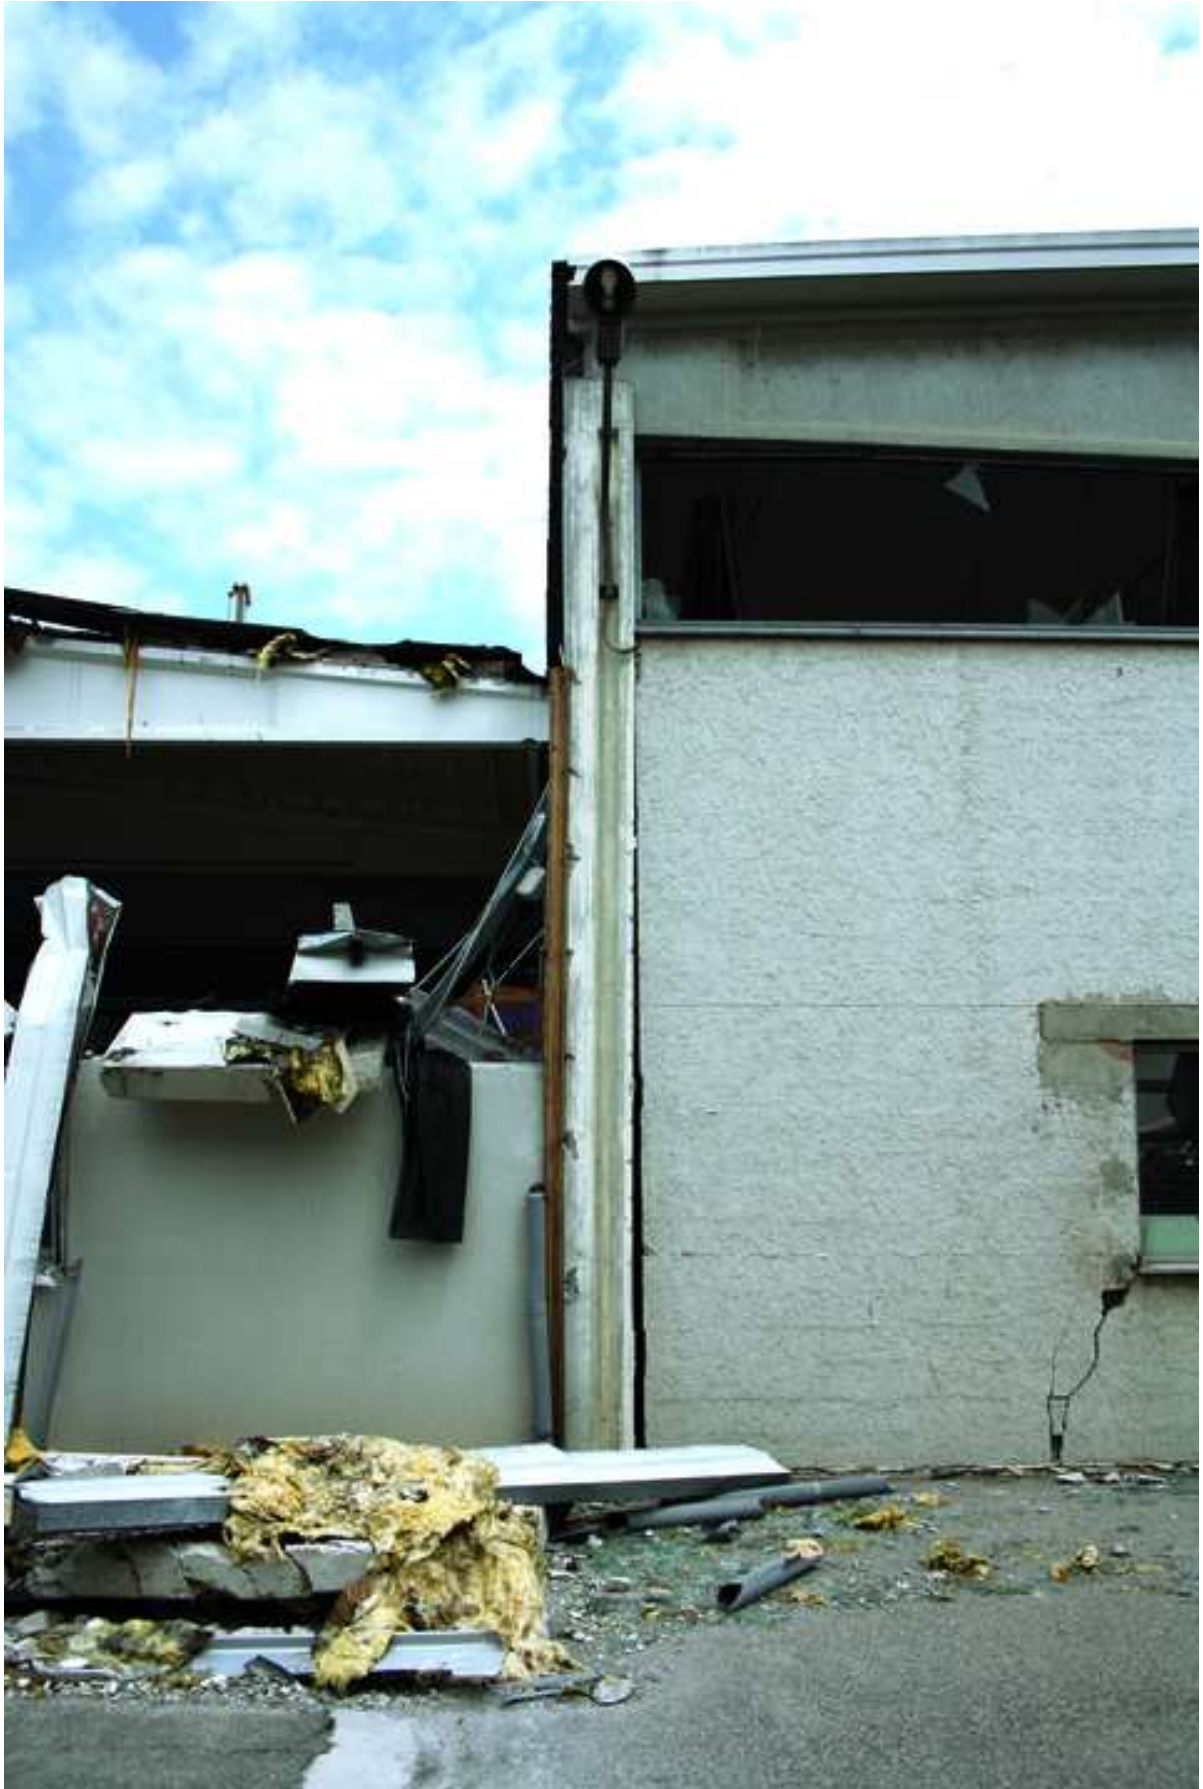
Figure 12
[Click here to download high resolution image](#)

Other damaged elements observed in Emilia are the columns. As depicted in Fig. 12 and 13, some columns lost their verticality due to permanent relative displacements and rotations experienced at

the foundation level, where socket foundations not designed for seismic loading were provided without additional interconnecting tie beams.

The presence of industrial RC floors and the loss of roof elements and beams could have contributed to this phenomenon: the former in providing only mono-lateral restraint to the columns relative movements, the latter in reducing the stabilizing gravity load. Such foundation typology was widely used since the nineties and it was commonly designed against the overturning induced by wind loads and industrial cranes only. Furthermore, being the foundations under-designed for seismic loads, they most likely experienced elastic uplift, considering the reduced foot print and the relatively high foundation vertical load safety factor. Proofs of uplift are provided by 45° cracks detected in the pavement in correspondence of the column edges.

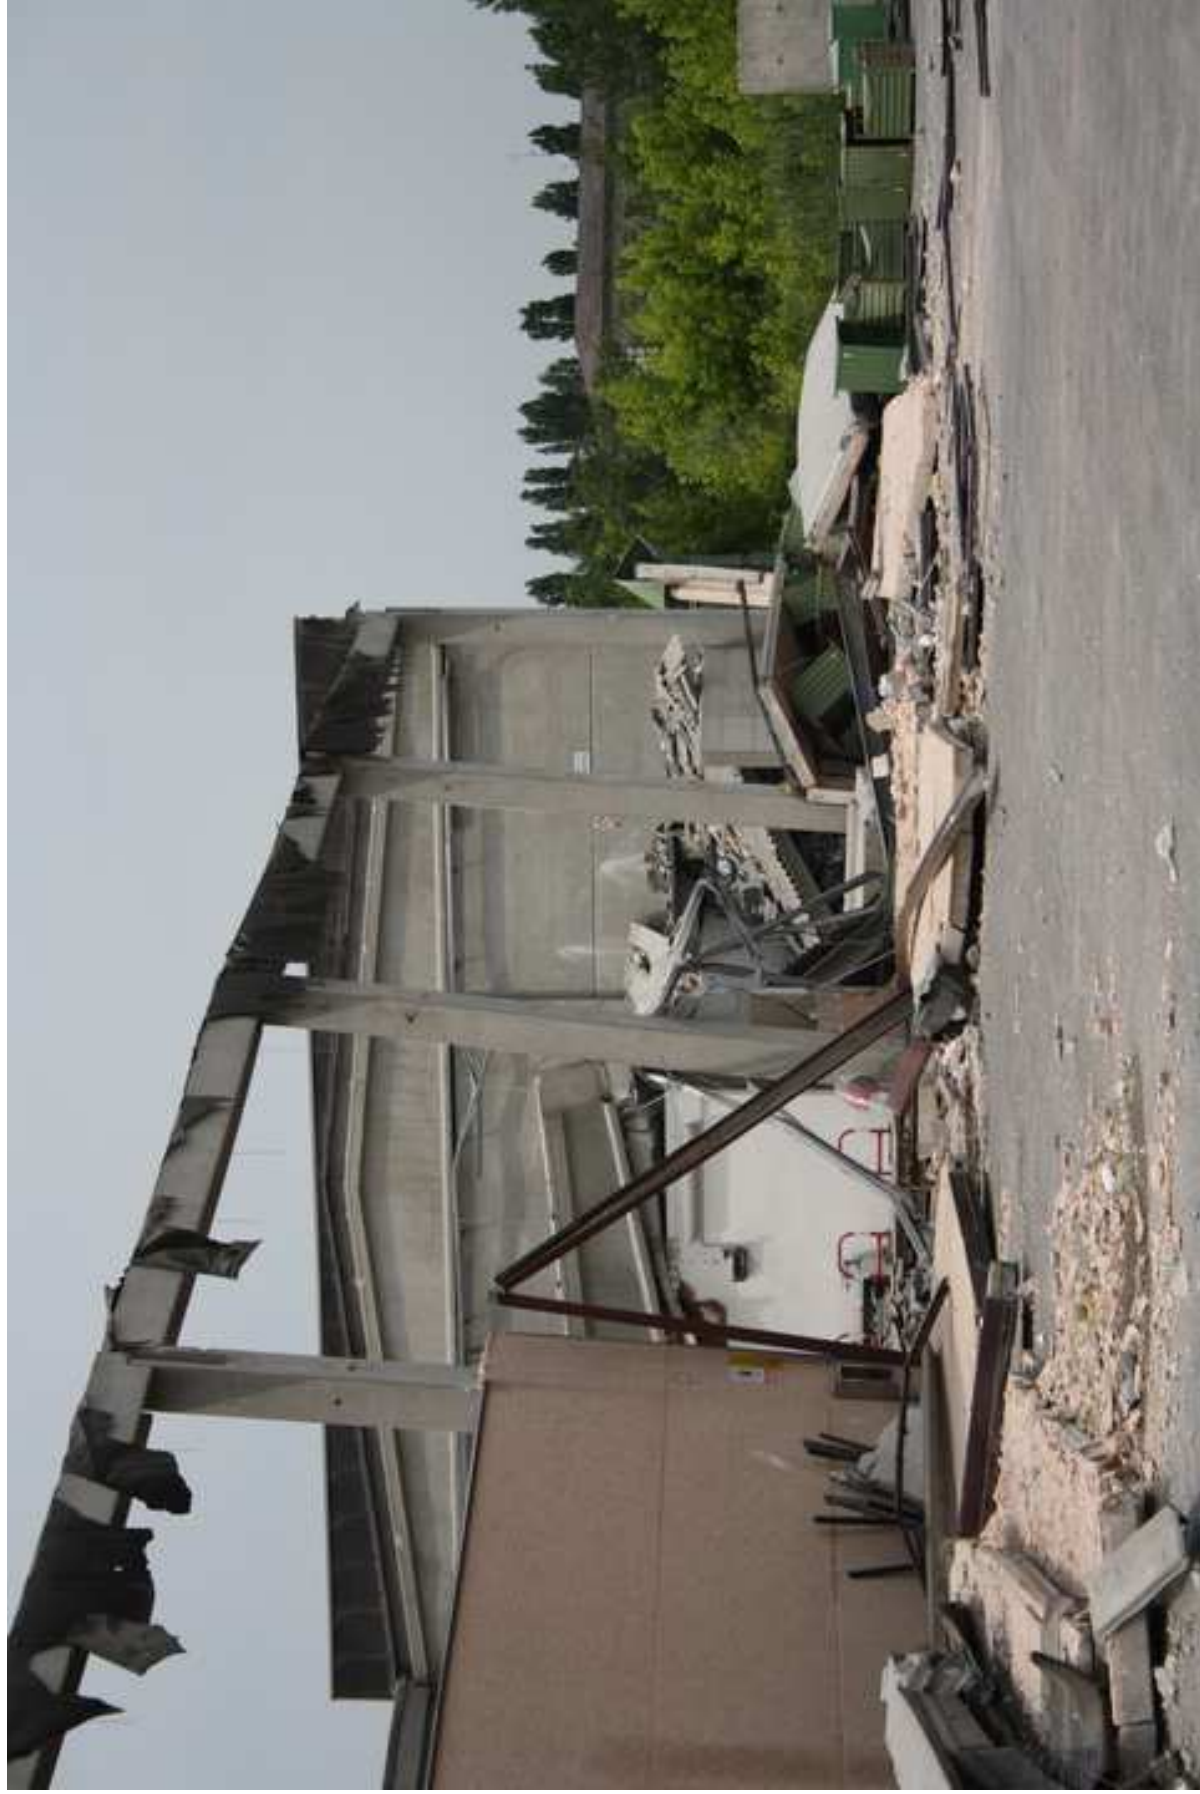
Figure 13
[Click here to download high resolution image](#)

- 29
- 30 **Fig. 13. Permanent rigid rotation of the columns in the isolated socket foundations**
- 31
- 32 **Fig. 14. Stocky-column failure due to the ribbon glazing and cladding panels discontinuity along the height**
- 33
- 34 **Fig. 15. Collapse of the forks at the top of the columns due to out-of-plane actions**

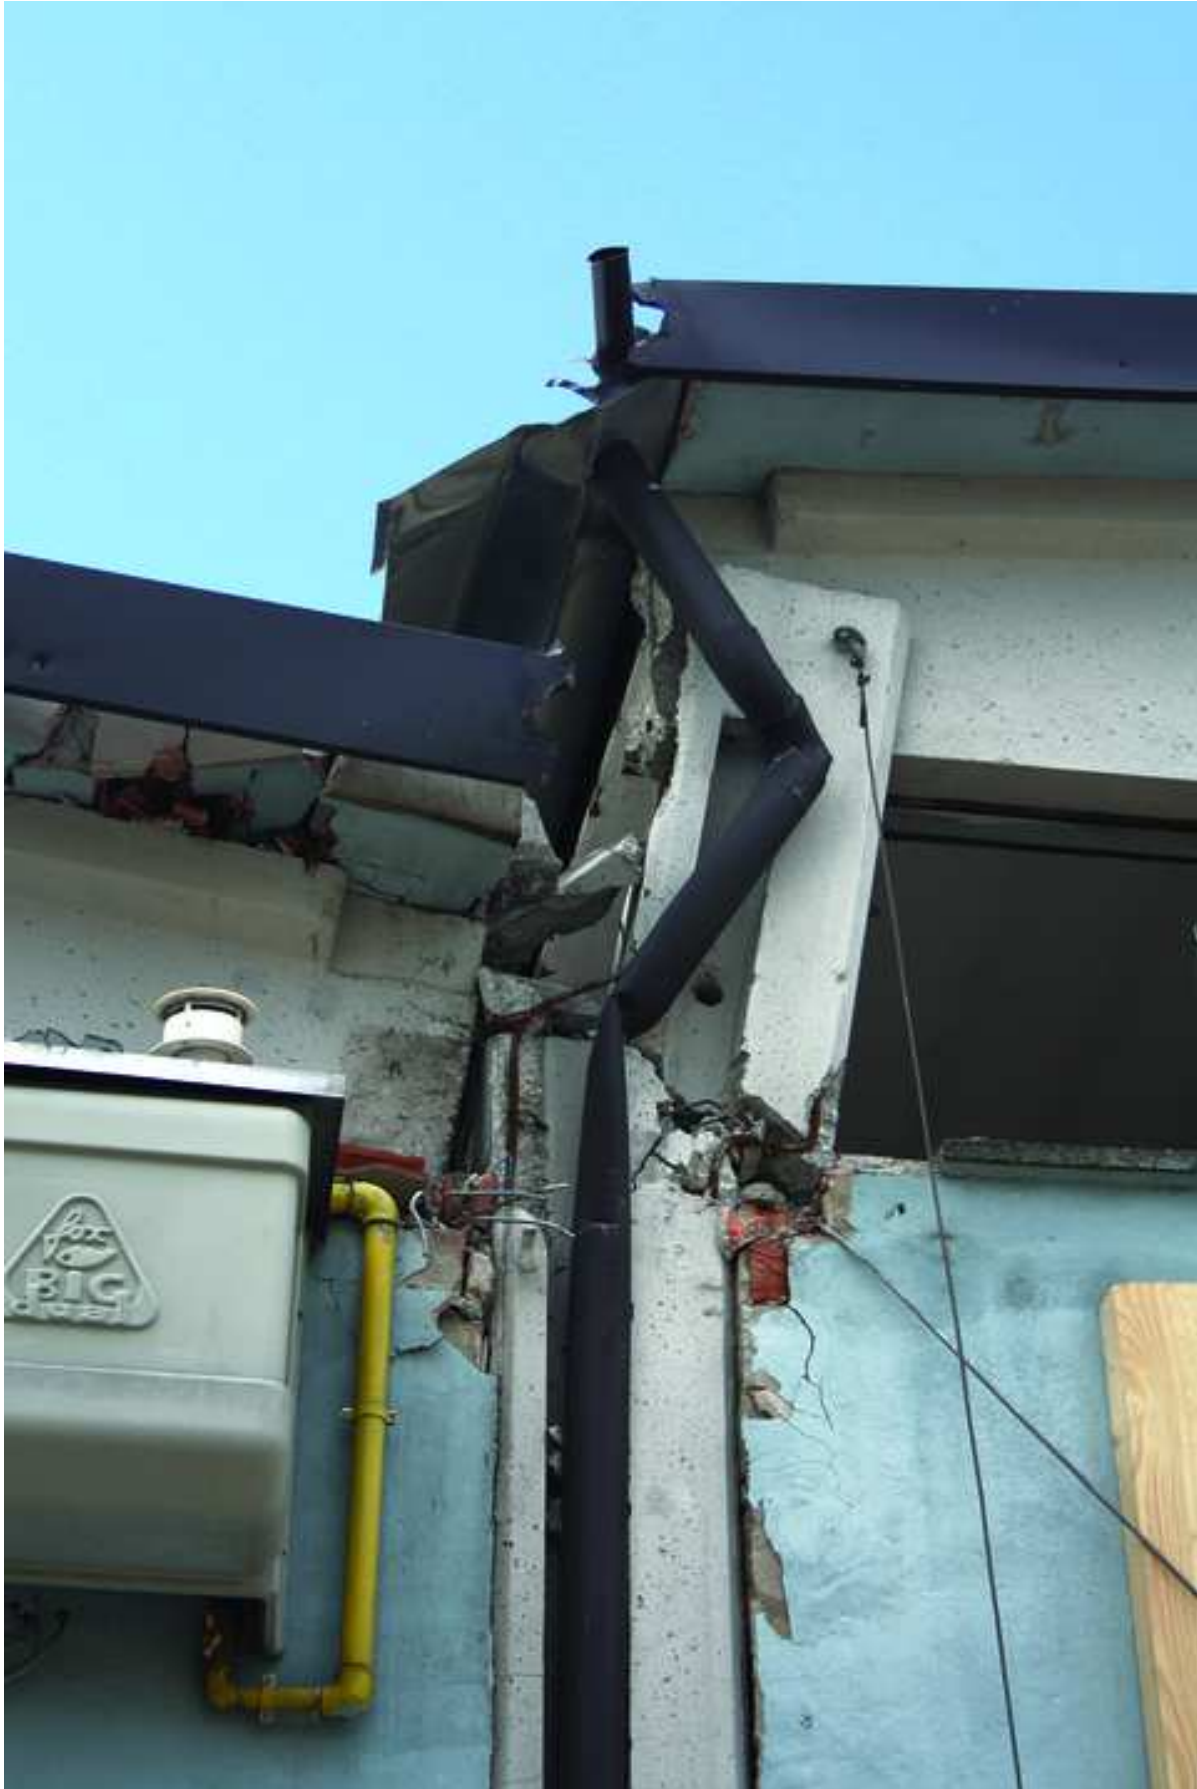
Figure 14
[Click here to download high resolution image](#)

Another column damage scenario is found in correspondence of ribbon glazing and cladding panels discontinuities where several stocky-column failures were noticed (Fig. 14). Furthermore, when RC forks were provided at the top of the columns, in more recent buildings, their flexural or shear capacities were clearly exceeded (Fig. 15), due to under-designed loads and poor detailing, therefore becoming ineffective in restraining the out-of-plane loss of the support.

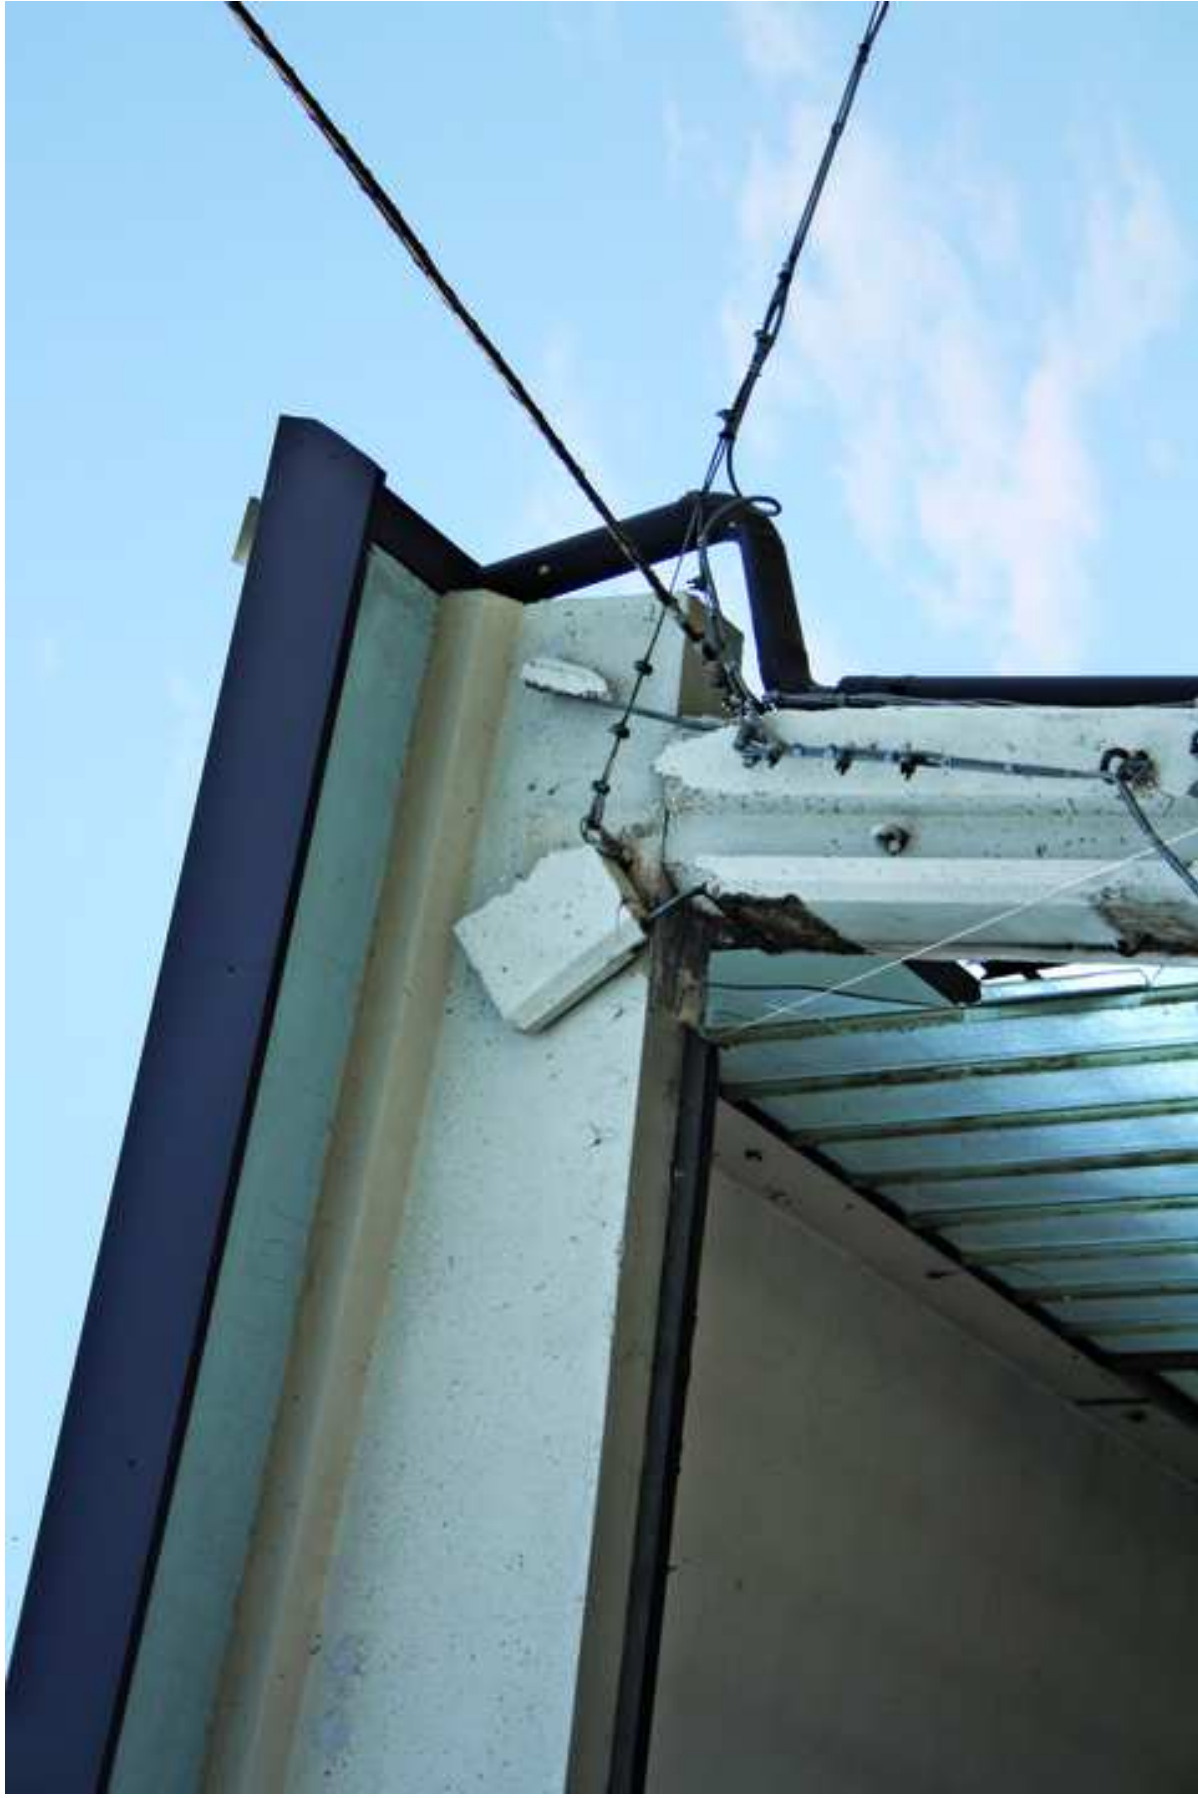
Figure 15
[Click here to download high resolution image](#)

The flexural and shear demand on existing RC forks at the top of the columns generally exceeded the capacity, leading to the inability of preventing the out-of-plane sliding and overturning of the framing beams. In addition, the columns were in some cases proven to rigidly rotate into the isolated socket foundations.
