SHEAR STRENGTHENING OF RC BEAMS WITH HIGH PERFORMANCE JACKET

Abstract

Keywords: Shear strengthening, High performance fiber, Reinforced concrete.

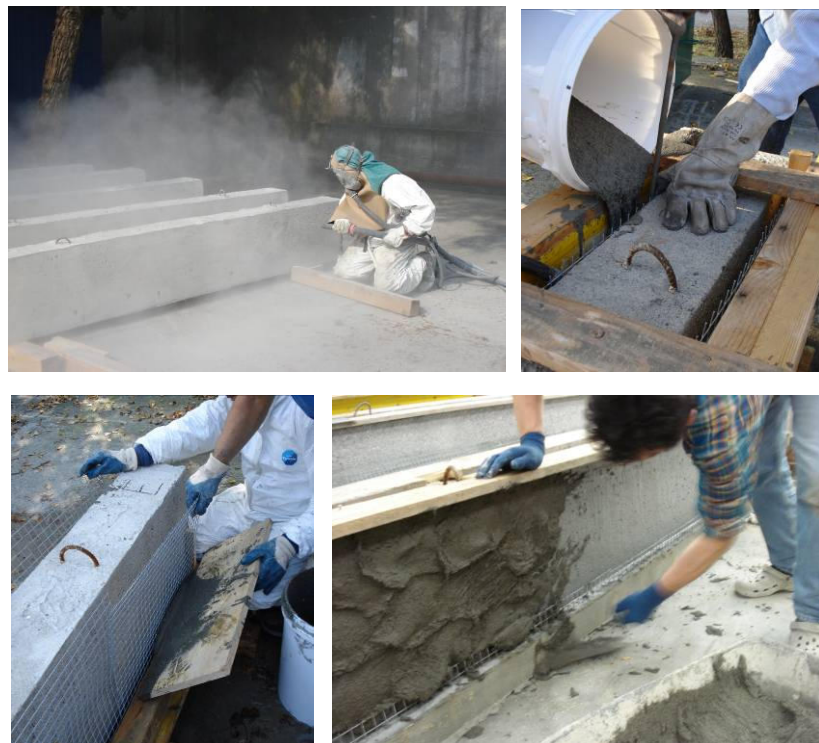
One beam was used as reference specimen while the other three beams were strengthened by applying a high performance jacket (**Tab. 1**). Firstly the beam were sandblasted in order to reach a roughness of about 1 mm, able to ensure a perfect bond between the existing concrete and the applied high performance concrete. This technique has been demonstrated effective in previous researches (Martinola et al. 2010). Eventually, the jackets were applied: for the self levelling material moulds were used while the thixotropic material was spread directly on the beam surface (**Fig. 2**). Within the thickness of the jacket was placed a wire mesh. This mesh is made of 2.05 mm diameter bent wires, assembled with a spacing of 25.4 mm. The results of the tensile test performed on single wires show a maximum strength equal to 550 N/mm².

Fig. 1 Sandblasted and jacketing application.

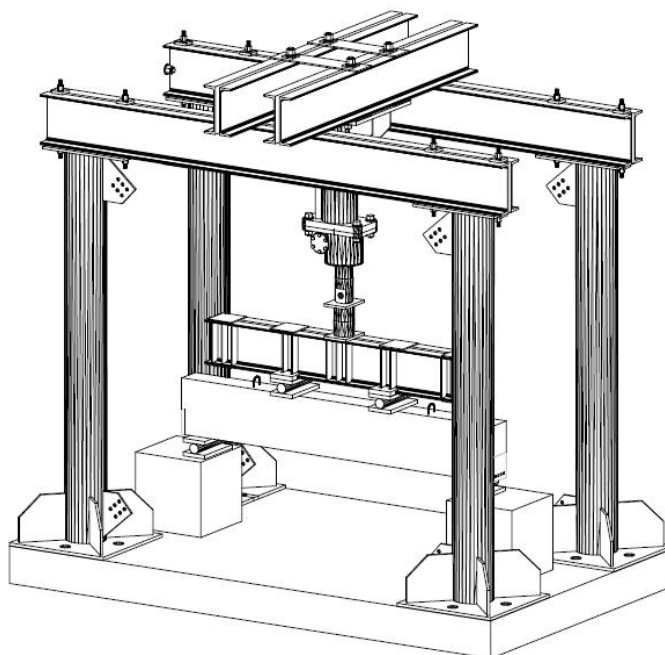
The beams were tested under a four point bending configuration, by adopting a steel reacting frame (**Fig. 3**). The load was applied by means of an electromechanical jack having a loading capacity of 1000 kN with a PID close loop control system. The test were conducted by imposing the displacement of the actuator with a constant speed equal to 0.01 mm/sec.

Fig. 2 Loading frame.

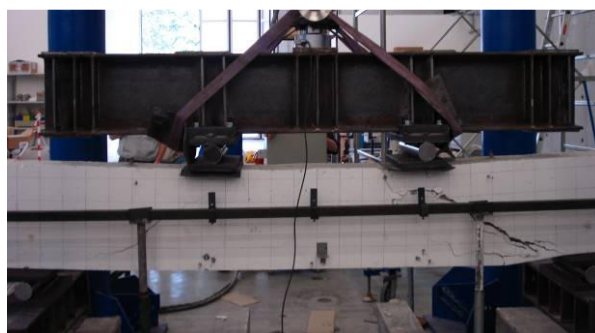
Fig. 7 Crack pattern at failure

At 450 kN load one of the shear cracks quickly widened. Together with both a sudden drop of load and the closure of all other cracks.

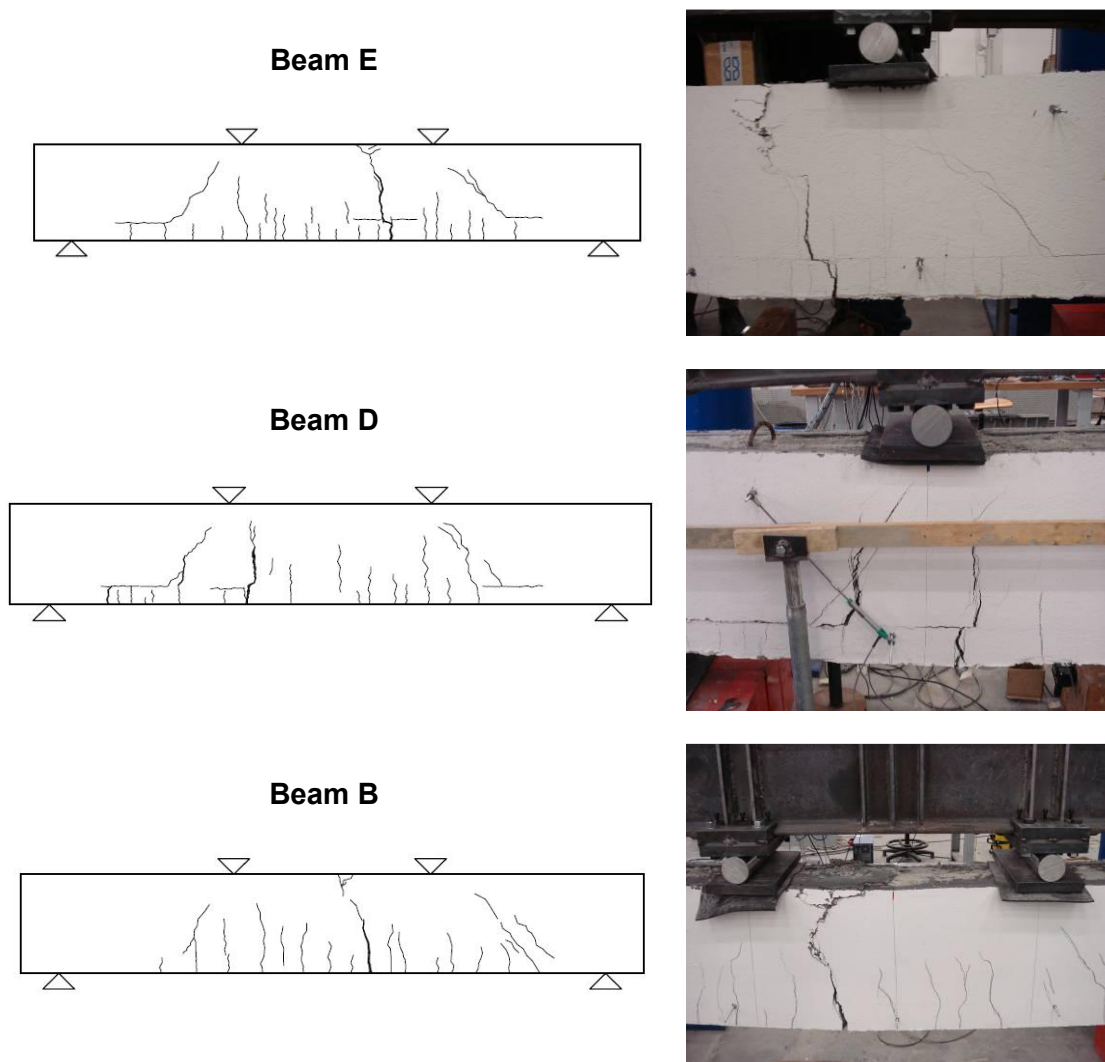
Furthermore, beams D and E displayed cracks located along the joint between self-levelling and thixotropic material (see Fig. 10). Such cracks developed roughly at the same time as did shear cracks and were located mostly in the shear regions between load points and supports.

Fig. 9 Crack pattern at failure for the beam with HPFRC jacket
