A VULNERABILITY INDEX EVALUATION FOR MASONRY BELL TOWERS IN VENICE

Giulio Mirabella Roberti¹, Michele Bondanelli², Francesco Trovò³

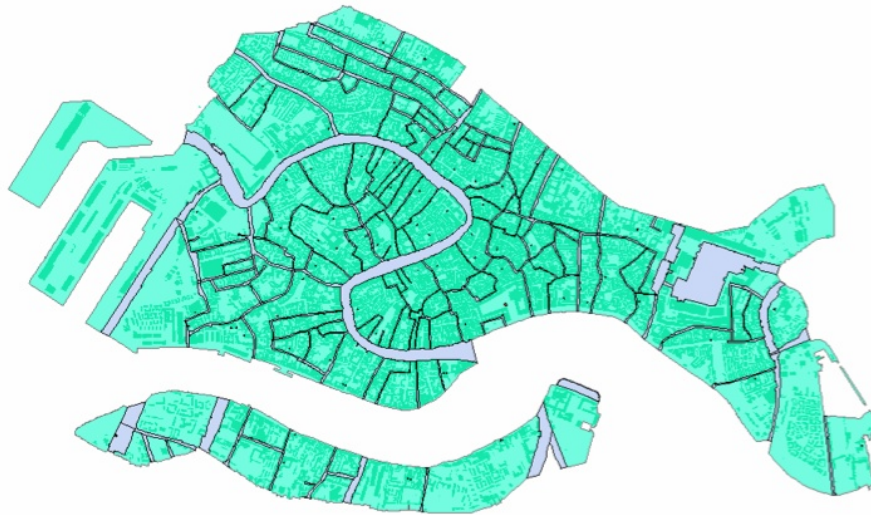
Fig. 2 A GIS screenshot with a general map of Venice and the location of the classified bell-towers

The first task of the research was to analyze and organize the data collected in the previous survey realized by the Cultural Heritage Office⁵, by transferring them on a geo-referenced support (GIS) in order to make the data inspection easier. The data collected in the *Survey and Control of bell towers of Venice* constituted a very important source for the study of these buildings: the survey was addressed to the whole complex of bell towers in Venice and surroundings, covering around 90 buildings, and focuses on different aspects:

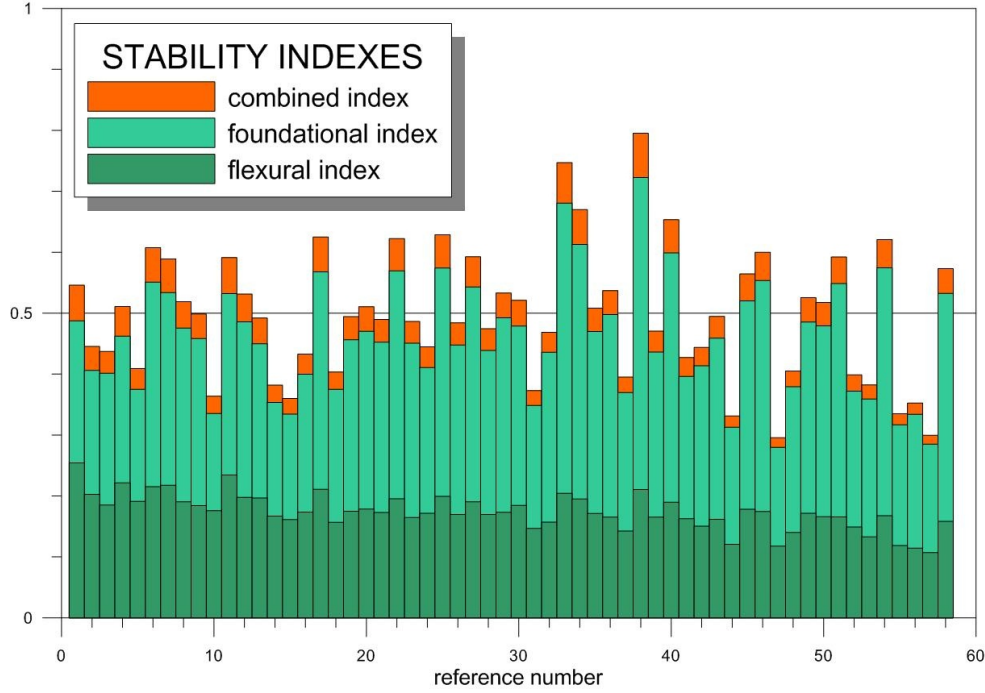
Fig. 3 Comparison of calculated stability indexes

increase of the base side of 1.2–1.4, giving an increase in the moment of inertia of 2.07–3.86. The subsoil reaction constant k_W for Venice was assumed equal to 2500 kN/m³. Moreover, we observe that it is possible to calculate the stability limit for a deformable heavy bar elastically pinned at the base, combining in this way the two results above, but the critical height can not be obtained in a closed form [8]; so one possibility is for example to combine the two indexes already obtained (eq. 5) and (eq. 7), resulting $i_W > i_E$, as:

$$i_{\text{inst}} = i_W \sqrt{1 + i_E} \quad (8)$$

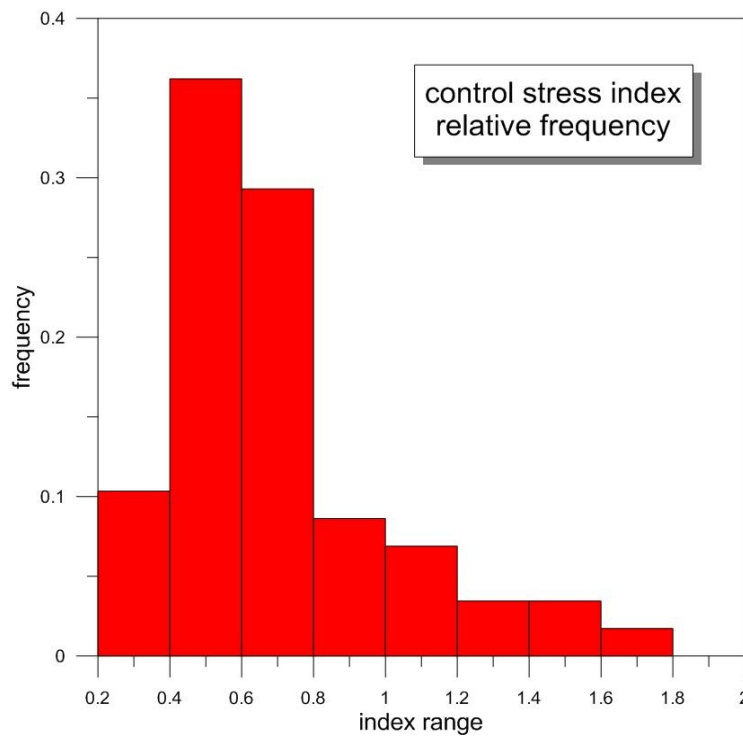
Fig. 4 Frequency distribution of control stress index

The statistical distribution of the values is highly asymmetric (the mean value is 0,69 and the median is 0.61), with a peak value around 0.5 and the tail on the upper side, suggesting a particular attention to be addressed to the more vulnerable elements.

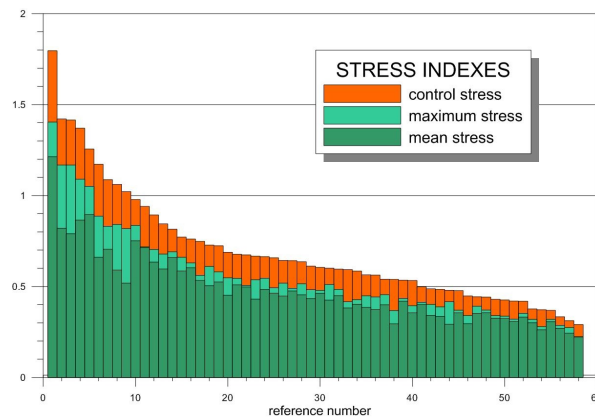
Fig. 5 Comparison of calculated stress indexes shown in decreasing order

As we can observe in Fig. 5, the vulnerability index defined above (eq. 11) can result greater than 1, due also to the growing effect of the instability index at the denominator; when this happens, it has to be interpreted as an alarming signal, that requires a more detailed analysis.

In our simulation, 9 bell-towers over 58 attain a risk index greater or equal to 1, and 5 have a value greater than 1.25; one in particular attains a value of nearly 1.8, that certainly means a very high vulnerability.

Often, but not always, this is due to a mean stress index > 1 , that means a static stress very high compared to the material characteristics observed (and to the assumed allowable stress), increased by the sensitivity to risk of instability: this seems anyway to give a meaningful parameter.
