Article

Effect of Load on the Corrosion Behavior of Friction Stir Welded AA 7075-T6 Aluminum Alloy

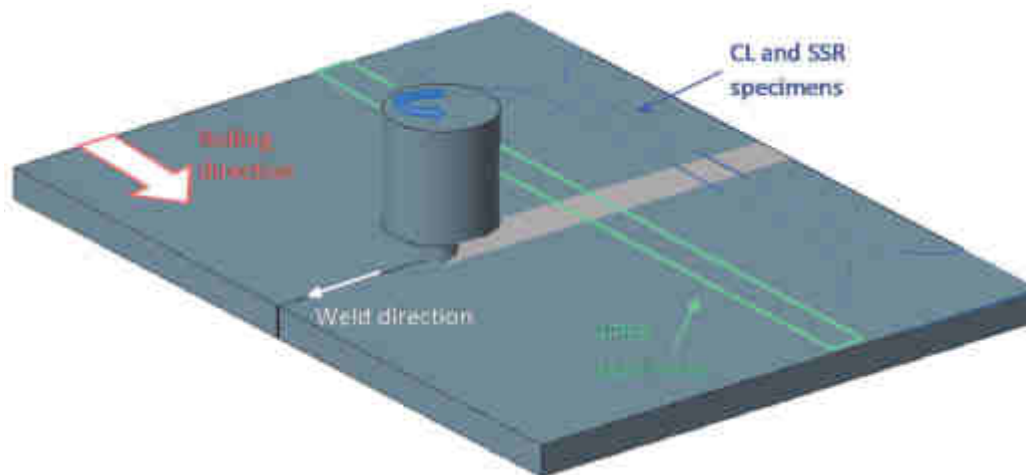
Figure 1. Schematic representation of specimens obtained by means of friction stir welding (FSW) welded sheet (draw not in scale).

Four-point bending (4PBB) tests have been performed according to ASTM G39 on 4 mm × 20 mm × 160 mm prismatic specimens obtained by FSW joints (Figure 1). The specimens were polished by emery papers up to 1000 grit and degreased in acetone in ultrasonic bath for 5 min. After polishing, the specimens were left in still air for 48 h to allow the formation of the protective film.

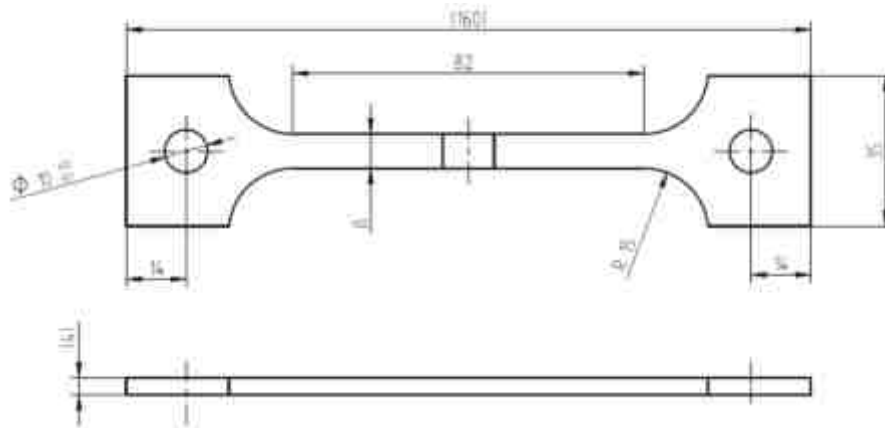
Figure 2. CL and SSR specimen: the weld is in the center of the gouge length, the thermomechanical affected zone/heat-affected zone (TMAZ/HAZ) extension is 40 mm for each side.

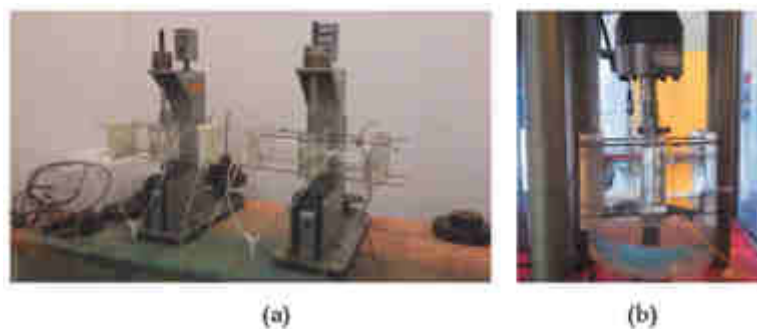
Figure 3. CL test device (a) and SSR test device (b).

The SSR tests were carried out by using specimens of the same dimensions as the CL tests. The set-up of the tests is shown in Figure 3b. The tests were carried out on a 30 kN testing machine at displacement rates varying from 5×10^{-7} to 5×10^{-3} mm/s. A displacement rate of 8.2×10^{-4} mm/s was used in order to have a strain rate of 10^{-6} s^{-1} as average value on all the gage length. During the tests, the load and OCP were measured continuously. At the end of the tests the specimens were washed in distilled water and rinsed in acetone to permit the observation of the fracture surface under the SEM. Then the specimens were longitudinally sectioned for the metallographic observation.

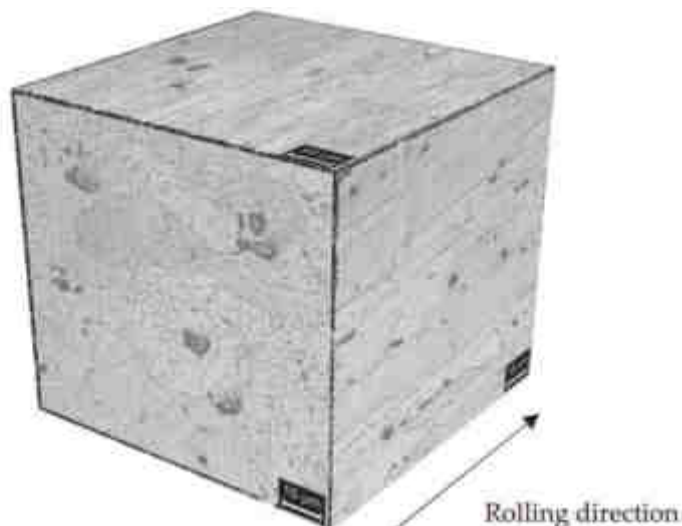
Figure 4. Optical image (Keller attack) of the alloy AA 7075 T6 (base material). Elongated grains along the rolling direction and the macro-precipitates are visible.

The microstructure of the AA 7075 T6 alloy has already been presented in [26]. Coarse precipitates along the grain boundaries (Figure 4) and micrometric precipitates within the grains of α -Al, oriented in the rolling direction [28], can be well demonstrated. The strengthening MgZn_2 nanoprecipitates

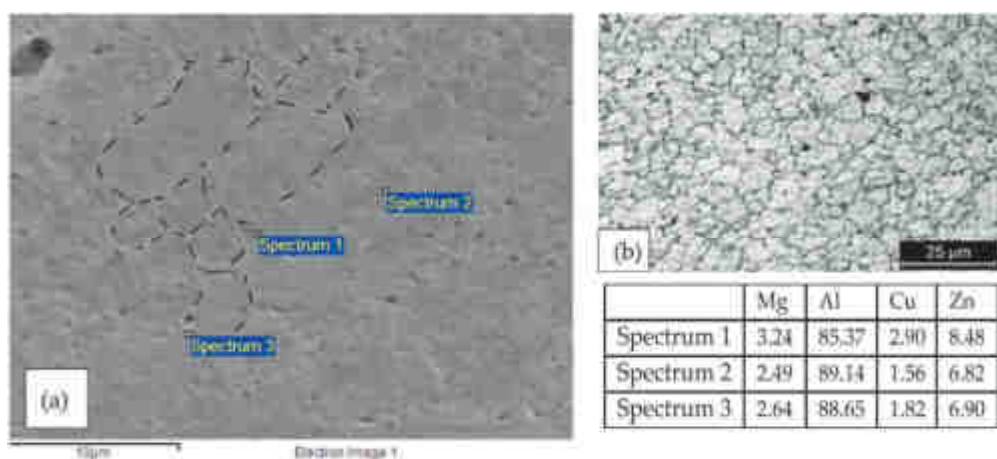
Figure 5. (a) SEM image of the nugget of the FWS 7075 alloy (no metallographic attack) the rounded recrystallized grains are visible owing to the precipitates of $MgZn_2$ on their grain borders and EDX spectra in which is visible an enrichment of zinc and copper in the correspondence of the precipitates. In the image the grain border is demonstrated; (b) optical image of the nugget with metallographic attack (Keller’s reagent) that better demonstrated the rounded recrystallized grains.

In the nugget, re-crystallized fine equiaxed grain structure can be noticed. In addition, $MgZn_2$ strengthening precipitates are dissolved (T6 artificial aging temper) into the supersaturated solid solution and reprecipitated after cooling (Figure 5). Venugopol et al. affirmed that the temperature obtained during the process is below the melting temperature of the alloy, but above the solutioning temperature, as demonstrated by the re-crystallization of the weld nugget and the redistribution of the precipitates [21]. For the same authors, the absence of fine precipitates in the weld nugget indicates that the cooling rates are such that larger precipitates could nucleate and grow but not the finer ones. In the TMAZ, the precipitates are quite random, and the coarsening of finer precipitates observed in base material can occur during welding [21].

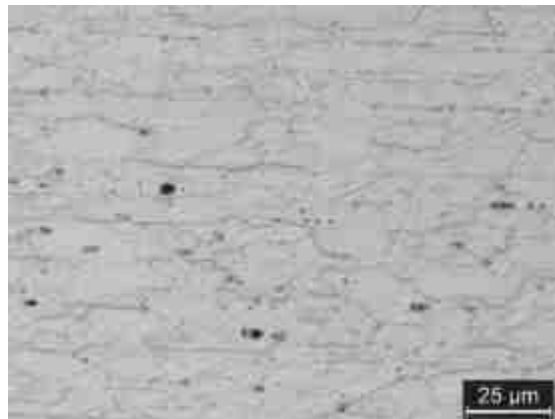
Figure 6. Optical image (Keller attack) of the HAZ of the FWS AA 7075 alloy. The grains appear elongated along the rolling direction; presence of macro-precipitates is evident.

The size of the precipitates at the grain boundaries of the HAZ (Figure 6) is unfortunately too small to permit their observation under the SEM, but many transmission electron microscope (TEM) observations were reported in the literature and they demonstrated that these smaller precipitates play a fundamental role in the intergranular corrosion and the SCC of these alloy series [18].

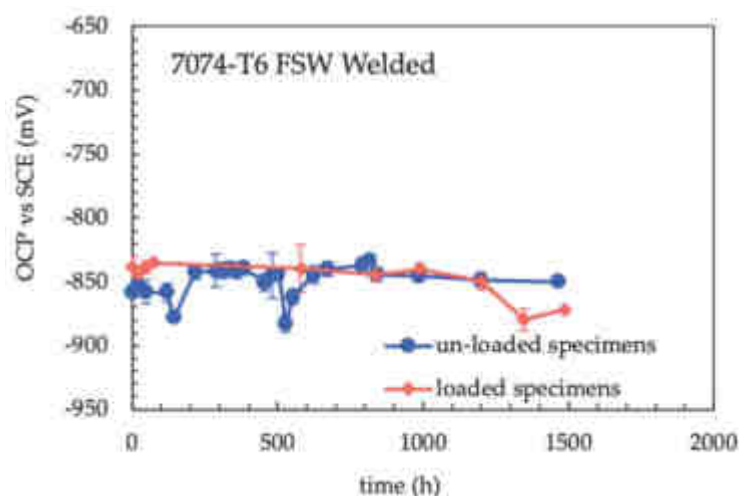
Figure 7. Open circuit potential (OCP) vs time for loaded and unloaded 4PBB specimens. The decreasing of the OCP of the specimens in the correspondence of the partial refresh of the test solution that breaks the aluminum oxide scale and exposes fresh metal surface to the aggressive solution.

The OCP measurements (average values of four specimens) did not show any evident differences between 4PBB loaded and unloaded specimens (Figure 7). The corrosion potentials generally were in the range of -870 – -840 mV vs SCE; the corrosion potential showed a sharp decrease during the solution refresh owing to the partial removal of non-adherent scale of corrosion products that exposes the corroded surface on the fresh solution; after this, the corrosion potential increases to the same potential values detected prior to the partial substitution of the testing solution. This effect was more marked for specimens without loading compared to loaded specimens. The corrosion potential of the loaded specimens decreases after 1300 h, then it increases again. Compared to the values obtained by the analysis of the three different zones (nugget, TMAZ/HAZ and base materials—Figure 8) similar results can be outlined in both the TMAZ/HAZ and the nugget. The base metal showed slightly nobler potential values.

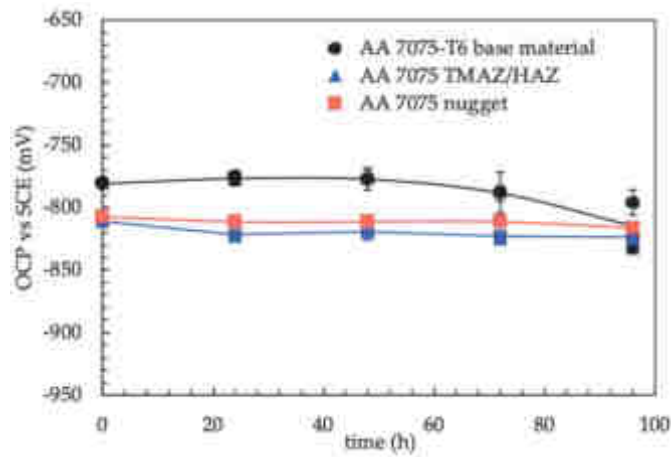
Figure 8. OCP vs time of the different zones (base materials, TMAZ and nugget) of the alloy AA7075 T6.

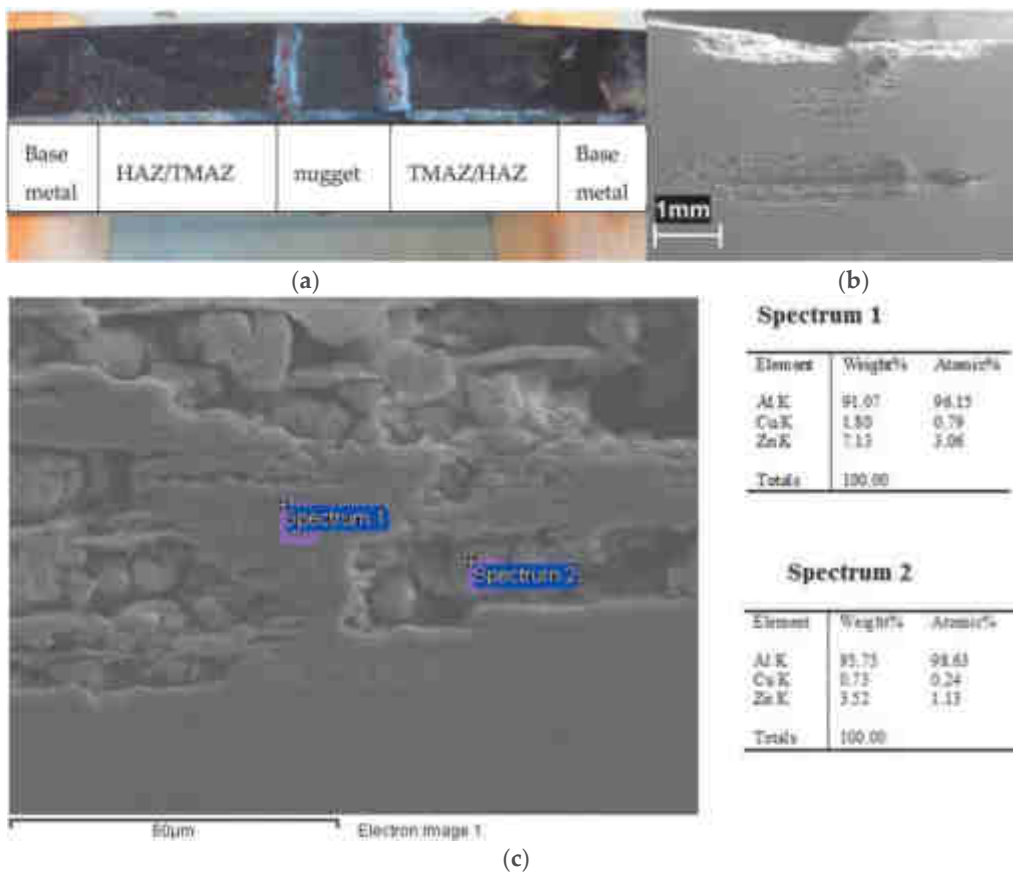
Figure 9. (a) Image of a 4PBB specimens after the test: an intense localized attack in the correspondence of the TMAZ and (b) SEM image of the metallographic longitudinal section of the loaded specimen in which is visible the deviation of the attack along the rolling direction, (c) particular of the attack and EDX analysis.

Figure 9a shows the corrosion morphology of the specimens at the end of the 4PBB tests. No differences in the corrosion morphology were observed between the loaded and unloaded specimens. The HAZ is preferentially corroded. The attack propagates along the grain boundaries, following the rolling direction (Figure 9b). The EDX analysis (Figure 9c) demonstrated the depletion of zinc and copper in the corroded zone (Spectrum 1) with respect to the un-corroded zones (Spectrum 2).

The fractographic analysis of the specimens demonstrated the microcracks initiation preferentially at larger precipitates. The nugget and the TMAZ/HAZ showed lower OCP, thus indicating higher susceptibility to corrosion than the base material. No SCC microcracks propagation was noticed at the nugget due to the large size of the strengthening MgZn_2 micro-precipitates—that decreased the SCC susceptibility—and the higher tensile strength compared to the TMAZ/HAZ zones. Under constant deformation tests, such as 4PBB tests, the applied stress naturally decreases during the exposure as localized attack propagate toward the specimen thickness. In addition, the tensile stress acts on these specimens in the direction of the elongated grains, and therefore the SCC cracks should propagate in the perpendicular direction. For these reasons, corrosion takes place in form of localized attacks at the elongated grain boundaries along the rolling direction (Figure 9).

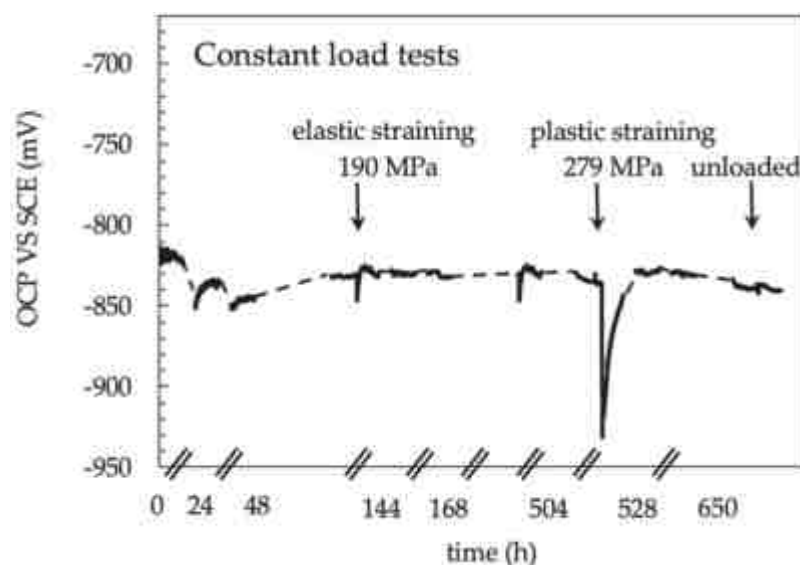
Figure 10. Open circuit potential measurements of the specimen loaded at different values during CL test. The decrease in the OCP mainly occurs as loading increase due to aluminum corrosion products cracking.

Figure 10 shows the effect of the applied load on the OCP of the CL specimen. The OCP of the unloaded specimens rapidly stabilized between -850 and -800 mV vs SCE. The fluctuations are mainly ascribable to the removal of corrosion products of aluminum formed at very early exposures, due to the recirculation of the testing solution. When the specimen is loaded in elastic field, a decrease in the OCP was noticed but the potential values stayed in the same range measured in unloaded condition. Conversely, at strain level exceeding the yield stress—i.e., in the plastic field— 100 mV decrease in the OCP occurred due both to the rupture of the thick corrosion product scale of aluminum and the plastic straining exposes the very active metal to the aggressive environment. The OCP came back to the initial value after about 24 h. This value remained almost constant, until the end of the tests. The specimen did not break during the tests but showed a corrosion attack mainly localized at the HAZ (Figure 11). Differently from the 4PBB specimens, the attack appears wider, and positioned perpendicularly to the loading direction coinciding with the rolling direction (Figures 11c and 12a). Some small ramifications along the grain boundaries were observed (Figure 12b).

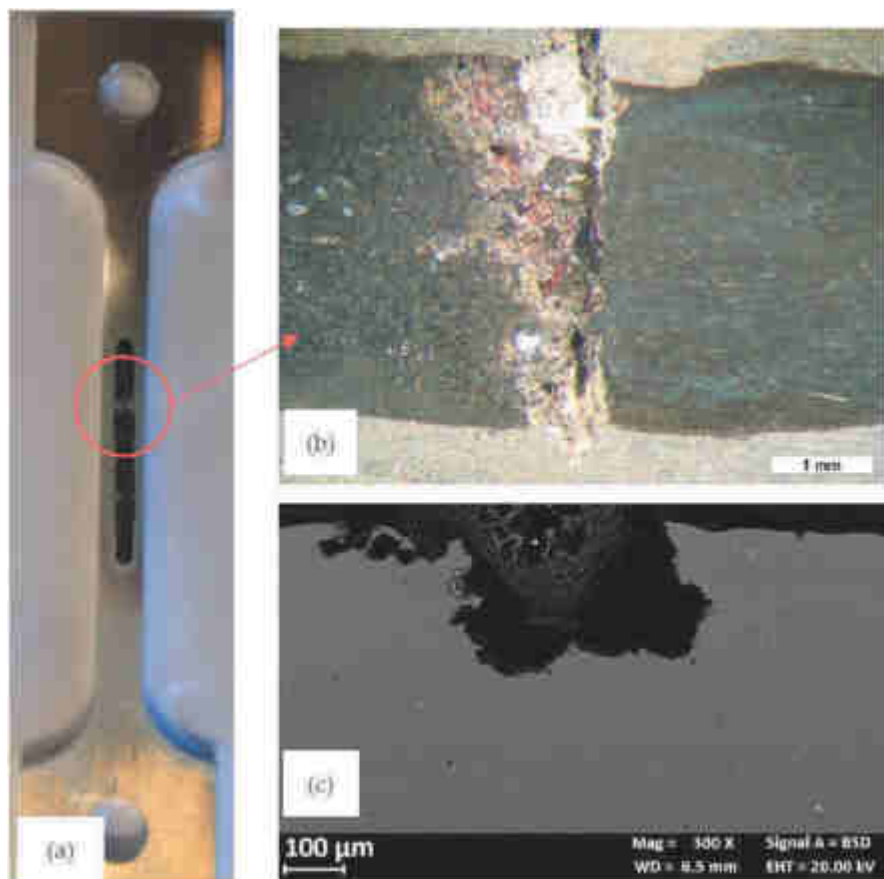
Figure 11. Aspect of the specimen at the end of the constant load test. (a) Macro image: the dark zone in the central part exposed to the NaCl 0.6 M solution; (b) close-up of the red circle with the selective attack of the TMAZ; (c) metallographic section of localized attack.

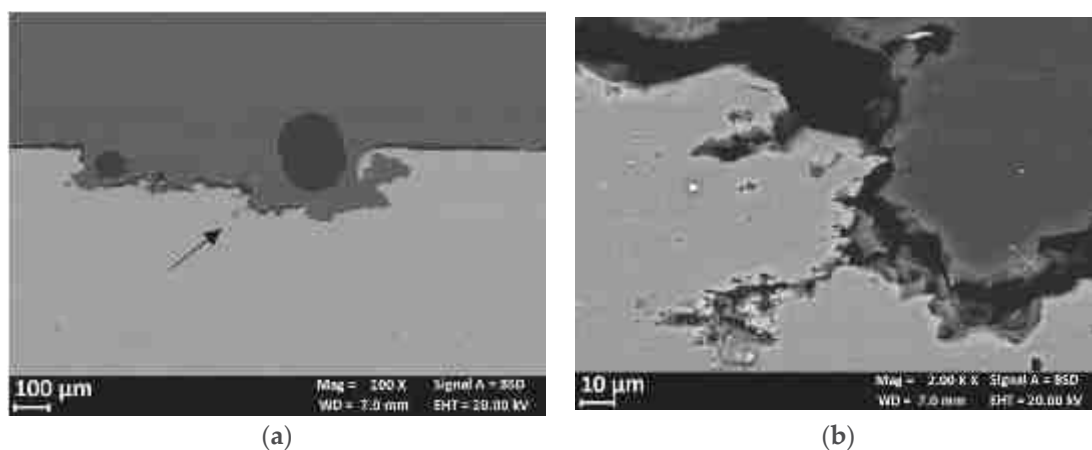
Figure 12. (a) Metallographic section of the enlarged localized attack in the TMAZ zone of the CL specimen. Close-up of the arrow in (b) in which is evident the change the morphology of attack that allow the rolling direction.

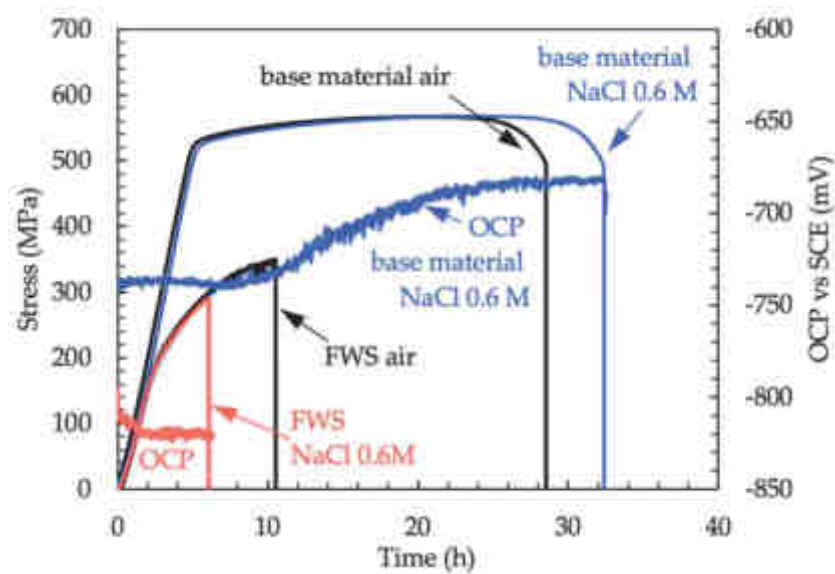
Figure 13. Stress vs time and OCP of the specimens during the slow strain-rate tests.

Figure 13 reports the load and OCP measurements performed during the SSR tests of the AA 7075-T6 base materials and the FSW joints. The tests were twice repeated, but only one curve for each condition is reported in the graph for simplicity. The tensile curves of the base material and the weld obtained in air or in NaCl 0.6 M are practically overlapped. The time to failure of the base material is close to the mean value with a very small deviation of 7%. 25% deviation was observed for the welded specimens. No stress-corrosion crack occurrence was noticed for the base metal and the time to failure in 0.6 M NaCl solution is even longer compared to the value measured at air. The role of active corrosion in NaCl solution can be hypothesized to enhance dislocation mobility and thus the plastic deformation, as reported by Jones et al. [28,29]. The authors named this phenomenon anodic attenuation of strain hardening.

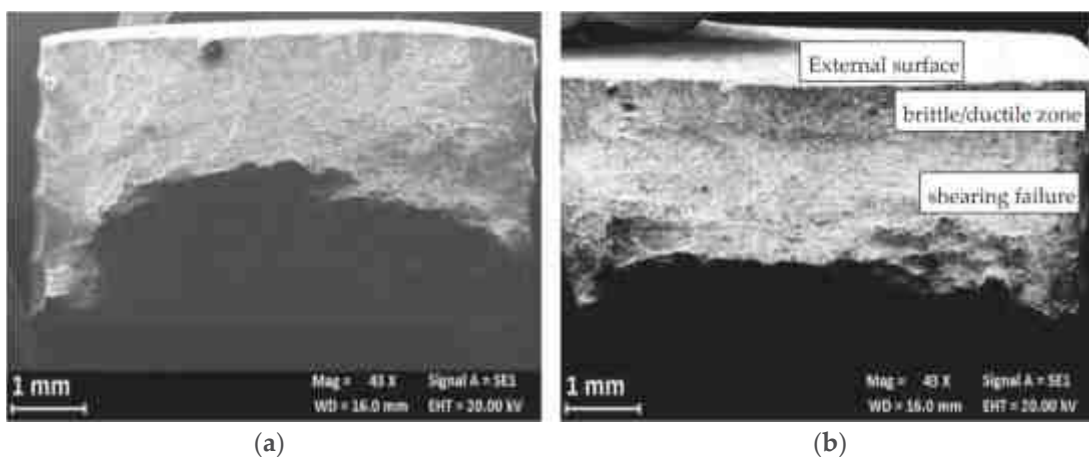
Figure 14. SEM image of the fracture surface of the AA7075 T6 specimen after the SSR test (a) macro in air, (b) macro in 0.6 M NaCl solution.

Figure 14 compares the fracture surface of the SSR specimens after the test in air and in 0.6 M NaCl solution. The fracture surface at air (Figure 14a) showed a shearing failure, typical of the prismatic specimens, while the fracture surface of the specimen after the SSR test in 0.6 M NaCl solution exhibits an initial flat area (Figure 14b) due to the presence of microdefects able to trigger localized corrosion initiation. These microcracks are mainly at macro-precipitates (black arrows in Figure 15a) and have

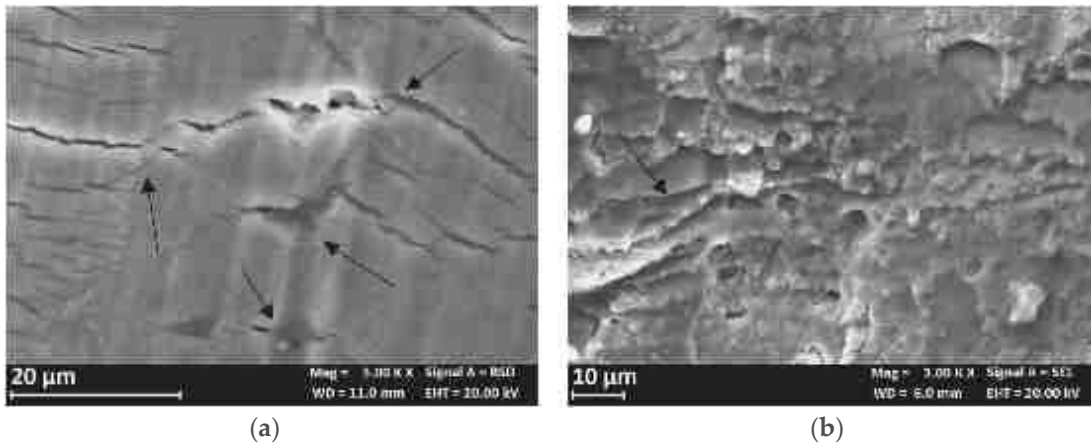
Figure 15. SEM image of the fracture surface of the AA7075 T6 specimen after the SSR test (a) specimen surface with corrosion products of aluminum and several microcracks at macro-precipitates (black arrows); (b) particular of fracture initiation zone after SSR test in 0.6 M NaCl solution.

depth less than 100 μm . In the correspondence of these microcracks, the fracture surface is heavily corroded (Figure 15b) and it is possible to observe the presence of several micro-precipitates. The flat zone of the fracture surface (Figure 16b) is mixed brittle/ductile as some small dimples and quasi cleavage areas were observed, similarly to the fracture surface at air (Figure 16a). The presence of very small zones with typical SCC morphology, indicated with the arrows in Figure 16b [29] was also confirmed; the final shearing fracture of these specimens was similar to that in air.

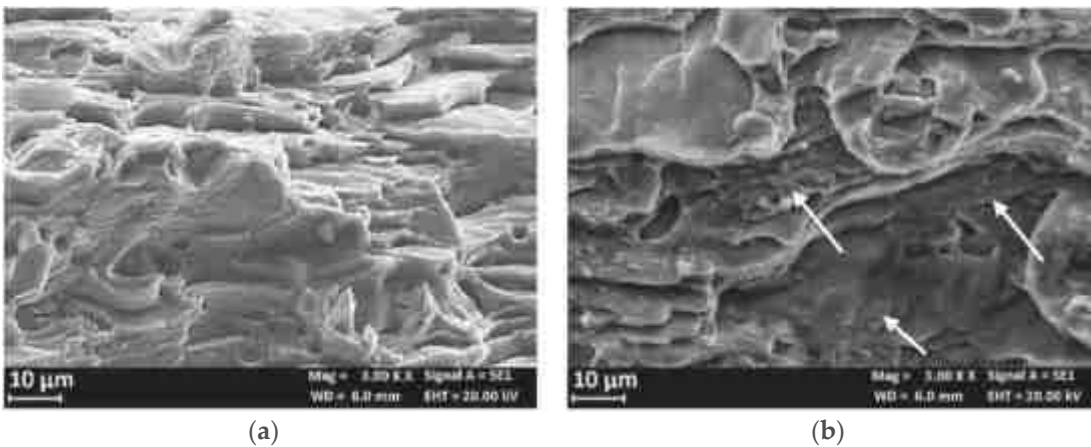
Figure 16. SEM image of the fracture surface of the AA7075 T6 specimen after the SSR test: (a) particular of the fracture surface at air and (b) in 0.6M NaCl solution (the arrows indicate small areas with typical SCC morphology).

Figure 18a reports the hardness profile of the longitudinal section of the weld. The hardness sharply decreases at the TMAZ/HAZ and, therefore, the plastic deformation mainly occurs at this point, thus decreasing the total elongation at break and the time of failure. Despite the high strain rate due to plastic strain localization at TMAZ/HAZ, slight decrease in the time to failure in 0.6 M NaCl solution was noticed compared to air—i.e., 10 ± 0.5 h—thus denoting SCC occurrence. Bala Srinivasana et al. reported about SCC phenomena in the HAZ of the AA7075 of mixed FWS joints of AA7075 and AA6056, when the specimens were tested at strain rate 10^{-7} s $^{-1}$ in NaCl solutions, but only localized corrosion in the tests carried out at 10^{-6} s $^{-1}$ was detected [36]. The SEM observation of the surfaces demonstrate a flat zone at fracture initiation with maximum depth of 1 mm (Figure 18b,c). The presence of non-coherent corrosion products of aluminum and several precipitates was also noticed (Figure 19a). EDX analysis detected the presence of zinc, aluminum, and copper, as well as magnesium depletion (Figure 20). The final fracture is by shearing (Figure 18b) and its morphology is characterized by elongated dimples and a few brittle areas (Figure 19b), similarly to the base material (Figure 16).

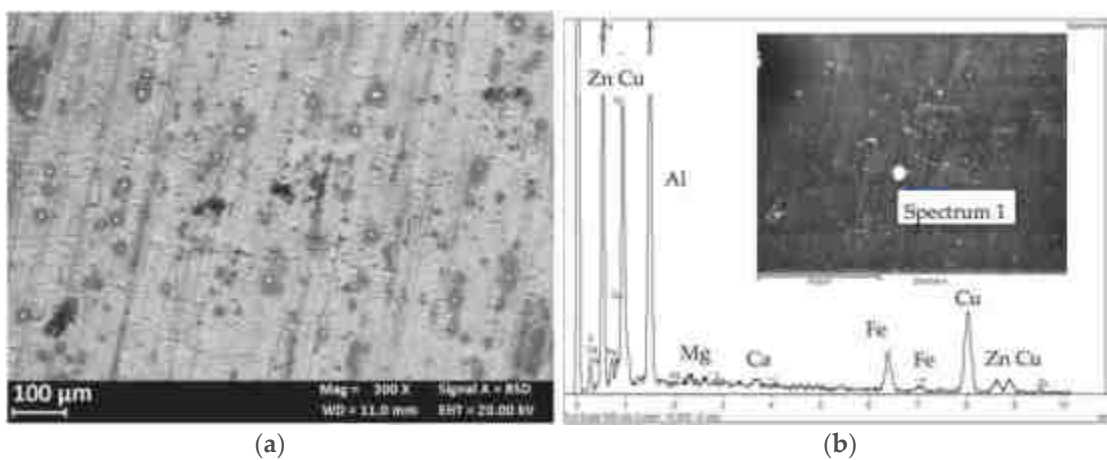
Figure 17. (a) Backscatter electron detector (BSD) image of the external surface of a base material specimen after the SSR test in NaCl 0.6 M, the bright zone indicates precipitates with higher atomic weight than the aluminum matrix; (b) EDX spectrum of one of these particles.

No macroscopic SCC phenomena were observed probably due to the strain rate (10^{-6} s^{-1}) value adopted and very aggressive NaCl solution. Results presented in other works [30] confirmed the absence of stress corrosion on this alloy during the SSR tests at the OCP and strain rate of 10^{-6} s^{-1} . The OCP remains constant in the elastic field, but it increases with the plastic deformation, probably due to the enrichment in iron and copper due to the dissolution of the surrounding aluminum matrix. This observation is supported by back-scattered electron (BSE) image and EDX spectrum (Figure 17).

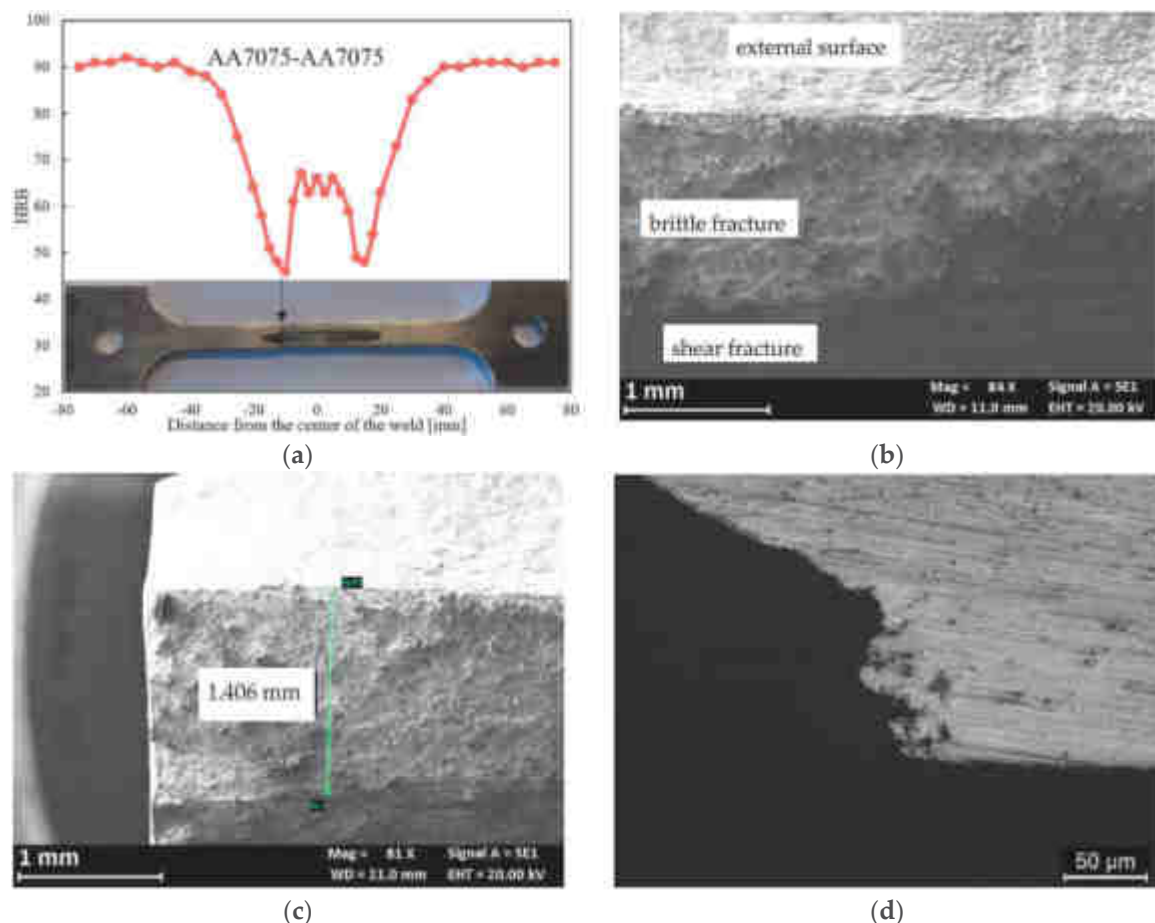
Figure 18. (a) Hardness profile along the FSW butt joint; (b) SEM image of the fracture surface, a flat zone of about 1 mm of growth (close-up in (c) is highlighted in (d)) metallographic section of the fracture surface in which is visible the flat zone and the small ramifications.

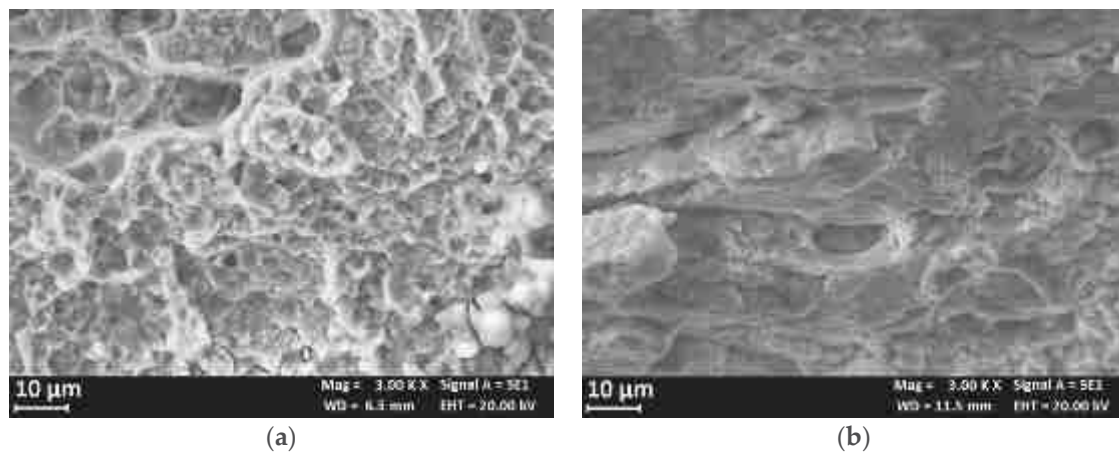
Figure 19. (a) Particular of the mixed ductile/brittle fracture zone and (b) of the ductile shearing final rupture.

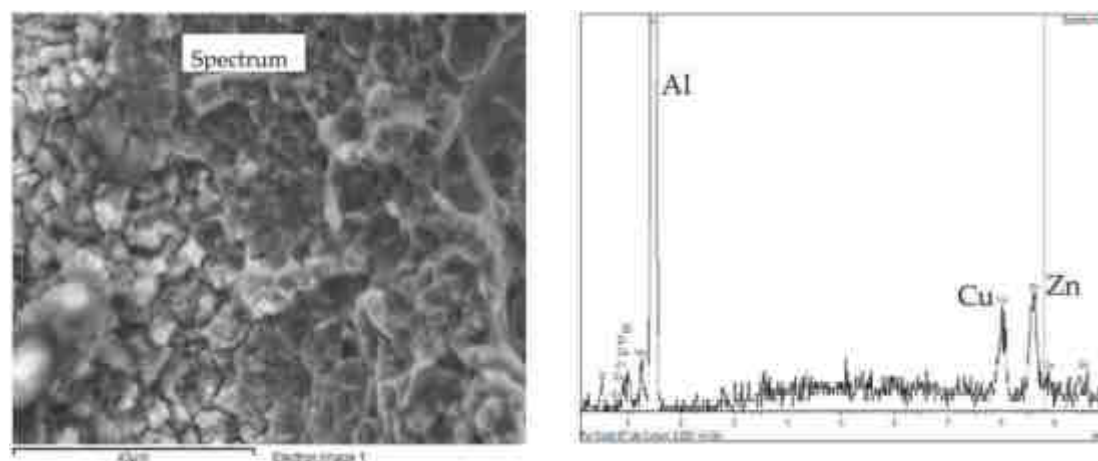
Figure 20. EDS spectrum of the precipitates present on the mixed ductile/brittle zone of the fracture surface of the FWS specimen after the SSR test in 0.6 M NaCl solution.
