1 **Comparing the observed and numerically simulated seismic damage: a unified**  
2 **procedure for unreinforced masonry and reinforced concrete buildings**

18 In this paper, a unified procedure for assessing the effectiveness of modelling strategies for  
19 existing buildings is proposed. The procedure is applied to unreinforced masonry and reinforced  
20 concrete real buildings struck by recent earthquakes. A matching index (MI) suitable to be  
21 adopted across different structural types is proposed. It aims to synthetically compare numerical  
22 outcomes with the evidence of the damage experienced by the selected case-study buildings.  
23 Results confirmed a good reliability and effectiveness of the developed numerical models (mean  
24 MI value higher than 0.70 for all the investigated case-study buildings) as well as the capability  
25 of the models in reproducing the same performance states that occurred in the real cases.

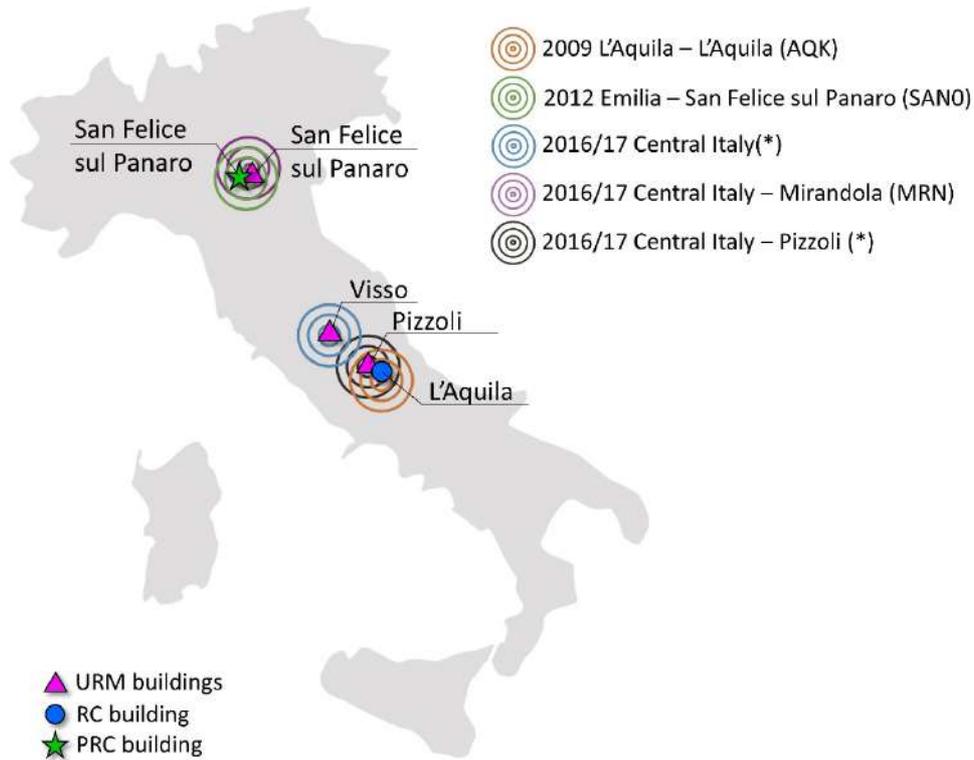
296 Figure 3 depicts the location of the investigated case-study buildings and that of the seismic  
297 actions adopted in the numerical simulations. In particular, those seismic events consist of the 2009  
298 L'Aquila (for the RC building), the 2012 Emilia (for the PRC building and one of the URM building)  
299 and the 2016/2017 Central Italy earthquake (the other two URM buildings).

301 Figure 3. Location of the five investigated case-study buildings in the Italy map with indication of  
 302 the seismic event and the ID earthquake (\*monitored structure).

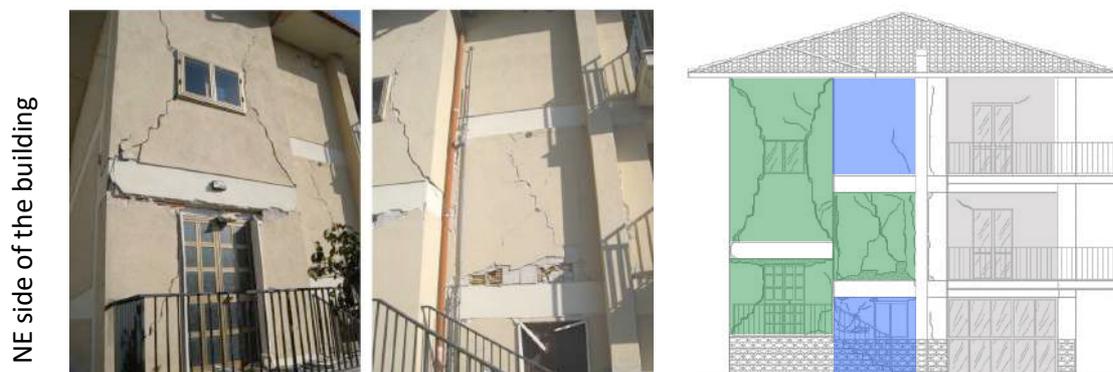
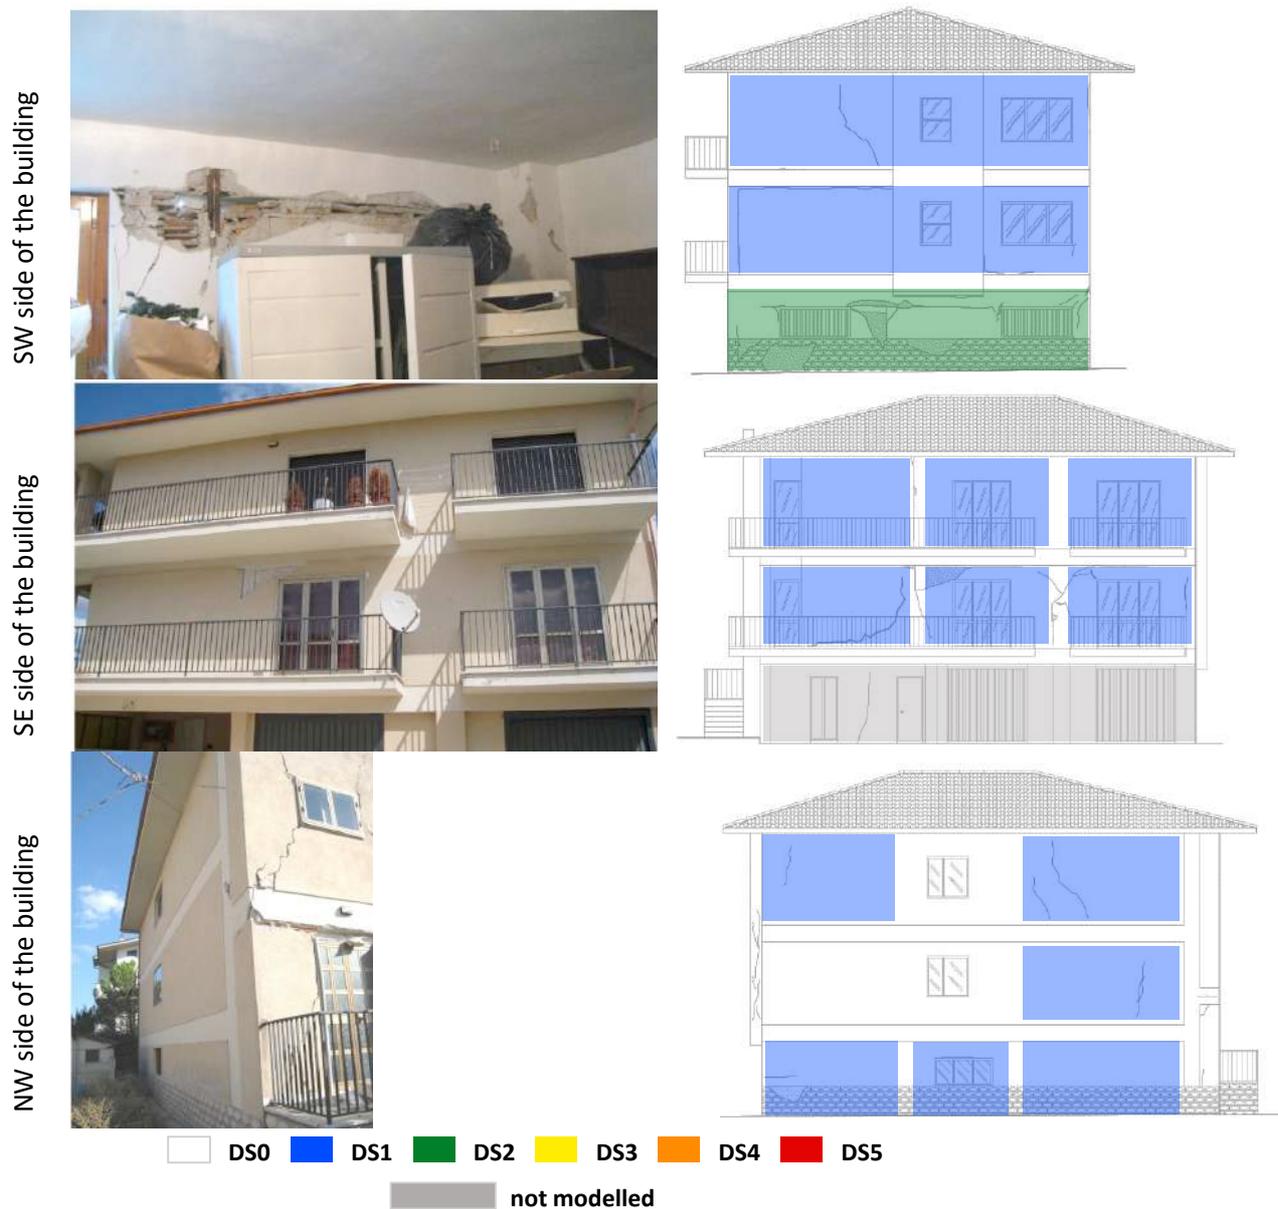
484 Figure 8. Damage attributed to the exterior infill walls of the RC building

476 associated with the detachment of the infill from the confining structural members, which is  
477 compatible with the attainment of DS1. For SE side, infills at the first storey were not modelled due  
478 to the presence of wide openings. Second-storey and third-storey infills present quite light cracking,  
479 with some loss of plaster but no crushing of brick units. This is compatible with the attainment of  
480 DS1. The condition of the central panel at the second storey may be considered “border-line” between  
481 DS1 and DS2 due to the detachment of plaster. However, the absence of visible and significant cracks  
482 made the Authors lean towards the assignment of DS1 also for this panel. For NW side, a light damage  
483 was observed. This is consistent with the attainment of DS1 or DS0.

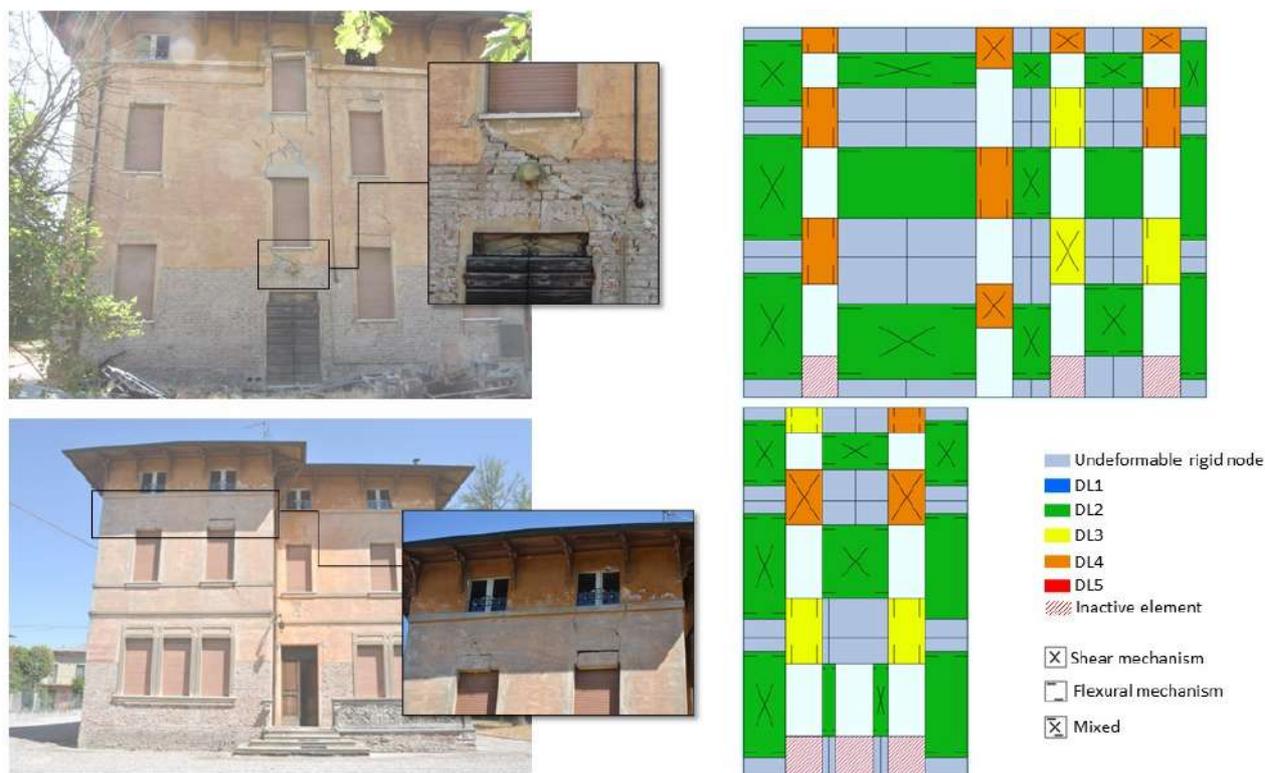
665 Figure 15. Comparison between the observed damage of the San Felice's case and that reproduced  
 666 by numerical simulation (the original 3Muri color pattern was modified to be consistent to the colors  
 667 assigned to each DL).

656 Despite the slight overestimation of the simulated damage, Figure 15 shows how the EF model  
 657 of the San Felice's building is able to well capture the damage concentration in the spandrels at the  
 658 upper level as well as the type and entity of damage that occurred in the piers; an analogous comment  
 659 is valid also for the other numerical models.
