THE INTEGRATED 3D SURVEY FOR PLANNED CONSERVATION: THE FORMER CHURCH AND CONVENT OF SANT'AGOSTINO IN BERGAMO

KEY WORDS: planned conservation, restoration project, cultural heritage monitoring, 3D integrated survey

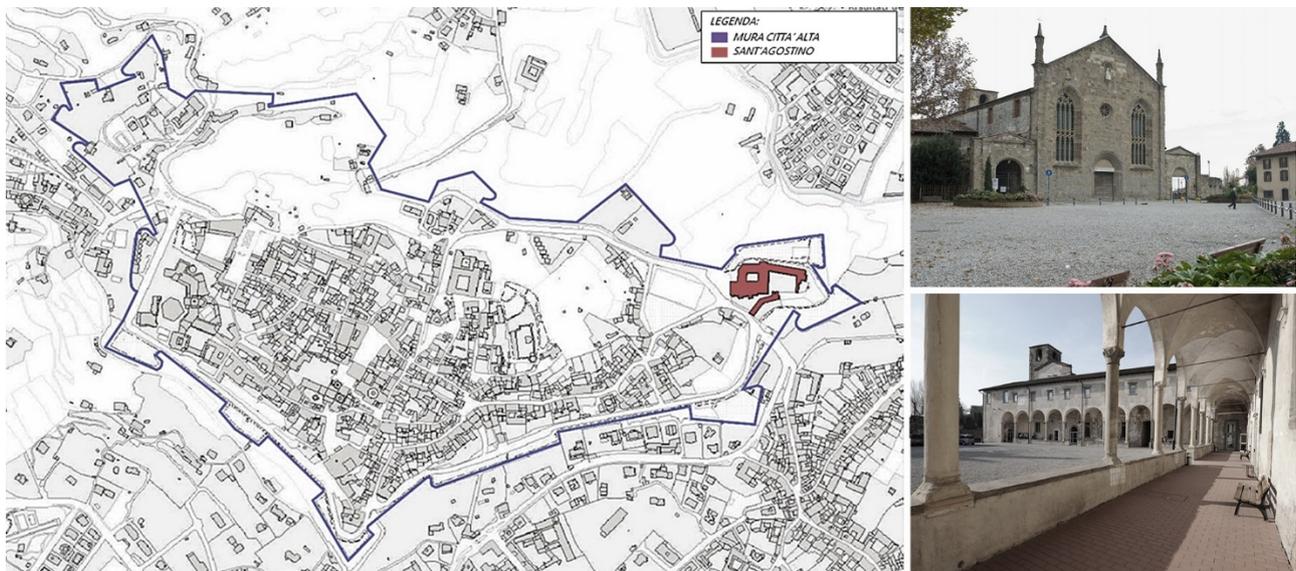
Figure 1. On the left, the layout of the Venetian city walls and the former convent. On the right, from top to bottom, the great cloister of the monastery and the façade of the church.

The religious complex, differently from that of the *Domenicani* for example, was not demolished because Augustinian fathers paid a large sum of money to enclose it in a more extended perimeter (Cristini 2012). Its eventual overthrow was strongly opposed also by the local administration (Bravi 2014). However, according to the architect Elia Fornoni, the modification of the first project (which foresaw the walls built against the fortress of San Marco) was mostly motivated by economic advantage linked to the construction. In fact, the original route, as well as to create an easily helpless area, would have required breaking down much of the rocky relief of the hill of *Sant'Agostino*: a very expensive and long work (Figure 1).

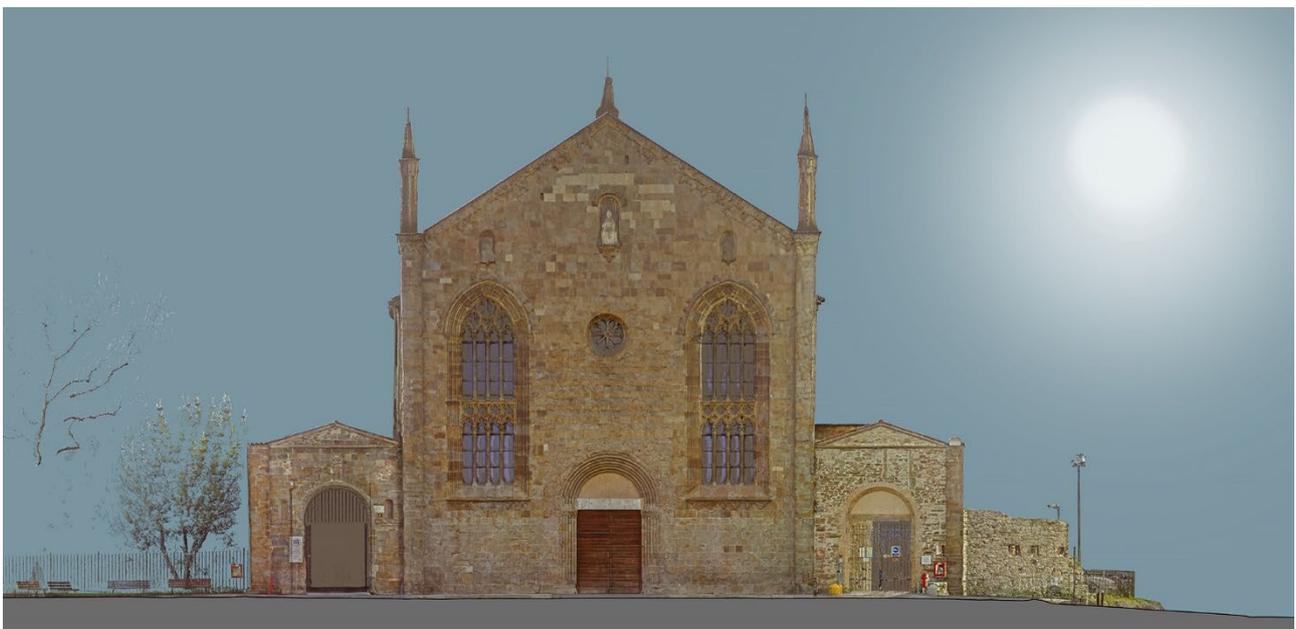
Figure 4. The façade of the church of *Sant'Agostino* after the restoration: the orthographic projection of the points cloud.

The first measurement campaign was carried out in July 2015 through the implementation of scans aligned to each chapel, along the longitudinal axis of the church. The not optimal lighting conditions (an uncontrolled mixture of sunlight and incandescent lights) partially compromised the colour quality of point clouds, nevertheless enabling a first 'recording' of the building's state of conservation (Figure. 4).

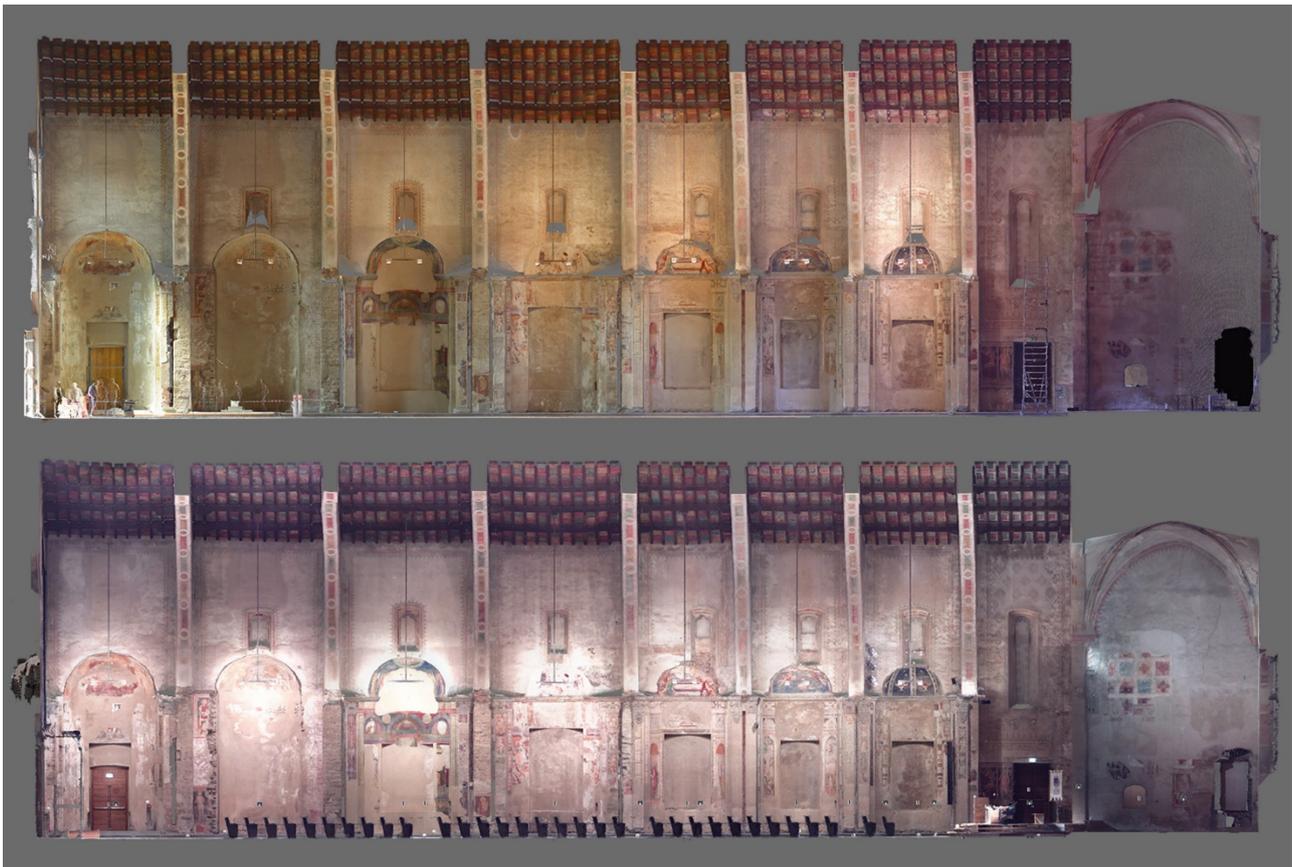
Figure 5. The left side of the nave of the former church of *Sant'Agostino* during and after restoration works. Comparison between the orthographic projections with the goal of monitoring the degradation evolution (surveys carried out in July 2015 and March 2016).

The second campaign, conducted approximately six months after the first, was carried out in March 2016 after the end of restoration works and with the aula magna was already operative. Scans were conducted within one day in a more rigorous way than previous, both because higher in number (in addition to those along the longitudinal axis, other acquisitions were taken frontally to each chapel) and because taken in a constant and controlled light environment, now assured by the new lighting system (Figure. 5).

The comparison between the data obtained from the first and second campaign, supplemented by hygrometric and thermographic surveys has allowed, for example, to verify the correct execution of the waterproofing works, especially on the left side of the aisle adjacent to the minor cloister.

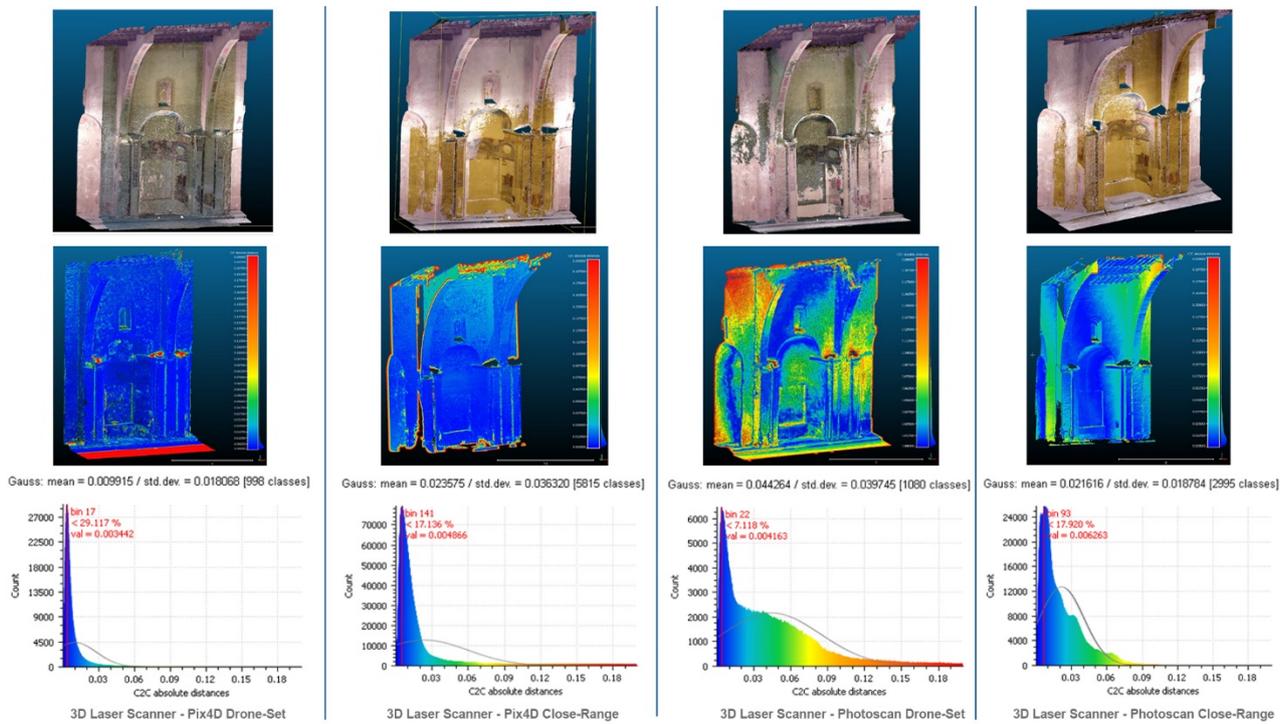
Figure 6. Comparison of different photogrammetric procedures with 3D laser scanning survey.

The processing carried out by 3D image-based reconstruction digital systems has seen the use of many software, also in order to compare the solutions. Every commercial product has, in fact, some particularities that make it more or less suitable for a given process. In particular, with reference to the mentioned problem, fewer errors have been noted with ©Pix4D Pro Mapper than with

©Agisoft PhotoScan. The first program better retains the geometry of the elements, even in the presence of light disturbances; while the second softens the geometries, supplying the lack of information and rounding the edges with uniform and regular surfaces (figure 6).

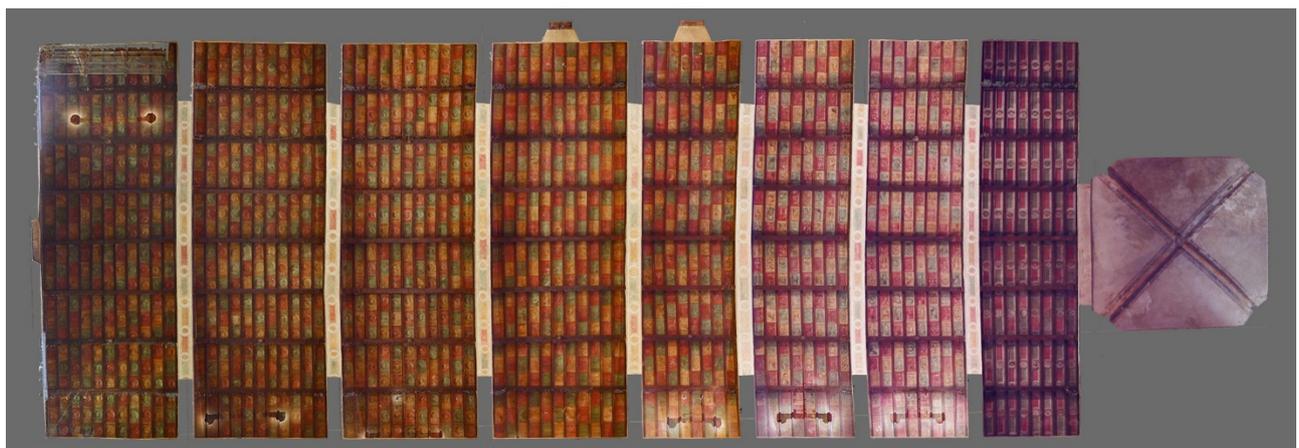
Figure 7. Orthophoto of the ceiling with the painted tiles between the beams and the joints of the roof. Lighting system are still visible.

of the painted tiles of the ceiling without the defects of enlightenment previously observed. The combined use of the images acquired both by the drone and terrestrial photogrammetry, as well as of 3D laser scanning measurements allowed to obtain a high definition model of the ceiling decorations (figure 7).

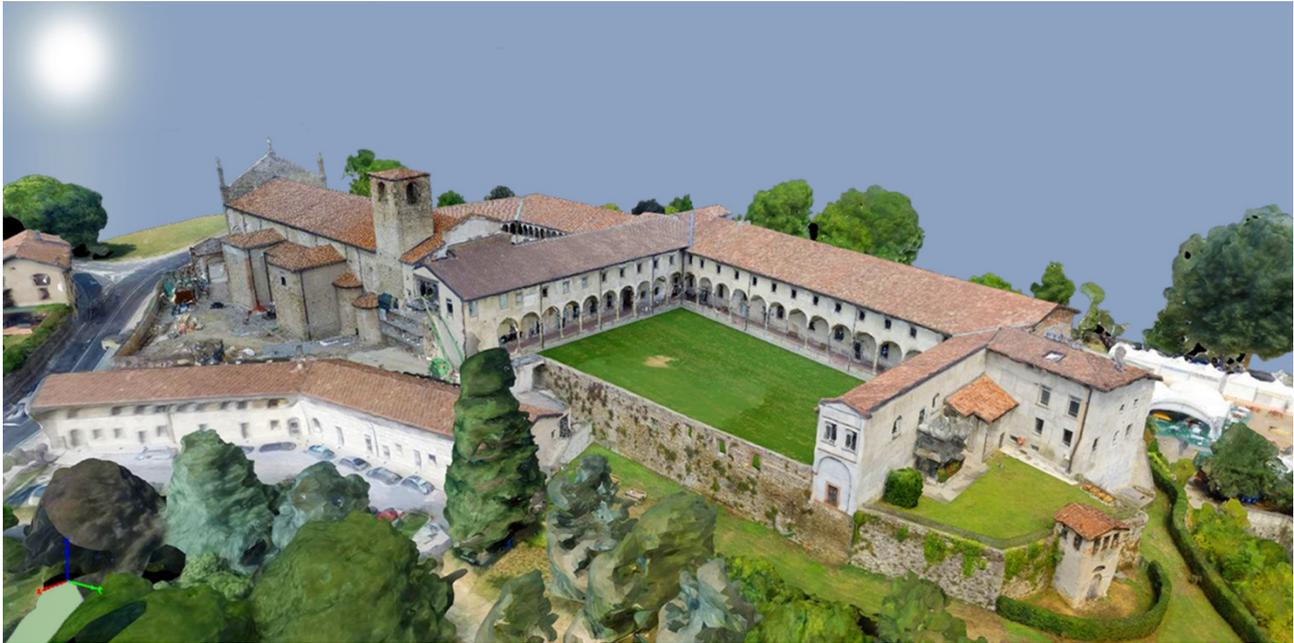
Figure 8. The complex of *Sant'Agostino* acquired from drone (summer 2015): a bird's eye view of the 3D model.

Despite having used the same drone - a small quadcopter equipped with an action camera with a high optical quality - the execution of external flights was different from the internal ones (Gabrlík, 2015). The UAV guidance was carried out in manual mode inside the church in order to allow flight a short distance from the ceiling above the lamp system. On the contrary, it was executed in automatic mode in external following the planning of the flight quotas, of the speed on the ground, of the trajectories chosen for the purpose of the best overlap of the images with an average overlap of more than 70%. In automatic mode, 'lift flights' were performed to acquire the images necessary for the reconstruction of the walls (figure 8, 9).

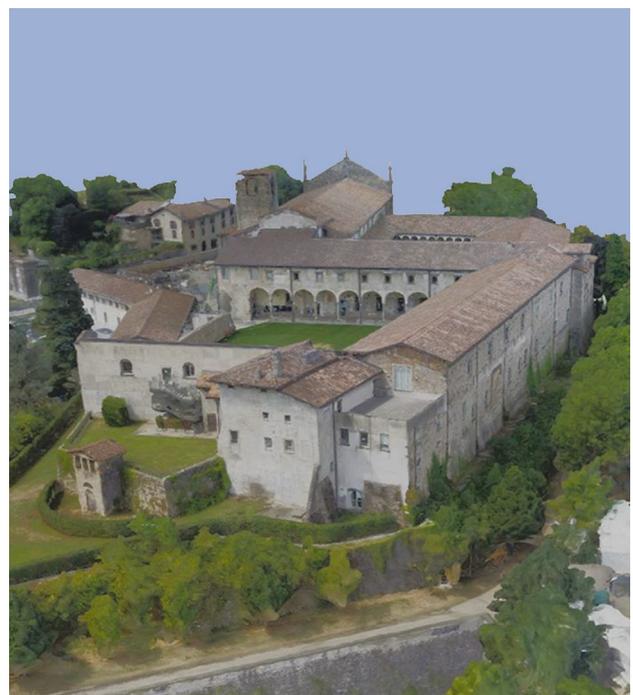
Figure 9. The complex of *Sant'Agostino* seen from the south.

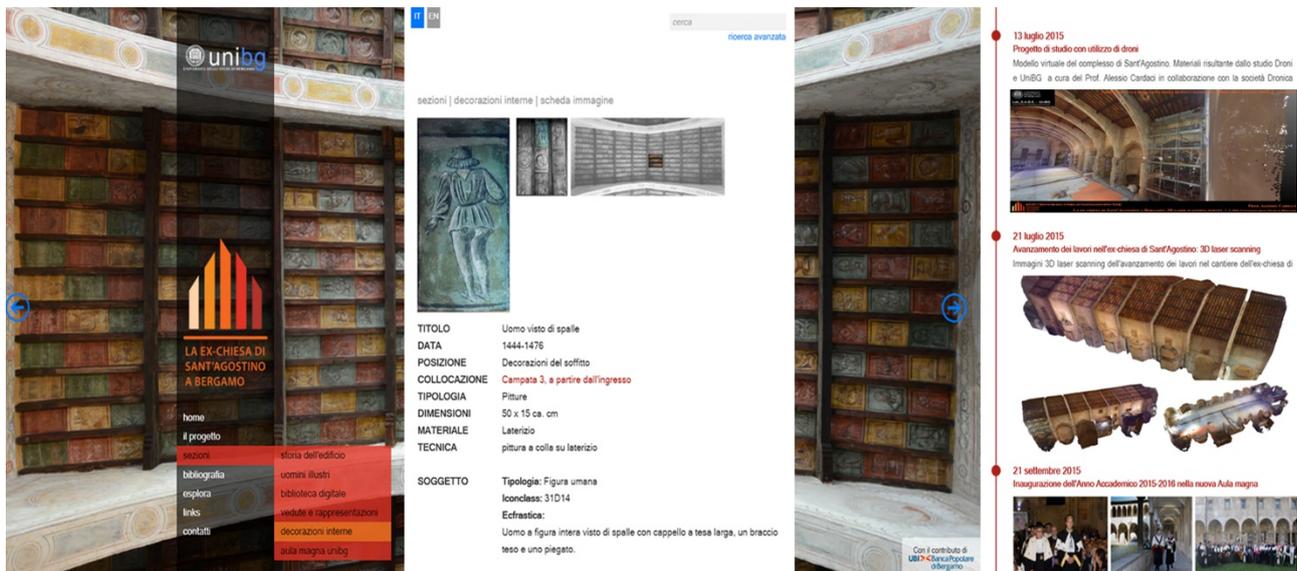
Figure 10. The multimedia data sharing platform and the history of the building based on a specific timeline.

The web portal is divided into two sections: the first diachronic, dedicated to the history of the building based on a specific timeline and including the function assumed by the former church over time, and the second analytic, which examines the architectural and decorative structures considering their state of conservation. Not a simple database for data collection but a relational system in which the different information, separated, can be reorganized through key fields to be interrogated and compared in a different way and dependent on the needs of the operator (Figure 10).
