Bond in Concrete 2012:
Bond, Anchorage, Detailing
Fourth International Symposium

An application of high performance jacketing for the shear strengthening of RC beams

A. Meda

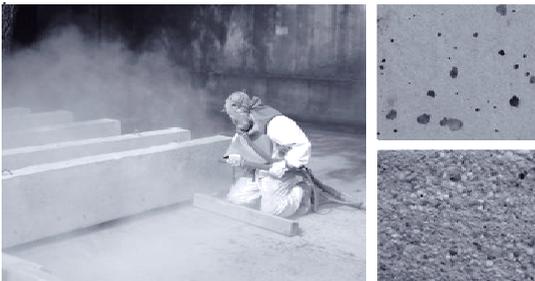
Figure 3. Sandblasting (left-hand); and surfaces before and after sandblasting (right-hand).

The beams were first sandblasted in order to obtain a roughness of about 1 mm, so as to ensure perfect bond between the existing concrete and the applied high performance concrete. This technique has been demonstrated effective in previous research (Martino et al. 2010). Figure 3 shows the sandblasting of the beams and, in detail the difference of the surfaces before and after the treatment.
