INTEGRATED SURVEY TECHNIQUES: PRELIMINARY STUDIES FOR THE CONSERVATION OF VILLA GALVAGNINA

KEY WORDS: Villa Galvagnina, integrated survey techniques, decay mapping, cultural heritage preservation

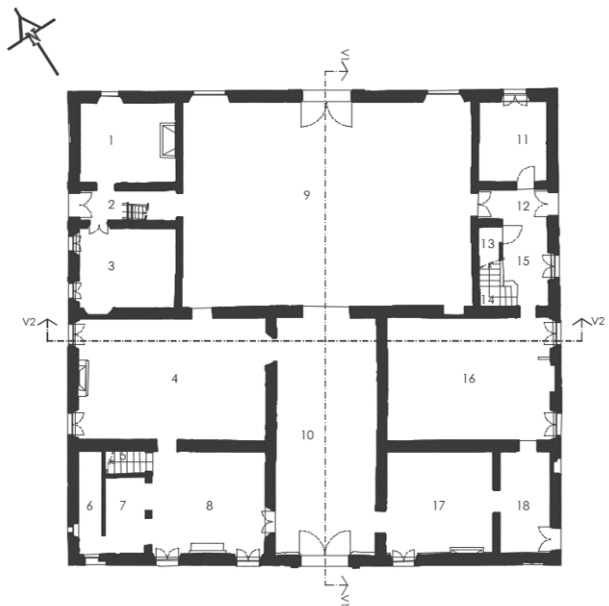
by the safety works conducted by the Superintendence: each of the ground floor rooms, with the exception of room number 11 (Fig. 2), and the rooms number 24, 27 and 28 on the upper floor (Fig. 3). However, a preliminary crack pattern of some other rooms could be outlined, on the base of the laser scanning survey. This draft has to be validated by a direct inspection.

Figure 2: Ground floor plan H1 obtained from the points cloud (Municipality of Mantua).

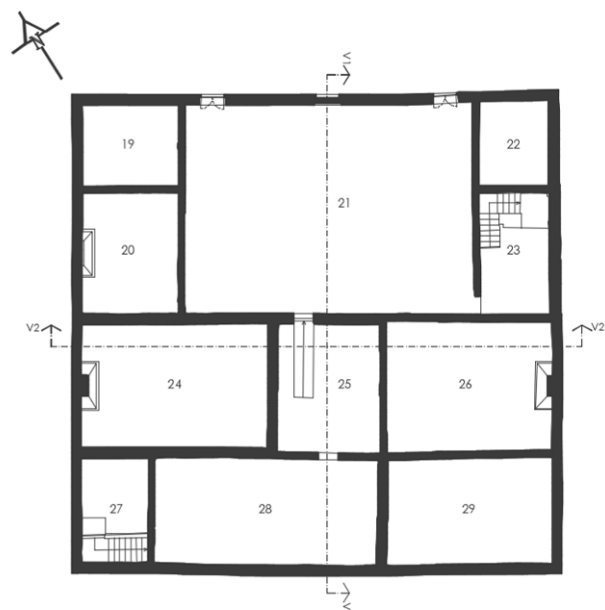
Figure 3: First floor plan H2 obtained from the points cloud (Municipality of Mantua).

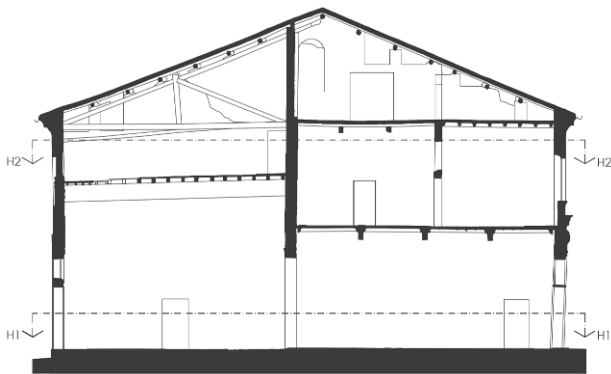
The villa has an approximate axially symmetric plan that is a positive factor for the seismic behaviour of the structure. However, the vertical organization of the spaces is not symmetrical, since the reception hall has a height of 7.3 meters, greater compared to the other rooms of the first floor, which is about 5 meters (Fig. 4). This difference determines a bad seismic behaviour, because of the absence of a horizontal diaphragm and the lack of a good tie rods reinforcement. An accurate survey of the steel anchor plates is indispensable in order to understand the structural behaviour of the building. Only a handful of steel anchor plates is visible on the façades, so it would seem that the structure cannot even count on the minimum contribution that a system of coplanar wooden floors joined to the walls could have provided.

Figure 4: Vertical section V1 obtained from the points cloud (Municipality of Mantua).
