Seismic performance of precast industrial facilities following major earthquakes in the Italian territory

Abstract

On the basis of detailed field observations on a relevant number of buildings, collected just after the earthquakes, seven representative industrial facilities are examined to outline the main vulnerabilities of one-storey precast concrete structures not designed and detailed for seismic loads.

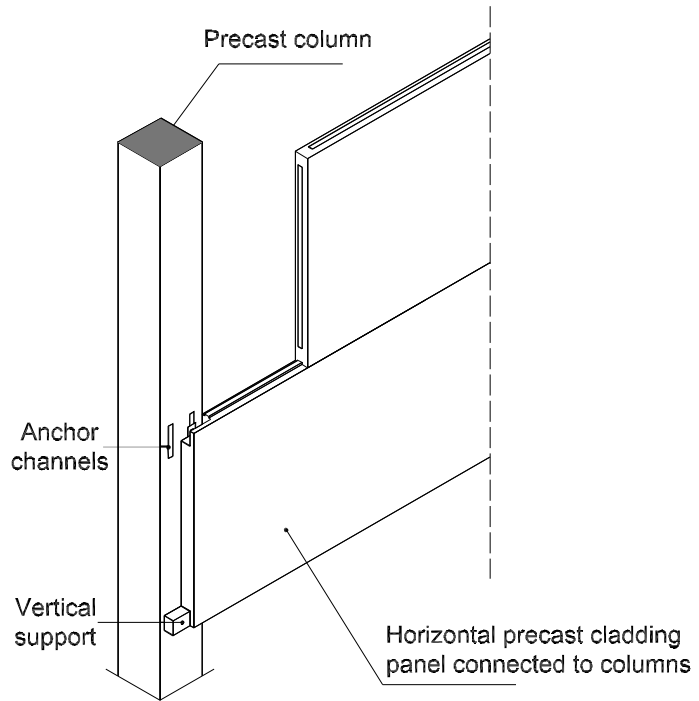
Figure 3

Conversely, category B presents longer spans, up to 27 m, covered by tapered I-beams which form gable roofs. As in category A, no moment continuity exists between beams and columns; the lateral load capacity of the structure is provided only by the cantilever action of the columns at the footings, which are not tied together. RC forks are provided at top of the columns as support of the beams but they are not designed to carry seismic induced lateral loads. Highly flexible roof diaphragms are the result of double-T pre-stressed joist or micro-sheds simply supported on the main beams with no mechanical connections. Both horizontal and vertical precast cladding panels are traditionally connected to the columns or to gutter beams by mechanical devices, typically anchor channels (Fig. 3).

7 **Fig. 3. Horizontal RC precast panel-to-column connection**

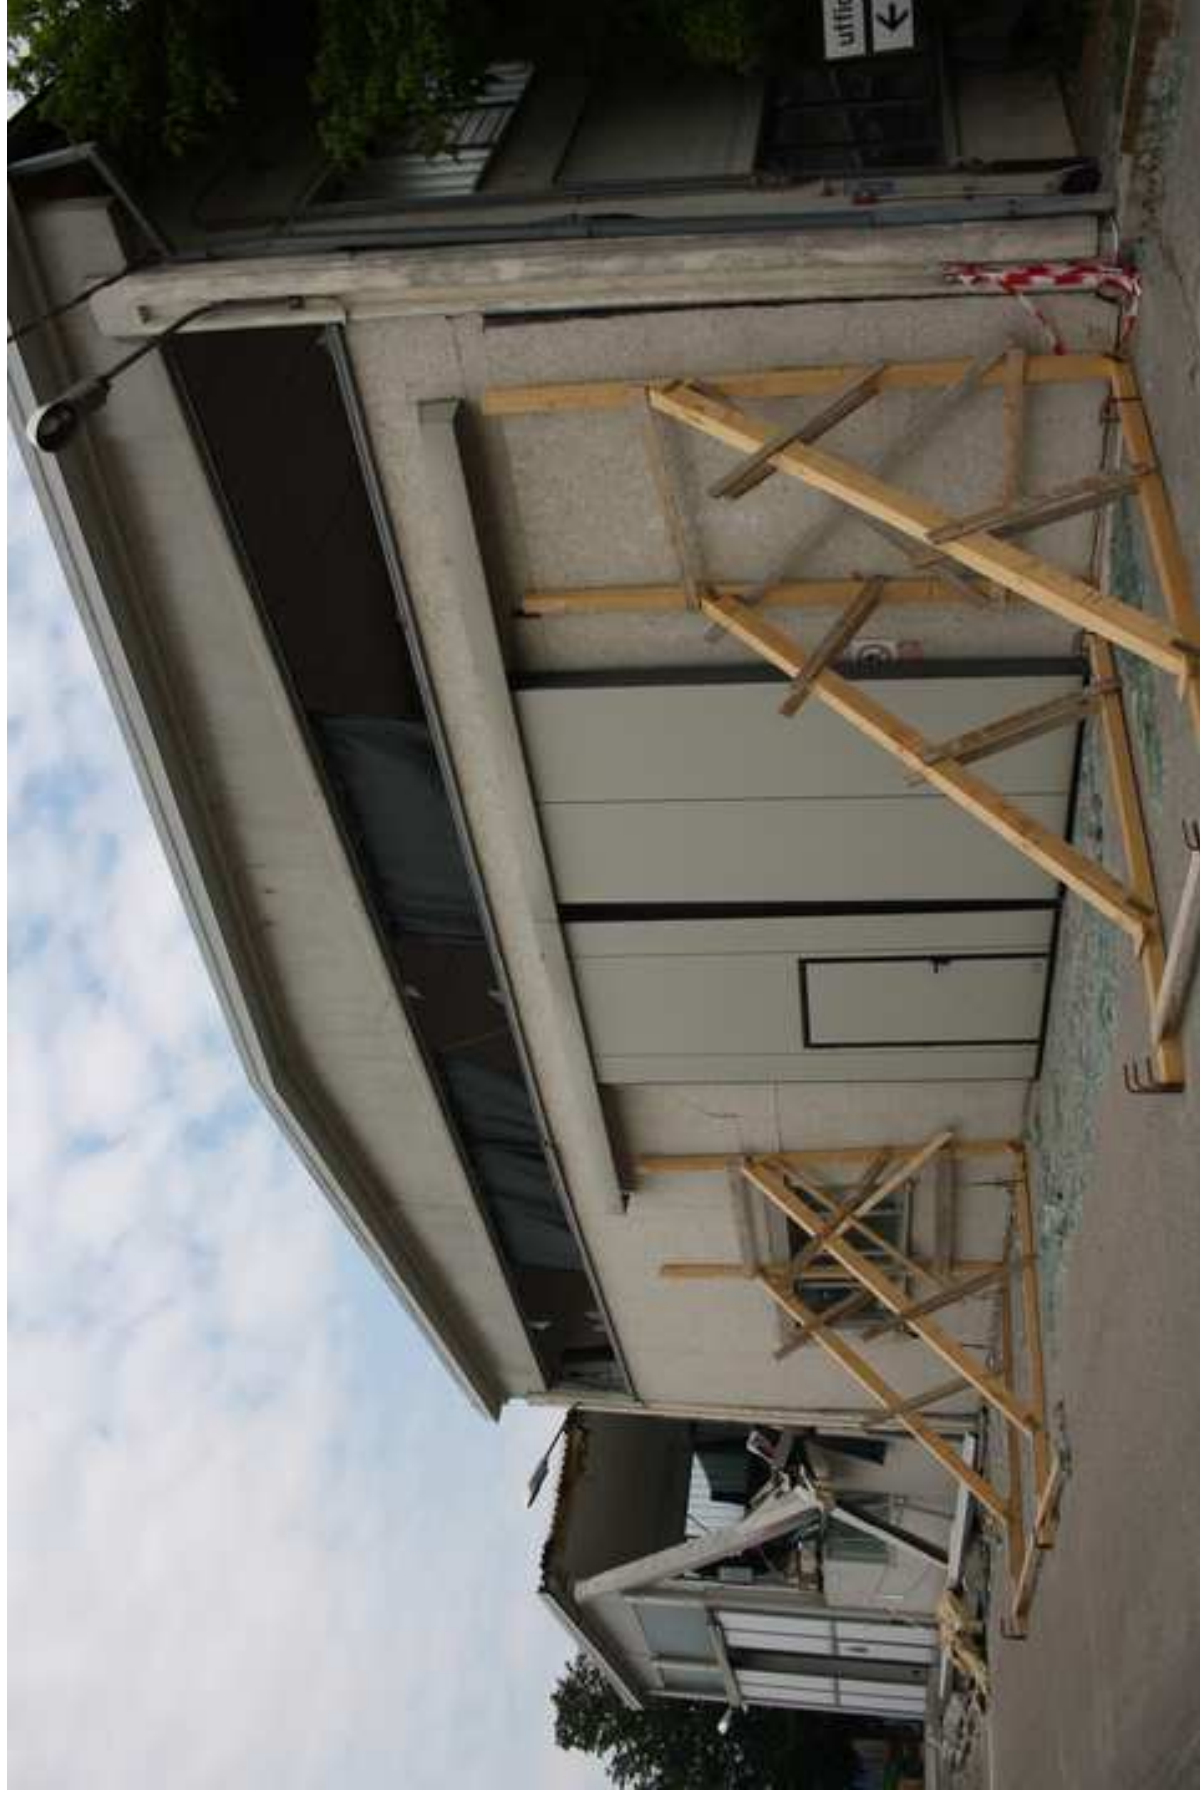
Figure 4a
[Click here to download high resolution image](#)

Examples of the two structural typologies (category A and B) are shown in Fig. 4a and 4b respectively.

9 **Fig. 4. (a) Example of one-storey precast structure built between the 70's and the 80's; (b) Example of more**
10 **recent one-storey precast structure with longer spans and precast cladding panels**

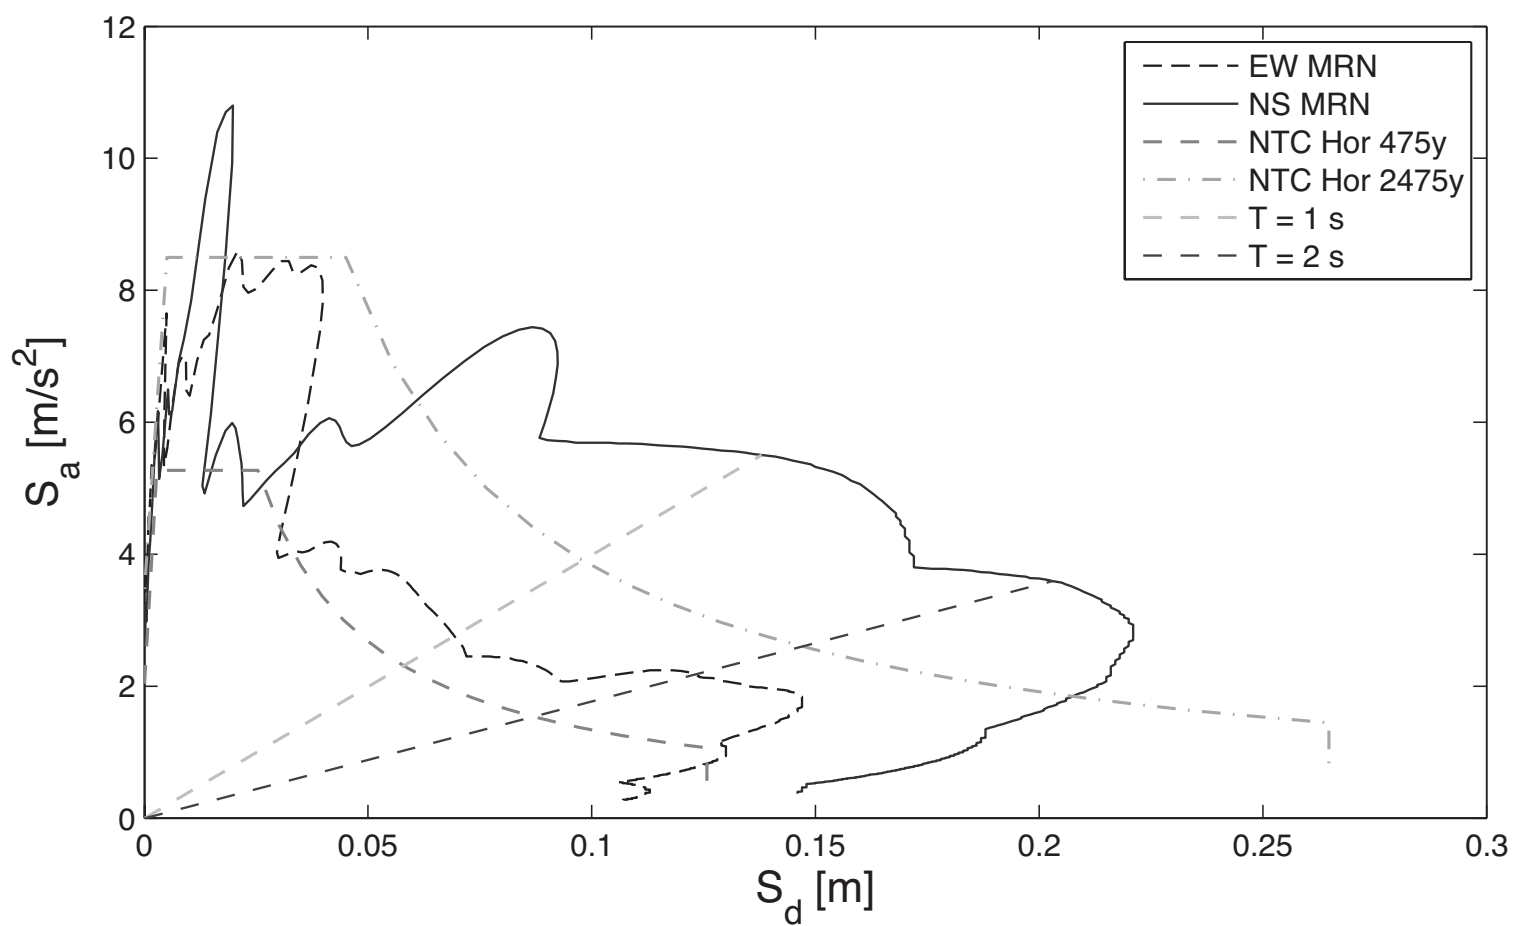
Figure 7a
[Click here to download Figure: Fig7a.eps](#)

Qualitative explanation of such collapses, mostly due to the loss of support of the friction based connections, may be searched in the preliminary computations described in the following. Fig. 7(a) shows the elastic ADRS (acceleration displacement response spectrum) graphs (5% relative damping) of the horizontal components, North-South (NS, solid line) and East-West (EW, dashed line), of the May 20th event at Mirandola and the elastic ADRS graphs determined for two return periods, respectively 475 and 2475 years, in accordance with the current Italian Building Code (D.M. 14/01/2008). Fig. 7(b) shows a similar comparison regarding the vertical component. Mirandola, MRN according to the Italian RAN (Rete Accelerometrica Nazionale) network nomenclature, is chosen as it represents the station closest to the epicentre. The accelerograms recorded include site effects according to D.M. 14/01/2008: soil class C ($180 \text{ m/s} < V_s < 360 \text{ m/s}$) and no topographic amplification.

16 **Fig. 7. (a) Elastic ADRS graphs from recorded time histories (NS and EW) and in accordance with the Italian**
17 **building code (NTC). (b) Elastic pseudo-acceleration response spectra of the vertical component. Note: $\xi = 5\%$**

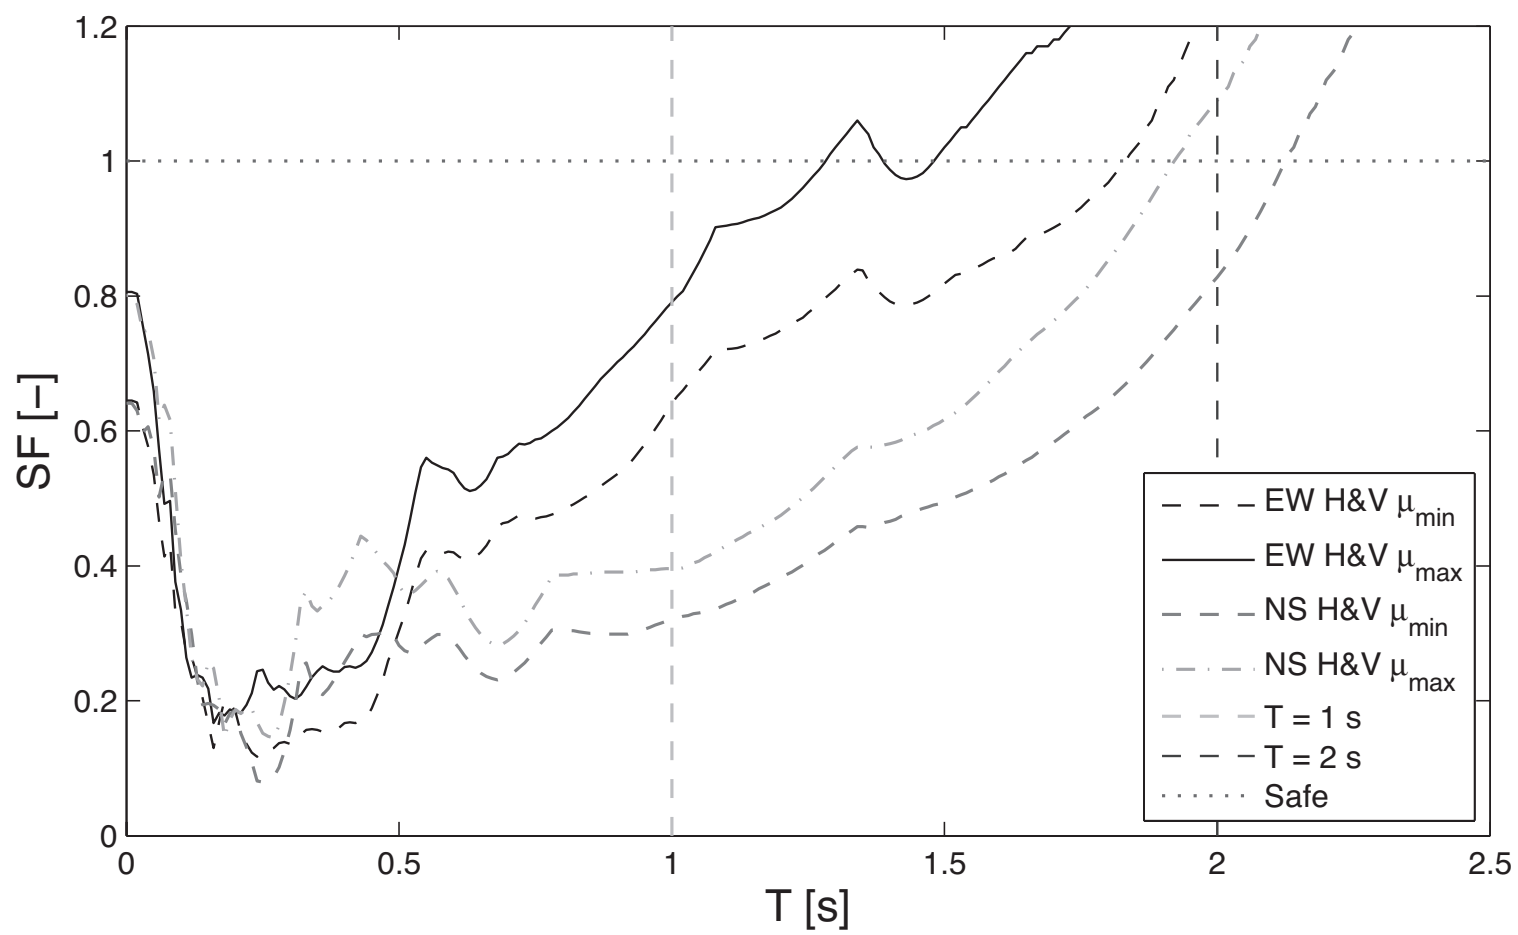
Figure 8b
[Click here to download Figure: Fig8b.eps](#)

Fig. 8(a) and (b) present the computed safety factor against the activation of the shear slippage at the beam-to-column connection level, by neglecting and considering the effect of the vertical component ($\pm\Delta N$) respectively. Roughly 10% decay of SF is observed if the vertical component is included, thus confirming the not so prominent effect of the vertical component even though peaks larger than suggested by D.M. 14/01/2008 occurred during the 2012 Emilia seismic sequence.

19 **Fig. 8. Variation of the SF against the activation of the shear slippage at the connection level, (a) by neglecting**
20 **and (b) considering the effect of the seismic vertical component**
