# Beam-Column Joint Retrofitting With High Performance Fiber Reinforced Concrete Jacketing

The possibility of strengthening existing R/C structures with a new technique based on the application of a High Performance Fiber Reinforced Concrete jacket is investigated herein, with the aim of studying the effectiveness of this technique for seismic retrofitting.

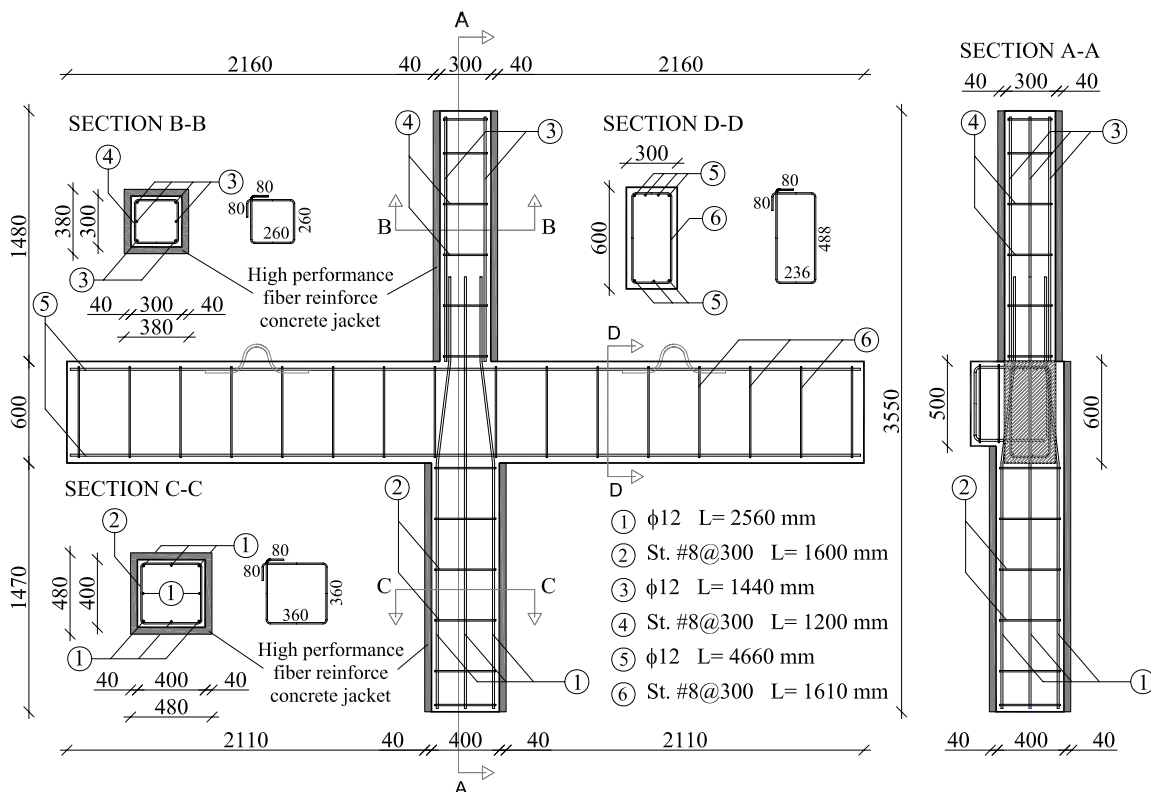
The test specimen was characterized by a column cross section of 300x300 mm in the upper part and 400x400 mm in the lower part, while the beam had a 300x600 mm cross section. The column was 3.55 m high and the beam 5 m long. To simulate the presence of the transverse beam in the real structure, a R.C. corbel was placed at the beam-column joint. The geometry of the specimen is illustrated in Figure 1.

Figure 1. Specimen geometry details.

The reinforcement and the concrete strength were typical of this kind of elements in the '60s: in the upper column there were 6  $\varnothing$ 12 mm longitudinal rebars, in the lower column 8  $\varnothing$ 12 mm bars and in the beam 3  $\varnothing$ 12 mm longitudinal rebars at the bottom and 4  $\varnothing$ 12 mm at the top.

The stirrups consisted of  $\varnothing$ 8 mm stirrups spaced at 300 mm in the whole specimen. No stirrups were placed inside the beam-column joint, as typical in the '60s. The concrete and steel strengths are specified in Table 1.

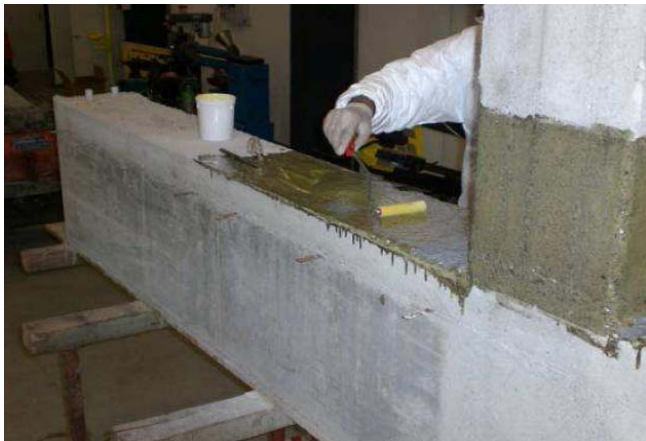
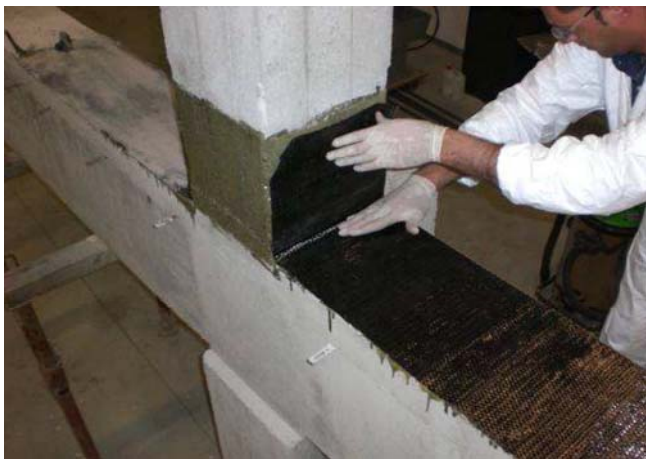
In addition, the upper faces of the two beams were levelled with a thin mortar layer and FRP sheets were applied to their upper face to enhance their negative bending moment capacity with respect to design static loads. The FRP sheets were bent at 90° and glued to the column. Eventually, they were encased in the HPFRC jacket (Fig.2a, 2b).

Figure 2. (a) Spreading of the bonding agent; (b) Application of the FRP sheets.

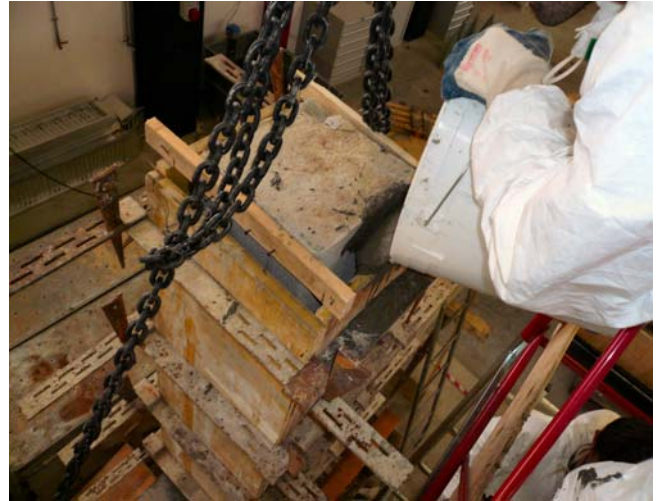
Figure 3. High performance jacket casting.

The strengthening jacket, having a thickness of 40 mm, was eventually cast adopting a self-compacting HPFRC (Fig.3). The mechanical properties of HPFRC are summarized in Table 1.

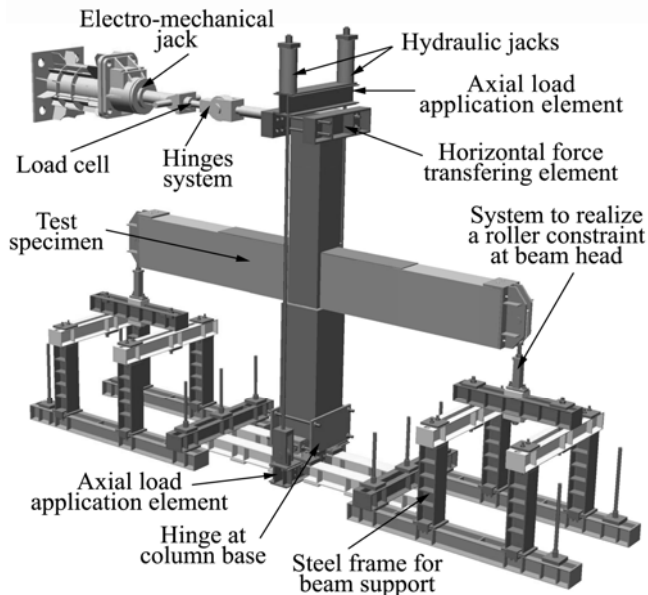
The beam-column joint was tested using the set-up illustrated in Figure 4.

The test set-up has been designed in order to develop a hinge constraint at the base of the column as well as a roller constraint at the top of the column and at the free beam ends. Therefore, the test specimen represents a multi-storey frame part being included among its inflection points and subject to horizontal actions.

The axial load, equal to 140 kN in accordance to the critical design load combination for the column in the building, was applied by means of two hydraulic jacks.

Figure 4. Test set-up.

As the test set-up and specimen geometry did not allow to apply the axial load on the column prior to jacketing, the fiber-reinforced concrete jacket and the FRP layers were applied to the specimen before the column was subjected to the axial load.

To obtain the load combination of shear and moment in the joint under serviceability loads, two forces of 24 kN were applied at the end of the beams before the horizontal cyclic load, by applying a prestress to the threaded bars connected to the end rollers.

Eventually, a horizontal cyclic load was applied at the top of the column by means of an electro-mechanical jack fixed to the reaction wall of the laboratory.

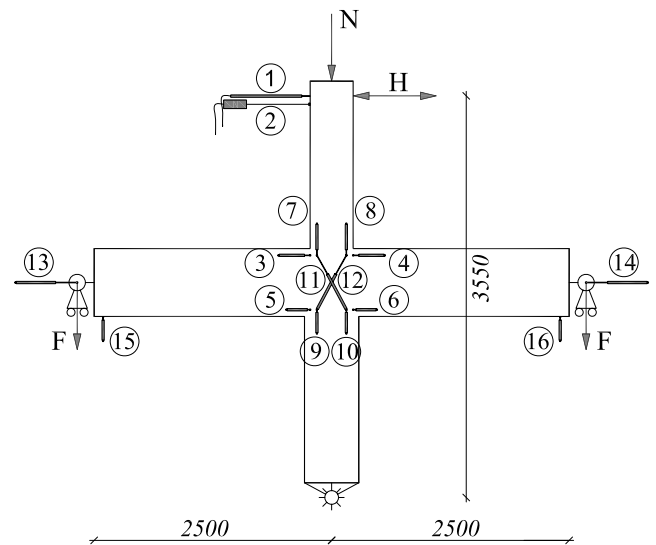
Figure 5. Displacement measurement set-up.

In order to measure the horizontal displacements, potentiometric transducers were placed at the column top at the load application level (POS 1 and 2 in Fig.5).

The rotations between the beams and the column were measured by means of a series of potentiometric transducers (POS 3-4-5-6 in Fig.5) and the rotations of the two halves of the column were measured by the potentiometric transducers in POS 7-8-9-10.

Furthermore two devices (POS 13 and 14 in Fig.5) were placed to measure the horizontal displacements of the beams' end and two transducers (POS 15 and 16) were placed at the beams' end to measure the vertical displacements. Another transducer was provided to check any out of plane displacements.

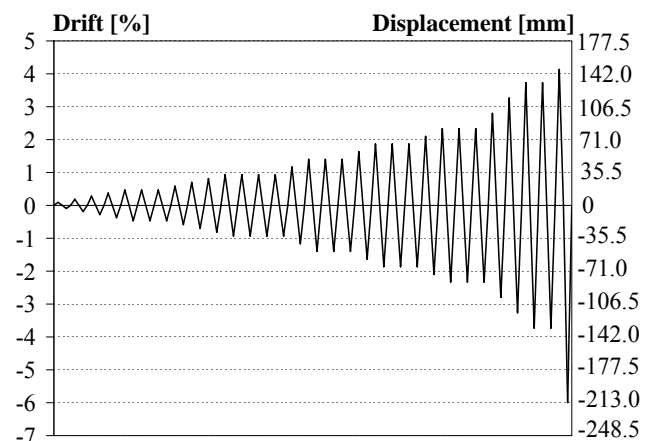
Figure 6. Loading History.

The horizontal load was applied with cycles characterized by increasing amplitude up to failure. The loading history of the test is shown in Figure 6.

Thirty two cycles were imposed, until a maximum displacement equal to 147 mm in the positive direction and 212 mm in the negative direction was reached.

At a drift equal to 0.5 %, 1 %, 1.5 %, 2% and 2.5 %, three cycles were carried out. Eventually, cycles for increments of drift equal to 0.5% were applied up to failure.

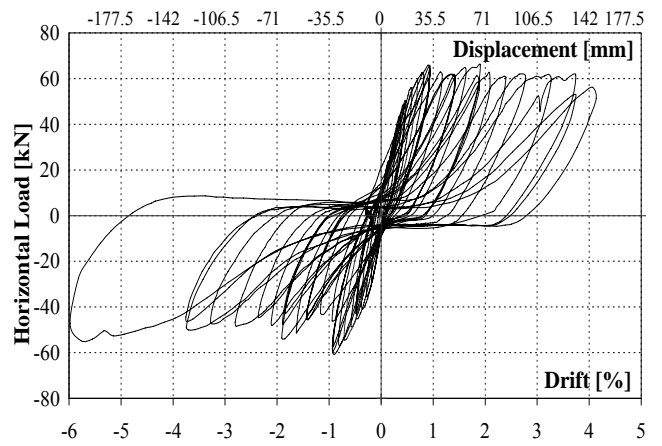
Figure 7. Horizontal load versus displacement at the load application point.

The results in terms of horizontal load versus displacement at the level of the load application point are shown in Figure 7.

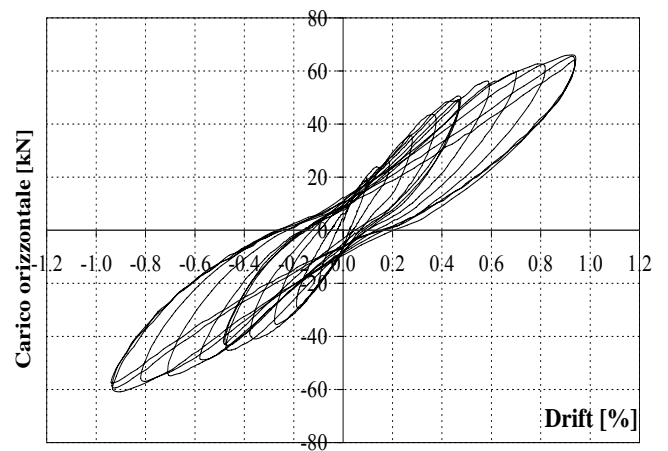
Figure 8. Horizontal load versus displacement up to a drift equal to 0.95%.

As shown in Figure 8, the joint behavior was stable up to a drift of 0.95%, whereby little damage was observed in the specimen. It is pointed out that the horizontal force at a drift of 0.95% was already higher than the design force at the ultimate limit state as resulting from the code verification of the strengthened building.

At a drift equal to 0.5%, compatible with the code requirement for the Damage Limit State (EN 1998-1, 2004), very little damage was observed. At this stage, a single hair-thin crack appeared in the jacket at the top column base.

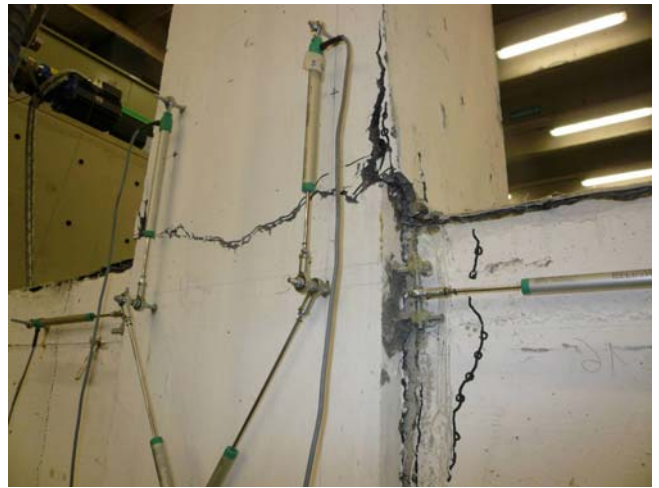
Figure 11. Failure of the column at the top.

The failure was due to the concrete crushing at the top of the joint, and by the debonding of the FRP strip on the column side, leading to the detachment of the HPFRC layer encasing the FRP sheet (Fig.11). The test ended at a drift equal to 6%.

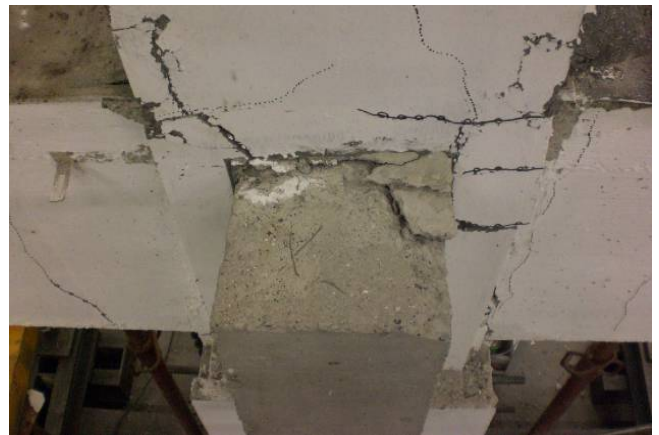
Figure 12. Cracks in the region with corbel interface.

It can be observed that no damage evidence was present on the joint surface while some cracks developed in the joint part where the corbel is located (Fig.12).

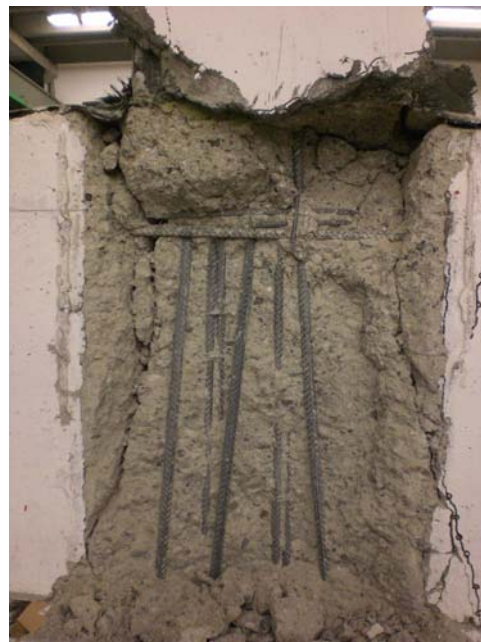
Figure 13. The joint after HPFRC jacket removal.

After the test, the high performance fiber reinforced jacket in the joint was removed in order to verify the conditions of the original concrete. As shown in Figure 13, the internal part of the joint was severely damaged.

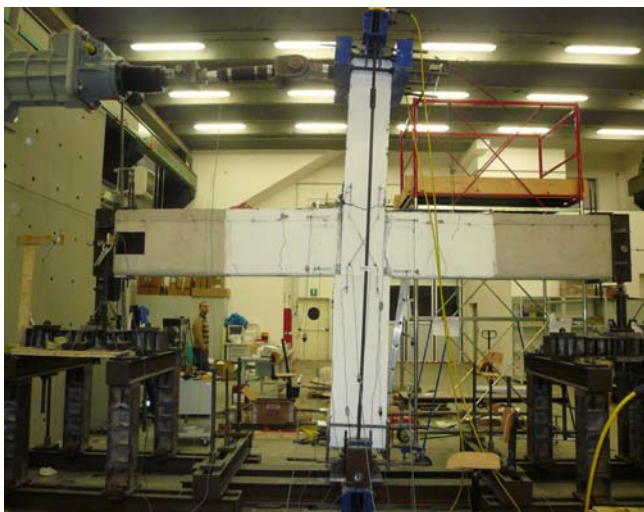
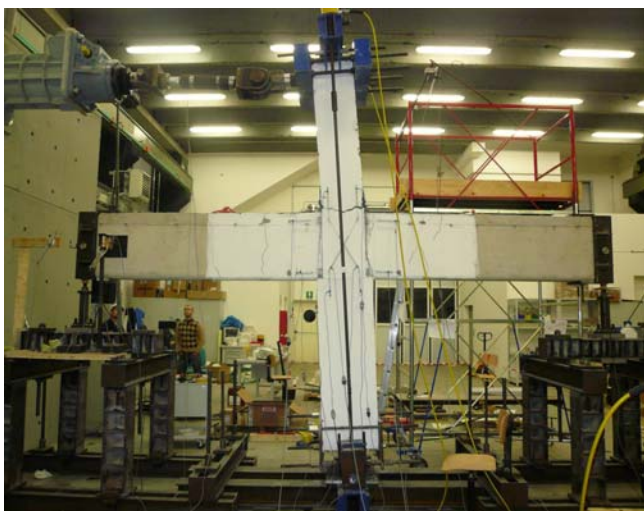
Figure 10. Specimen at a drift equal to  $\pm 4\%$ .

The top column failed during the cycle at a drift level equal to 4% (142 mm), as shown in Figure 10.

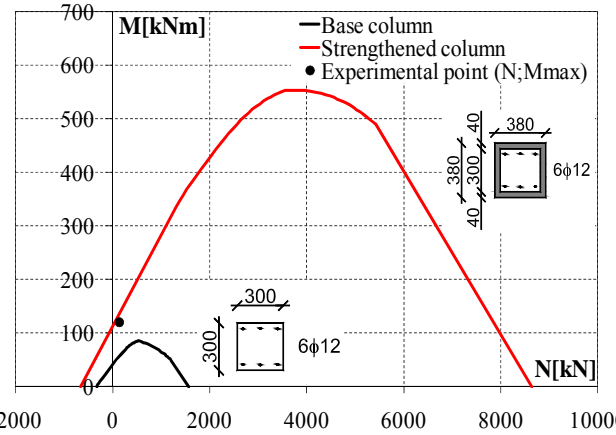
Figure 14. M-N interaction diagram for the upper column.

Figure 14 shows the M-N envelope for the strengthened section, compared with the unreinforced one for the upper column section of the beam-column joint, with the indication of the experimental point corresponding to a maximum bending moment of 120 kNm for an axial load of about 140 kN.

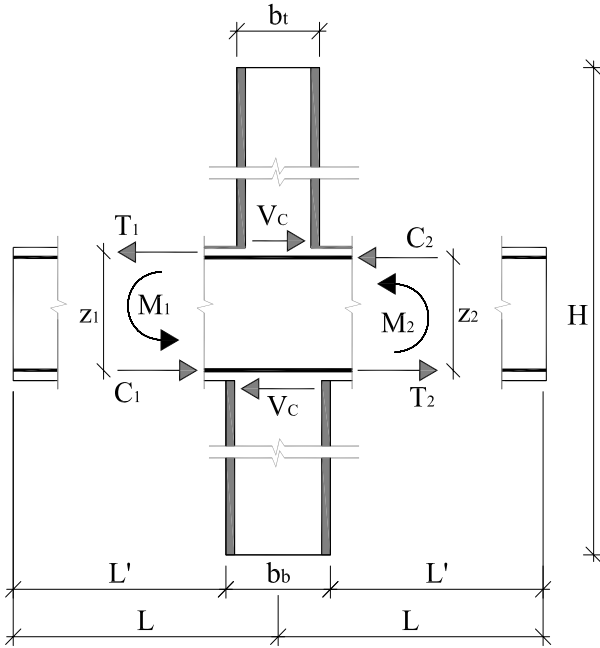
Figure 15. Forces associated to joint strength verification

For the experimental specimen, the strength of both original and retrofitted joints was evaluated by adopting the average material properties and a unit safety factor  $\gamma_{HPFRC}$ . In addition, the total shear acting on the node was computed by application of Capacity Design rules as (Eq.4):

where  $M_1$  and  $M_2$  are the resisting moments of the beams (as shown in Figure 15),  $z_1$  is equal to  $0.9d$  for the original section and  $0.9h$  for the retrofitted section, with  $h$  depth of the beam and  $z_2$  is equal to  $0.9d$  in both cases.
