# Operational modal analysis, seismic vulnerability assessment and retrofit of a degraded RC bell tower

This paper presents damage assessment through Operational Modal Analysis (OMA) and Finite Element (FE) model updating of the bell tower of the church of Castro in Bergamo, Italy. The tower is a 39 m high reinforced concrete structure with hollow cross-section and double-curved shape. The research was dictated by the need to identify the actual damage state of the structure, which was found through visual inspections. Piezoelectric accelerometers were used to record the ambient vibrations in subsequent test setups, using the roving technique for system identification. A detailed FE model was created with shell elements and calibrated to match the system identification results. A simplified beam model was then developed based on the modal analysis results of the detailed model. A sensitivity analysis was performed to identify the most influential model parameters on the modal characteristics of the system. Subsequently, the optimal values of these parameters were determined by an optimisation procedure carried out using a typical global optimization algorithm. The updating results

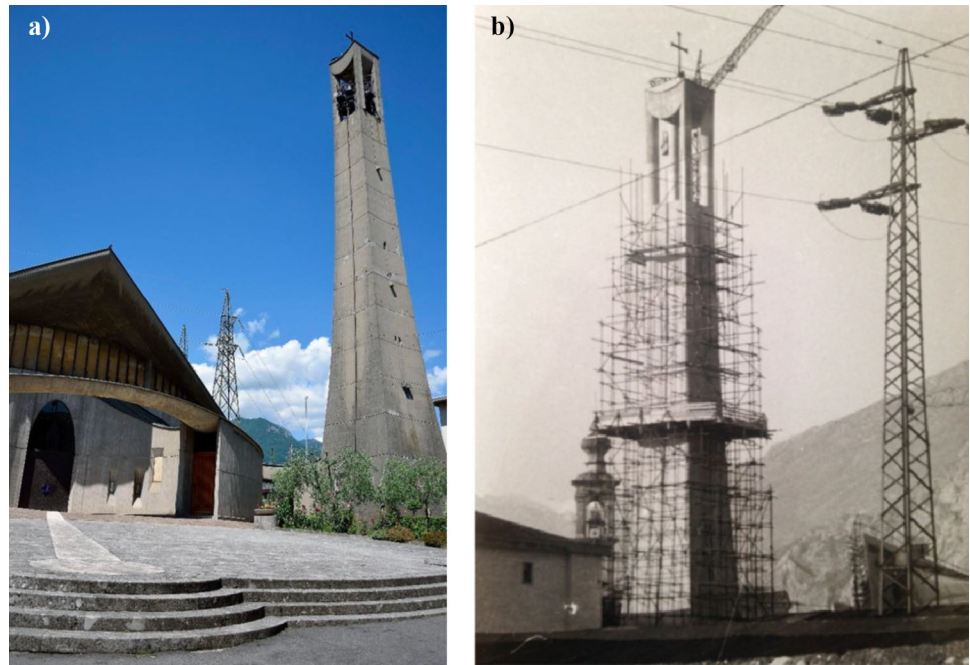
**Fig. 1** **a** View of the church with the adjacent bell tower; **b** bell tower at the time of construction

This paper presents the OMA, model updating, seismic assessment and retrofit of the bell tower of the church of San Giacomo (Fig. 1) in the city of Castro (Bergamo—Italy). The bell tower is 39 m high and has a hollow reinforced concrete (RC) cross-section and a double-curved shape. The tower was designed by the architect Vittorio Sonzogno in 1966 and built in 1969 together with the adjacent church.

The almost 39 m high RC bell tower (Fig. 1) has an internal square cross-section with a plan curvature on the four sides and a curvature along the height (Fig. 2). The bell tower extends over seven levels above ground and one below ground. The floors consist of 20–25 cm thick RC slabs. On the top floor is the belfry with a height of 9.30 m, a square cross-section of  $(2.81 \times 2.81) \text{ m}^2$  and vertical openings of  $(1.56 \times 4.84) \text{ m}^2$  on the four sides. The weight of the bells was estimated at 2 kN/g. The main geometric details are shown in Fig. 2. Noteworthy is the presence of a continuous vertical discontinuity on two opposite sides of the bell tower. Figure 3 shows an example of the original documentation.

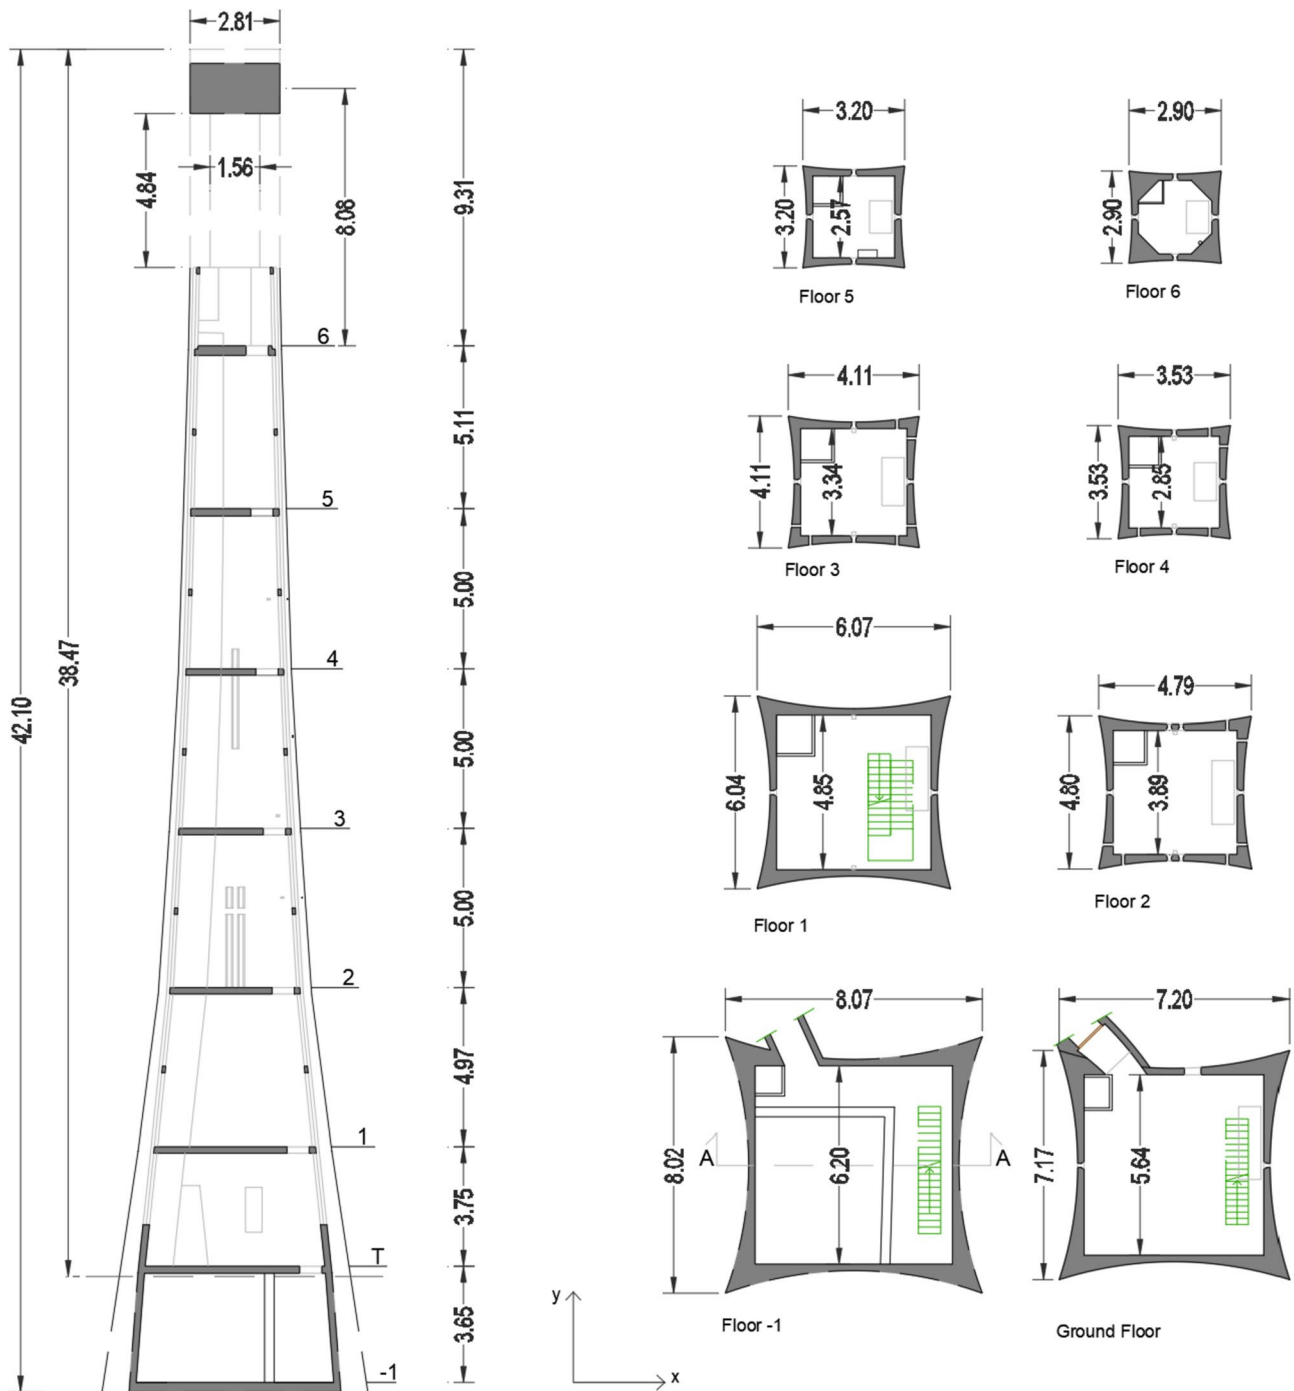
Fig. 2 Vertical and horizontal cross-sections of the bell tower at the various levels. Note: Dimensions in meters

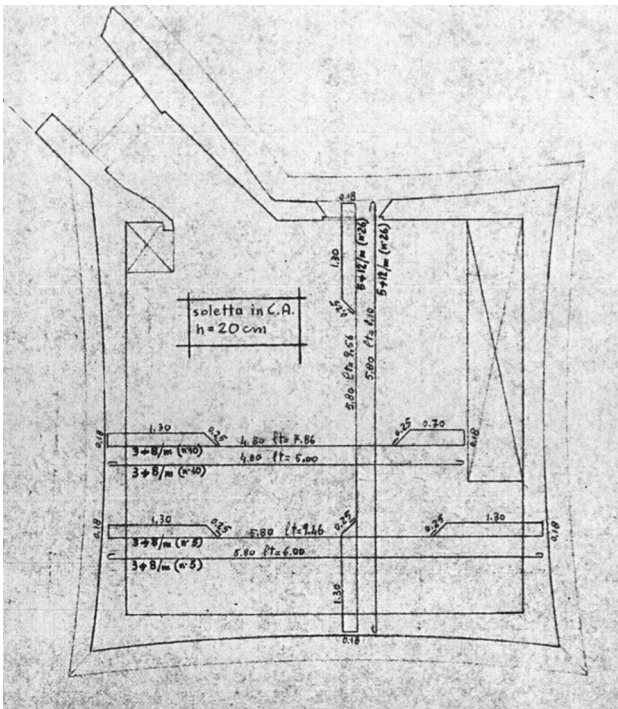
**Fig. 3** Example of the original drawings of the bell tower: steel reinforcing bars details for the ground floor

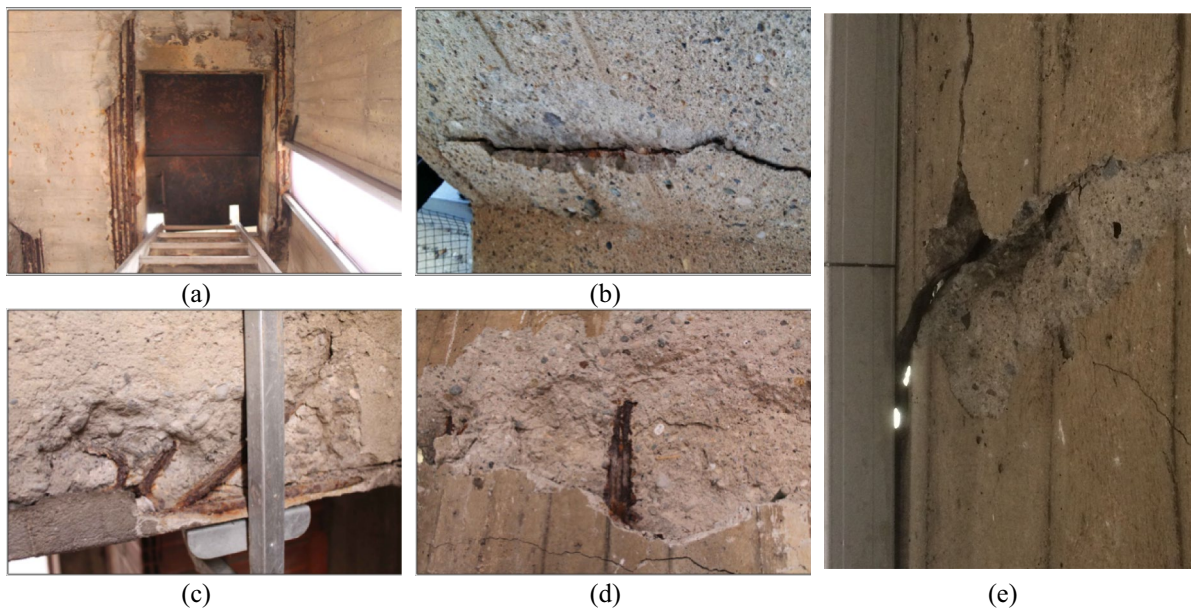
**Fig. 4** Details of some deteriorated areas of the bell tower: **a** last floor; **b** belfry; **c** 5th floor slab; **d** 3rd floor slab; **e** cracking at the 3rd level

The bell tower was in an evident state of deterioration (Fig. 4), with a horizontal wide crack at the 3rd level, probably due to several factors, such as the curvature of the cross-section, which is more pronounced at this level, and the vertical curvature, which results in a marked washing out of the concrete, highlighted by the chromatic

surface change. In addition, the vertical openings and the horizontal joints collect a greater amount of rainwater that penetrates from above, leading to significant deterioration of the tower, such as corrosion of the rebars, exacerbated by the presence of chemical substances due to previous pickling operations in a nearby steel factory. Gravel pockets on the surfaces caused by faulty execution of the concrete pour were also noted, as well as spalling of the concrete cover at the corroded reinforcement areas. Some relevant details are shown in Fig. 4.

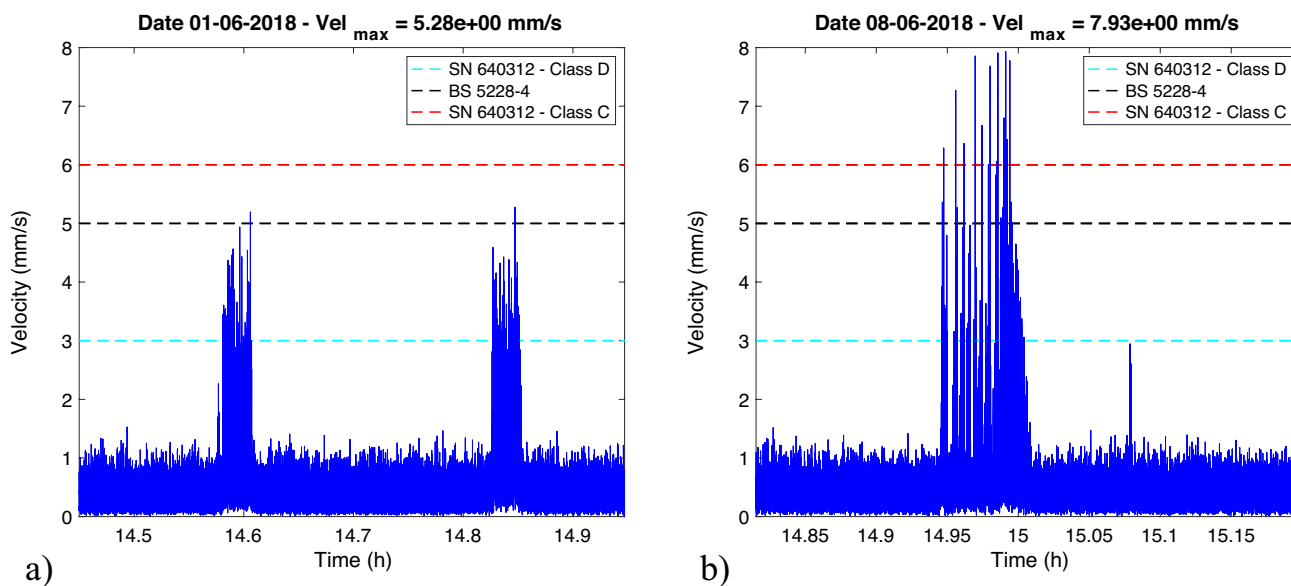
Fig. 5 Particle velocity at the damaged region of the 3rd level during bells in celebration with hammers (a) and bells swinging (b)

Damage caused by vibration is usually assessed by measuring the particle velocity or uniaxial velocity of a given region [17], as this kinematic quantity is directly related to kinetic energy (Fig. 5). The velocity was determined from the integration of the acceleration measurement and by

applying the same digital filter used to cleanse the raw data. The determined particle velocity was at the limit of incipient non-structural damage, especially in the case of bell oscillation. Considering the state of the structure (oxidation of reinforcing bars and concrete spalling), the recorded vibrations, even if they do not cause structural problems in new constructions, could accelerate the degradation process by

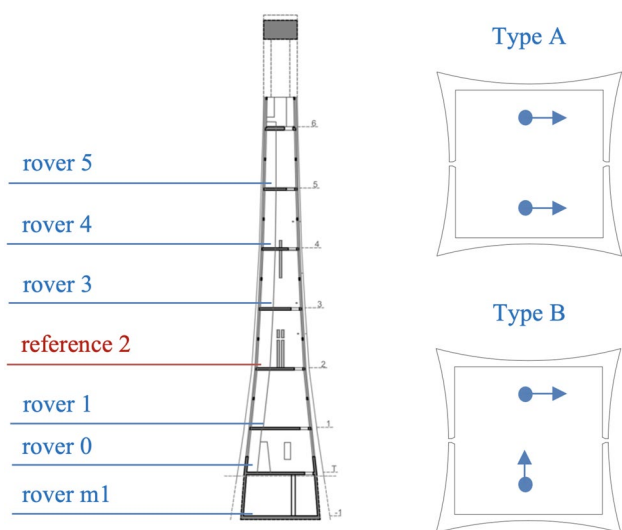
Fig. 6 Ambient vibration recording setup

Four highly sensitive piezoelectric accelerometers (Wilcoxon 731A) in two different configurations (Type A and Type B) were placed for system identification (see Fig. 6). To overcome the limited availability of sensors, the roving technique was used. Specifically, in each configuration, two sensors were left in the same position for all registrations

(reference), while the others were moved for each registration (rover). The Type A configuration allows the identification of possible torsions in each plane, while the Type B configuration allows the estimation of modal shapes in the orthogonal direction. Overall, despite the limited availability of sensors, the roving technique allowed a comprehensive assessment of the system’s behavior. The data were processed using a band-pass filter in the range 0.2–40 Hz. The various acquisitions have variable lengths between 250 and 600 s, which have been found proven to be sufficient for identifying the system.

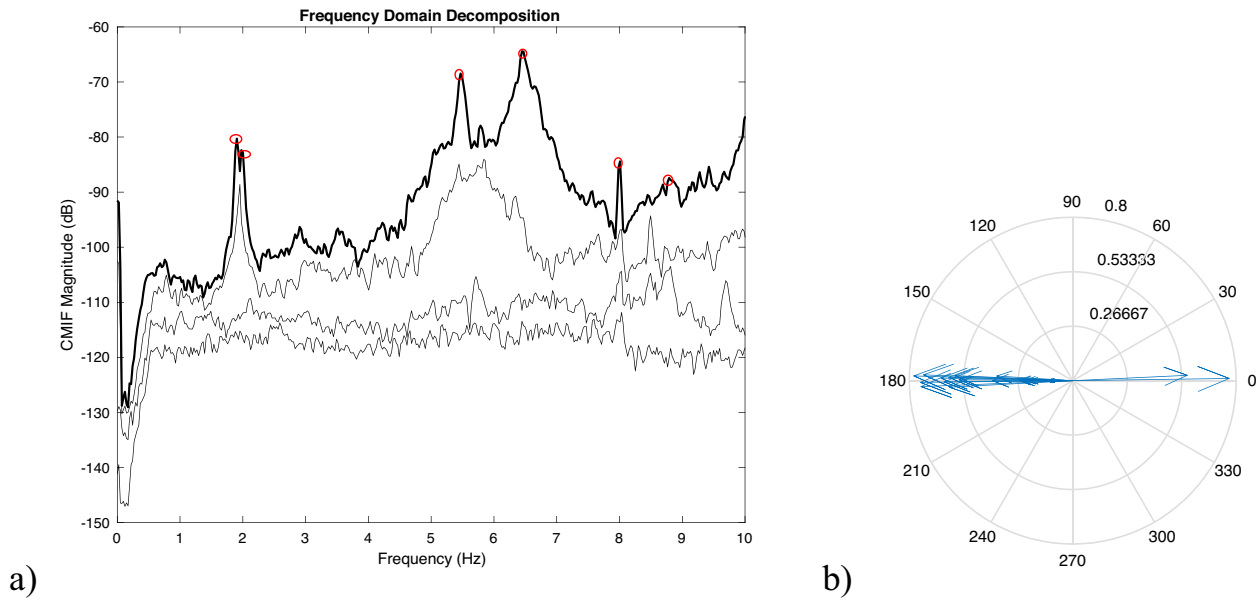
**Fig. 7** **a** Example of envelope of singular value decomposition and peak picking (red circles); **b** example of compass plot of the 3rd mode shape

Figure 7 shows an example of the FDD results. The 1st peak was discarded because it corresponded to a local vibration mode. It is worth noting that the first two frequencies are very close and could only be identified by careful choice of frequency resolution (Fig. 7a). As an example, Fig. 7b shows the polar plot of the 3rd vibration mode shape in complex plane. From the figure the eigenvector components are practically collinear, i.e., mainly represented by real numbers, which indicates that the vibration mode is classically damped.

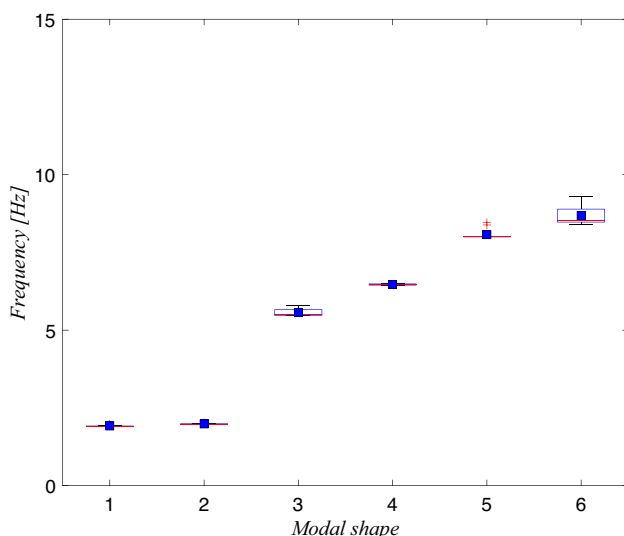
**Fig. 8** Statistical distribution of the identified modal frequencies

Figure 8 shows the boxplots of the results plotted according to the corresponding distribution curve. The boxes are defined by the 25th and 75th percentiles, while the middle markers represent the median values. The whiskers represent the maximum and minimum values without considering outliers. Outliers are plotted individually with the symbol ‘+’. From the results (Table 1 and Fig. 8), there is little variance

in the estimated frequencies, demonstrating the good accuracy of the selected peaks. The modal shapes obtained from the identification process are shown in Fig. 9. The focus was on the first two vibrational modes. Since no sensors could be placed in the upper part of the bell tower, the modal shapes were partially derived considering only the results of the lower levels. As can be seen in Fig. 9, the first four modes reflect modes of vibration that are compatible with a cantilevered structure such as the bell tower. The rotation of the mode shapes along the vertical axis of the tower is an aspect that will be specifically analysed in the following sections. In particular, the dependence between the non-pure bending in the two main planes and the crack extension is discussed. The fifth and sixth mode shapes did not appear to correspond to any physical mode; for this reason, they were subsequently excluded from the optimisation problem.

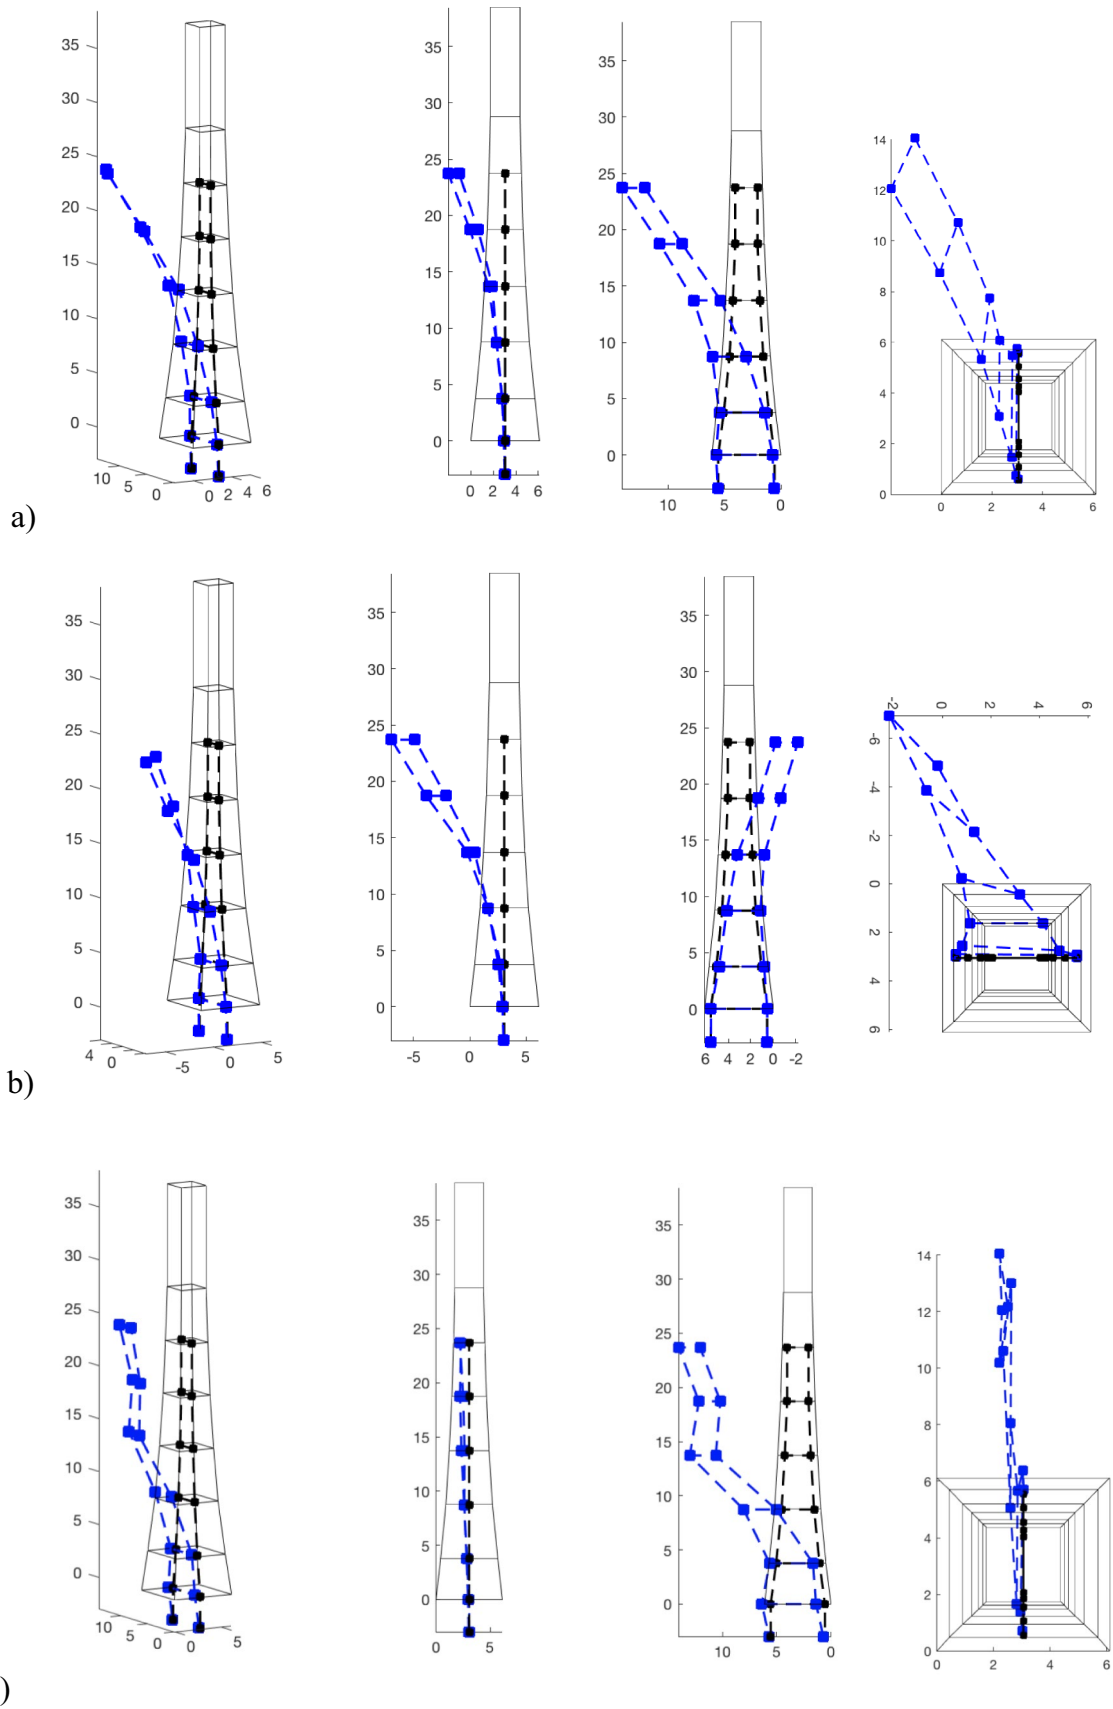
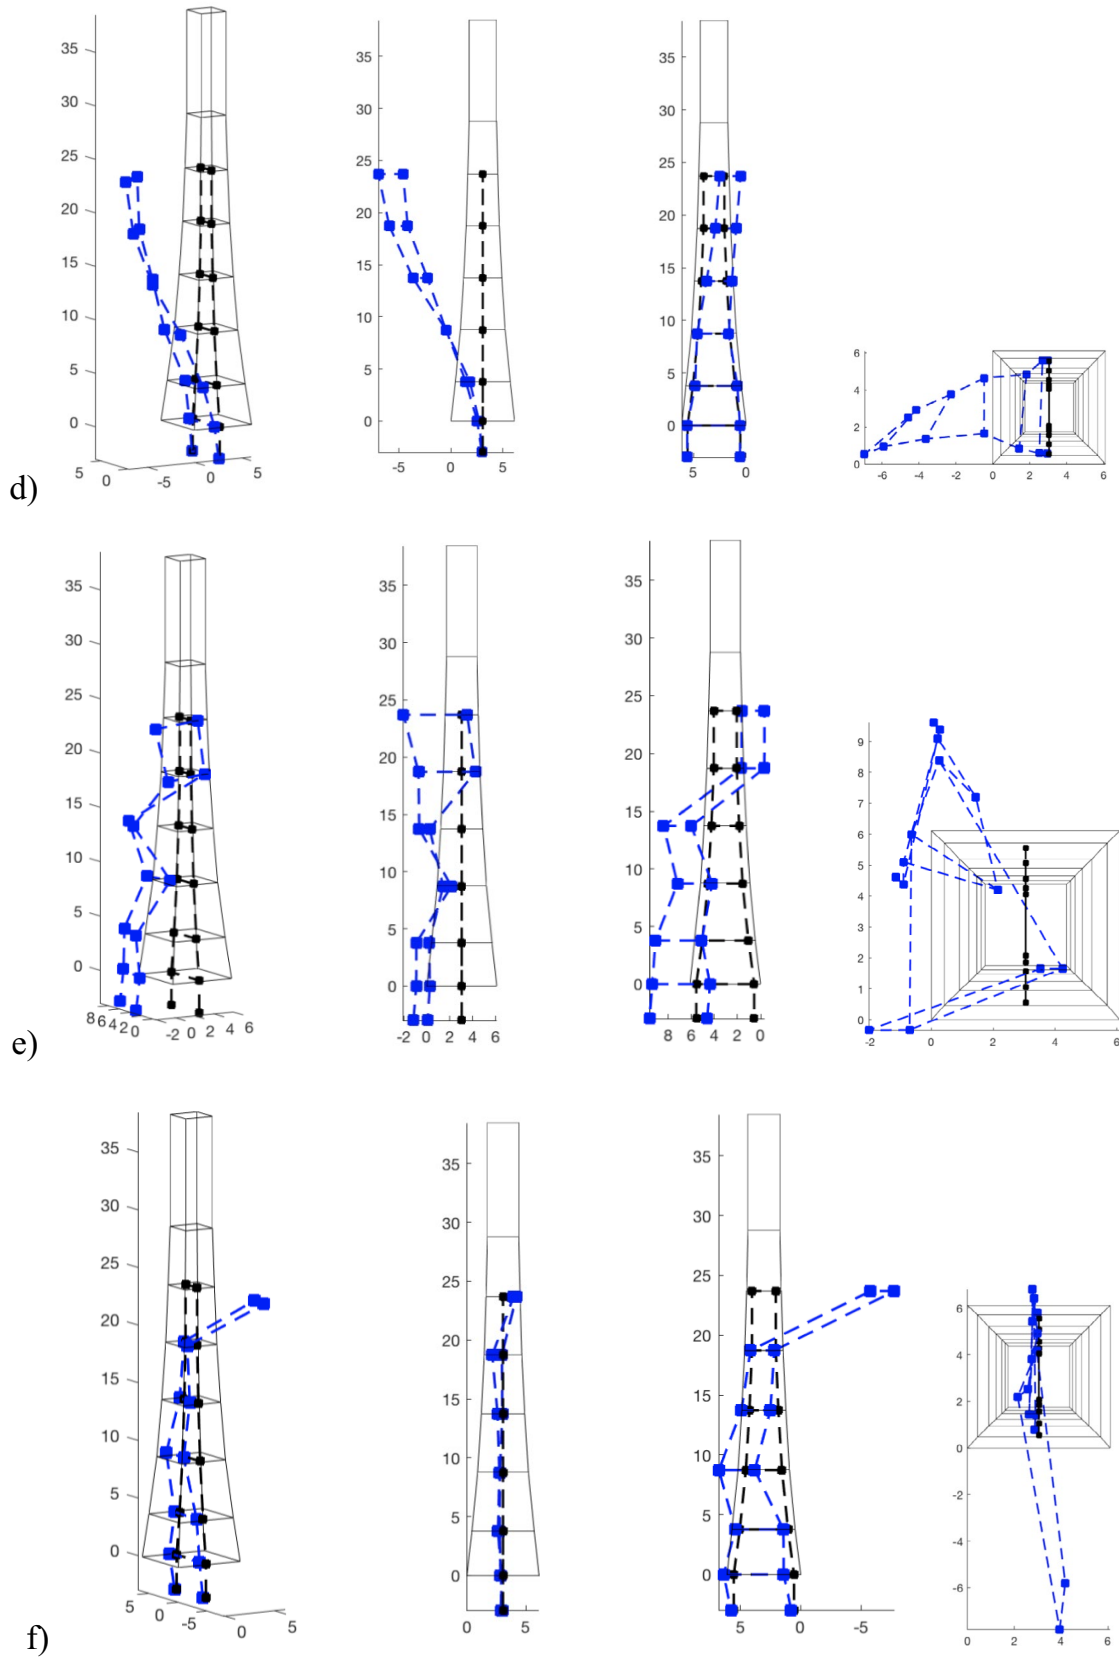
Fig. 9 1st, 2nd, 3rd, 4th, 5th, and 6th mode shapes from OMA

Fig. 9 (continued)

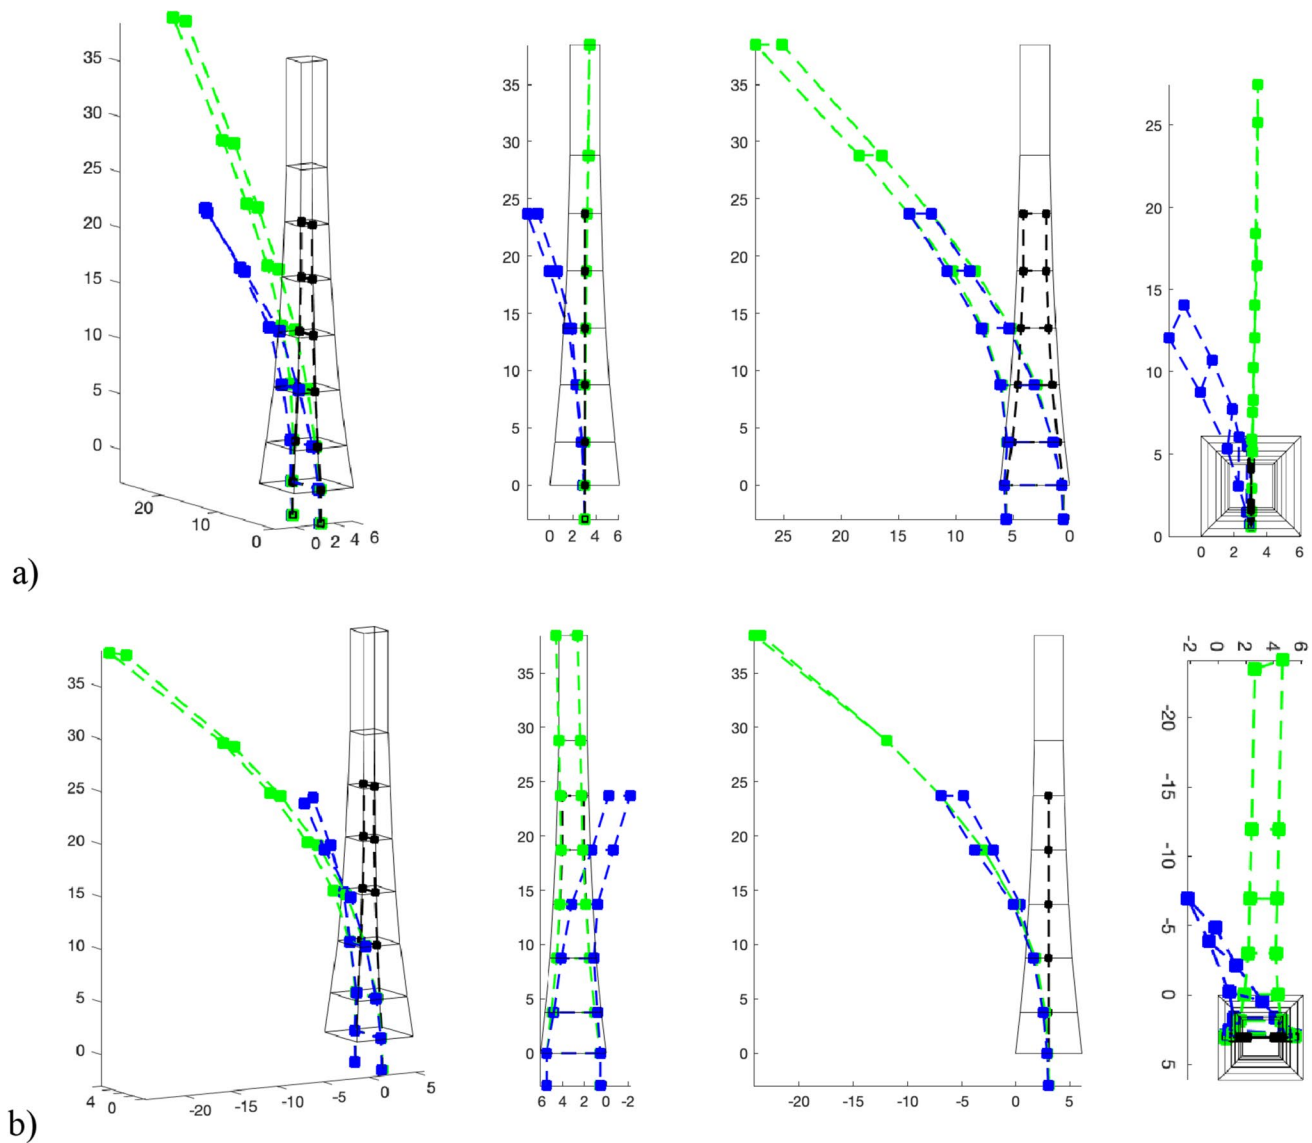
**Fig. 11** Comparison between 1st mode shape (a) and 2nd mode shape (b) before update: OMA (blue dashed line) and FE (green dashed line)

Figure 14 shows how the first two modal shapes change depending on the extent of the crack on the 3rd level. Without the crack (black lines), the modal shapes are pure flexural modes in the  $x$  and  $y$  directions, while as the cracked area extends (red line), the modal shapes rotate about the vertical axis, as seen in Fig. 11.

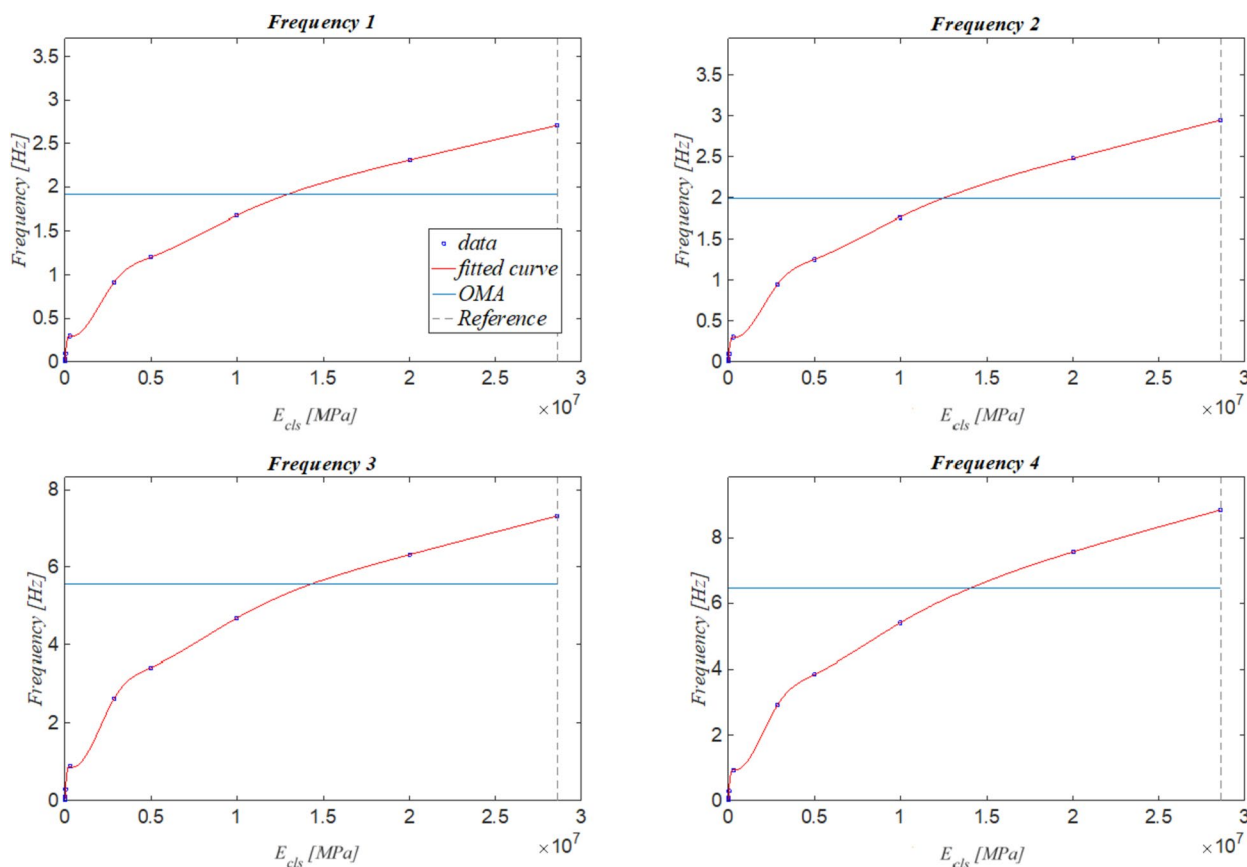
**Fig. 13** Sensitivity of the modal frequencies as a function of the modulus of elasticity of the concrete

Figure 13 shows the effect of the elastic modulus on the natural frequencies of the FE model.  $E_{cls}$  significantly affects the dynamic response of the structure: in general, the modal frequency increases when  $E_{cls}$  is increased. It is worth noting that the same elastic modulus was used for the entire structure. Figure 13 also shows the intersection between the FEM results and those of OMA. As expected, only one intersection was observed for each natural frequency.

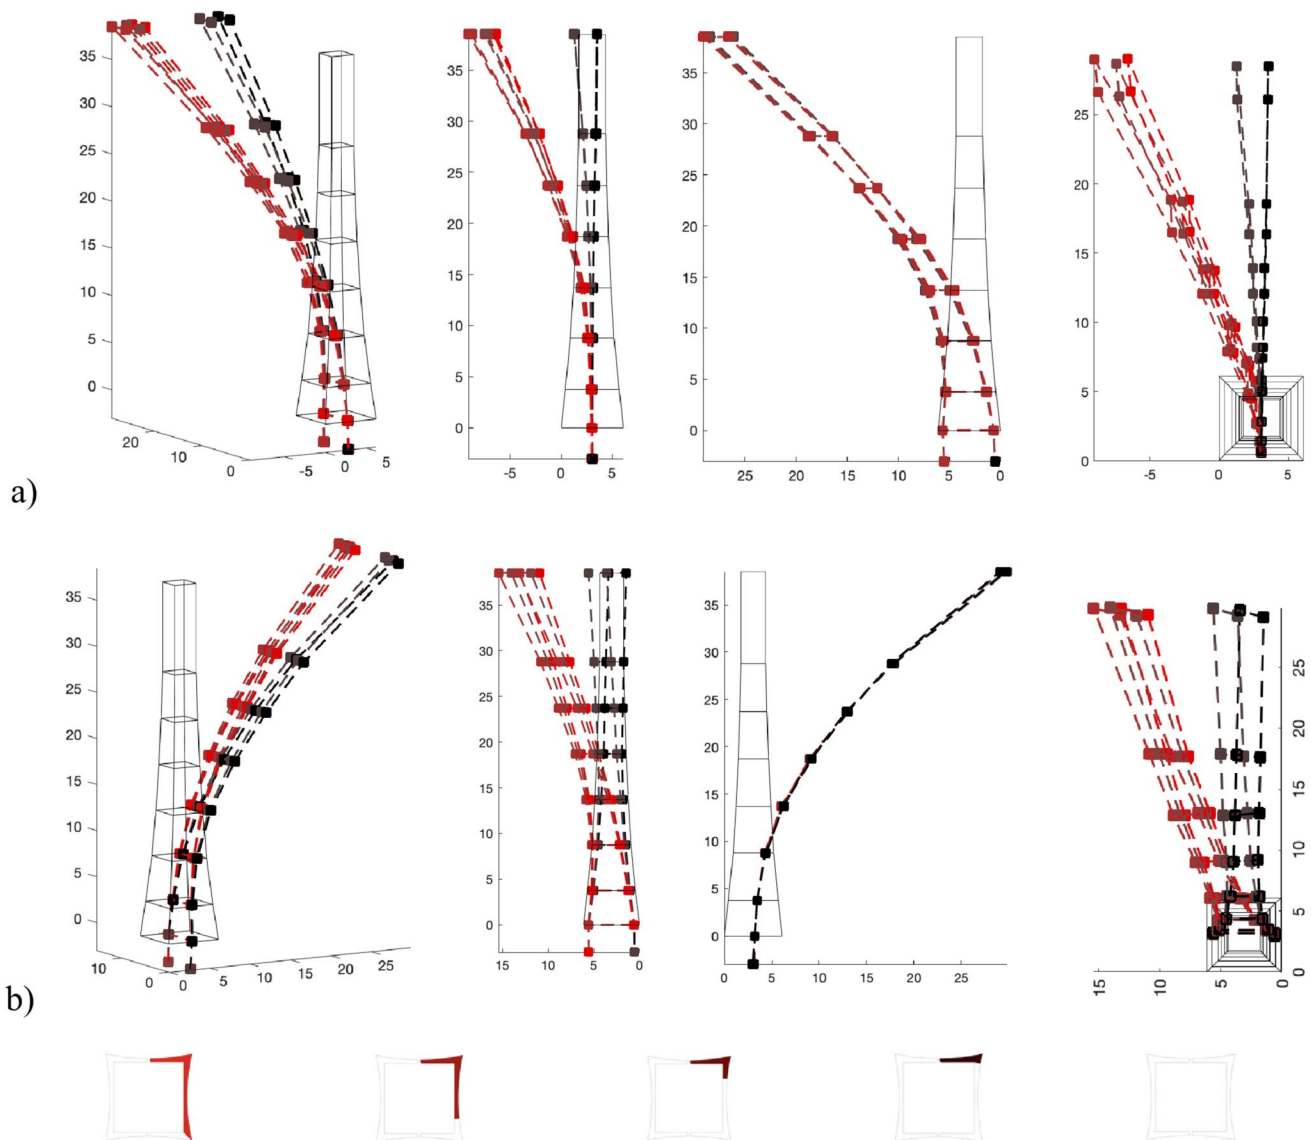
Fig. 14 Sensitivity of the 1st mode shape (a) and 2nd mode shape (b) as a function of the crack extension

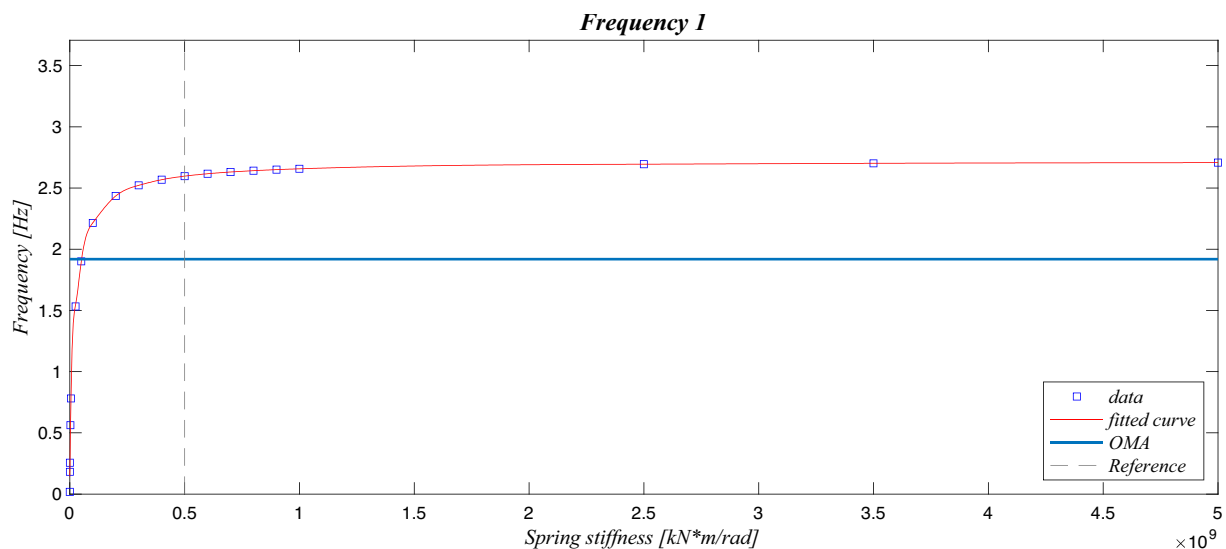
**Fig. 15** Sensitivity of the 1st modal frequency as a function of the base spring rotational stiffness

The spring stiffness at the base affects both the modal frequency (Fig. 15) and the mode shapes (Fig. 16). As for the latter, the spring stiffness particularly affects the modal curvature at the base of the bell tower. It is worth noting that both the modal frequency and the mode shape do not change beyond a certain value of the spring stiffness.

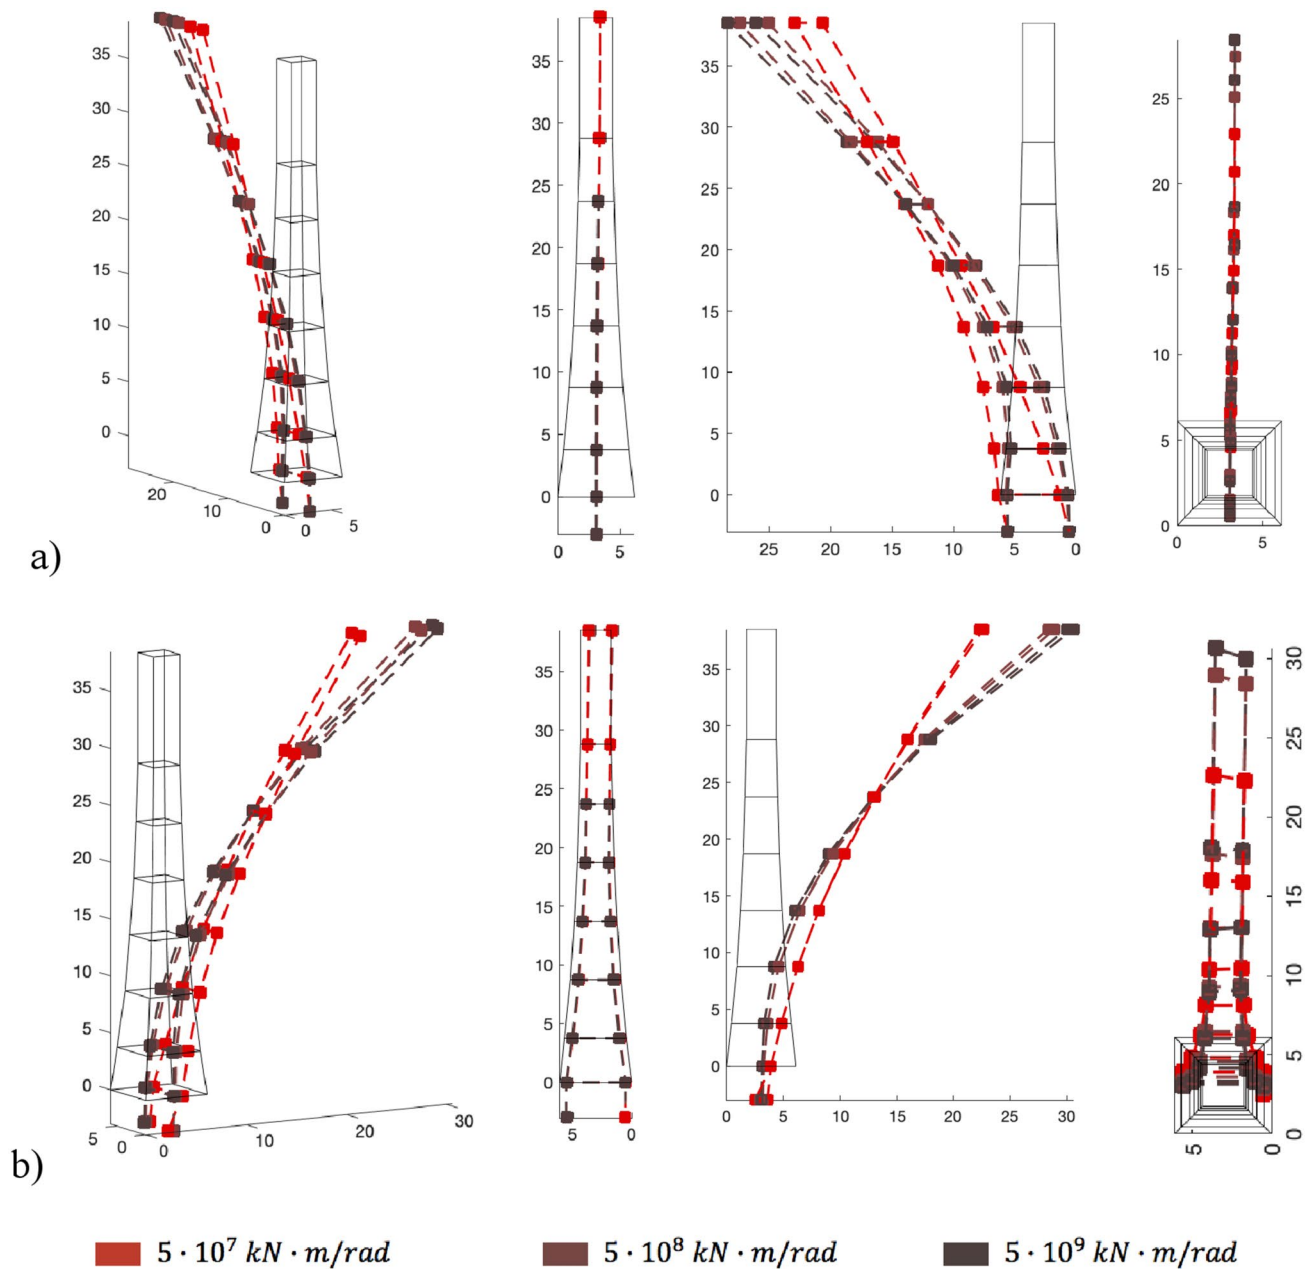
**Fig. 16** Sensitivity of the 1st mode shape (a) and 2nd mode shape (b) as a function of as the base spring rotational stiffness

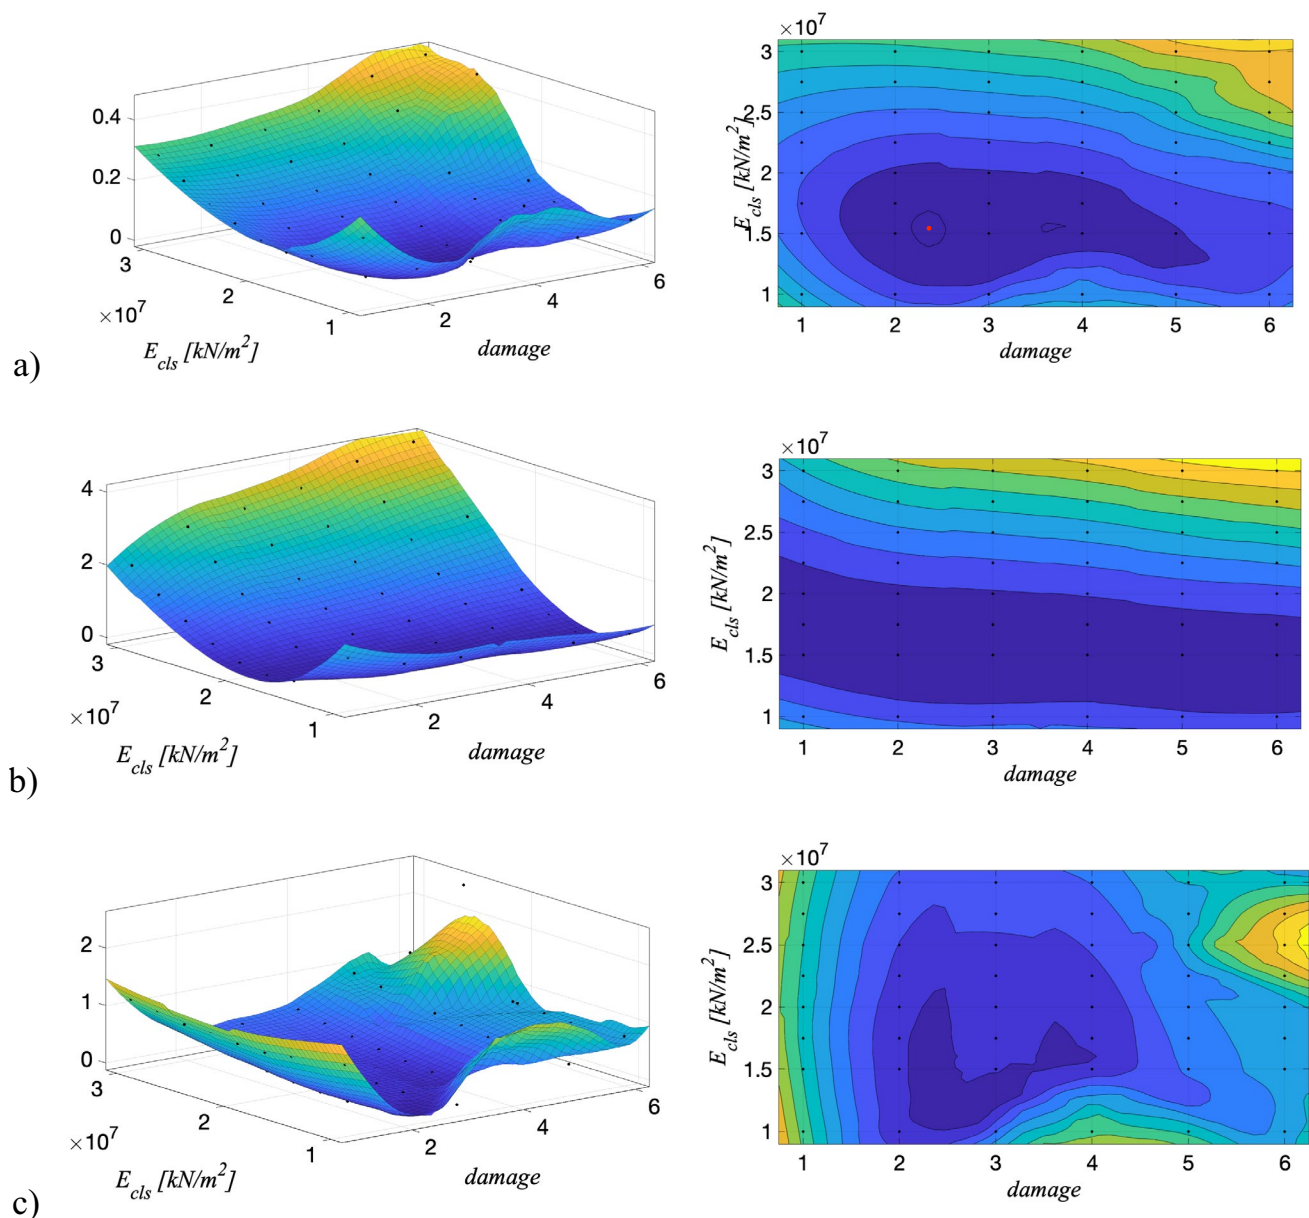
**Fig. 17** Objective functions with different weights: **a** same weights between modal frequencies and mode shapes; **b** higher weights for modal frequencies than mode shapes; **c** higher weights for mode shapes than modal frequencies

function surface is shown in Fig. 17 as a function of crack extension and modulus of elasticity and for different weights.

When more weight is given to the modal frequencies (Fig. 17b), the damage extension becomes less sensitive, while the elastic modulus of the concrete becomes less sensitive when more weight is given to the modal shapes (Fig. 17c). It is interesting to note that the objective function in Fig. 17c has two minima. This can be explained by analysing the sensitivity analysis shown in Fig. 14: as the extent of damage increases, the rotation of the mode shape increases up to an extent of damage corresponding to half of the C-shape cross-section. With a subsequent increase in the damaged area, the rotation of the mode shape decreases, which leads to two minima of the objective function, i.e., to the unobservability of the inverse problem.

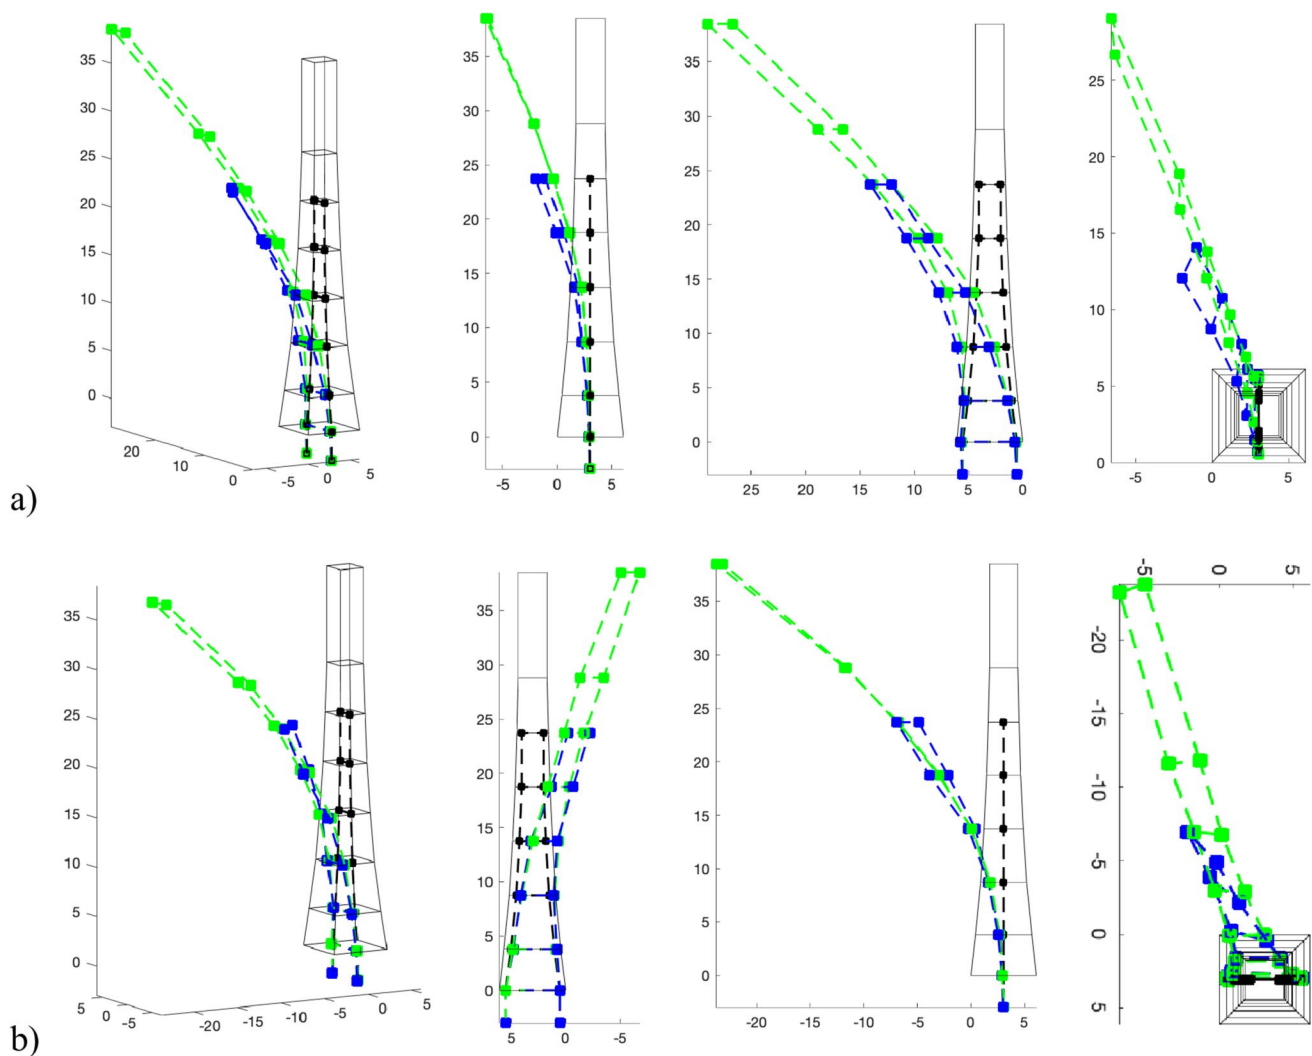
**Fig. 19** Comparison between 1st mode shape (a) and 2nd mode shape (b) after update: OMA (blue dashed line) and FE (green dashed line)

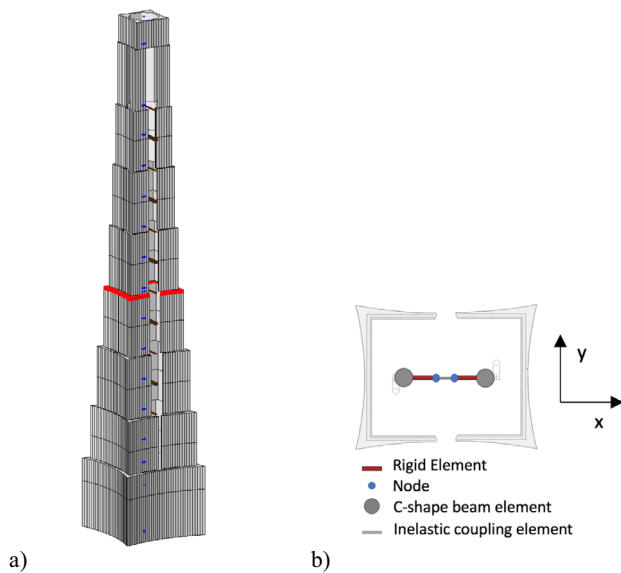
**Fig. 20** Simplified beam-like finite element model (a) with the crack position in red, and cross-section (b)

of the existing RC slab. To validate the simplified beam model in the elastic domain, a modal analysis was performed and the results were compared with those of the shell-type model, which showed good agreement (1st and 2nd mode frequencies equal to 1.92 Hz and 2.00 Hz, respectively). Once the nonlinear FE model was defined, a seismic vulnerability assessment was performed using nonlinear static (pushover) analysis according to the current building codes. The flowchart of the entire applied framework is shown in Fig. 21.
