# Operational modal analysis, seismic vulnerability assessment and retrofit of a degraded RC bell tower

This paper presents damage assessment through Operational Modal Analysis (OMA) and Finite Element (FE) model updating of the bell tower of the church of Castro in Bergamo, Italy. The tower is a 39 m high reinforced concrete structure with hollow cross-section and double-curved shape. The research was dictated by the need to identify the actual damage state of the structure, which was found through visual inspections. Piezoelectric accelerometers were used to record the ambient vibrations in subsequent test setups, using the roving technique for system identification. A detailed FE model was created with shell elements and calibrated to match the system identification results. A simplified beam model was then developed based on the modal analysis results of the detailed model. A sensitivity analysis was performed to identify the most influential model parameters on the modal characteristics of the system. Subsequently, the optimal values of these parameters were determined by an optimisation procedure carried out using a typical global optimization algorithm. The updating results

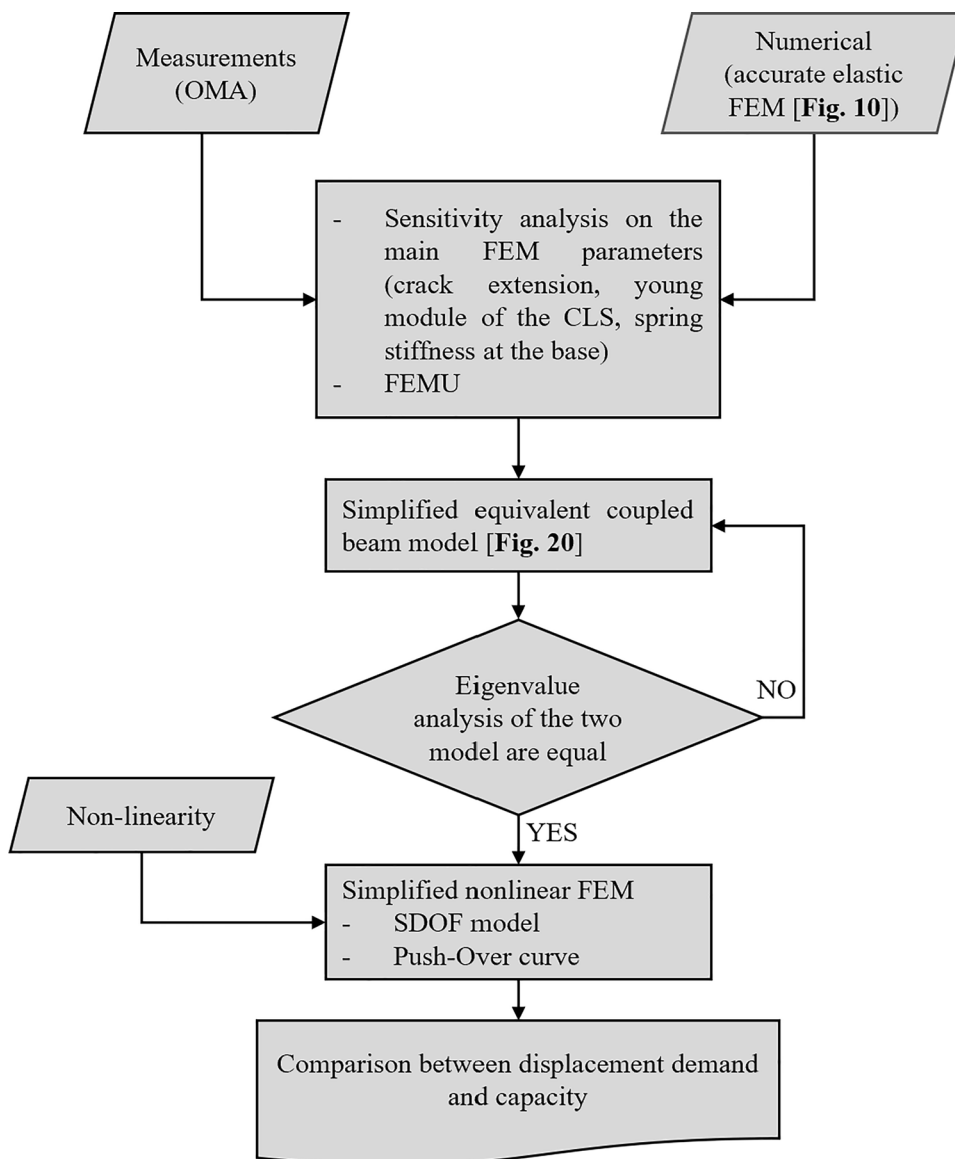
**Fig. 21** Flowchart showing the various steps of the entire followed framework

of the existing RC slab. To validate the simplified beam model in the elastic domain, a modal analysis was performed and the results were compared with those of the shell-type model, which showed good agreement (1st and 2nd mode frequencies equal to 1.92 Hz and 2.00 Hz, respectively). Once the nonlinear FE model was defined, a seismic vulnerability assessment was performed using nonlinear static (pushover) analysis according to the current building codes. The flowchart of the entire applied framework is shown in Fig. 21.

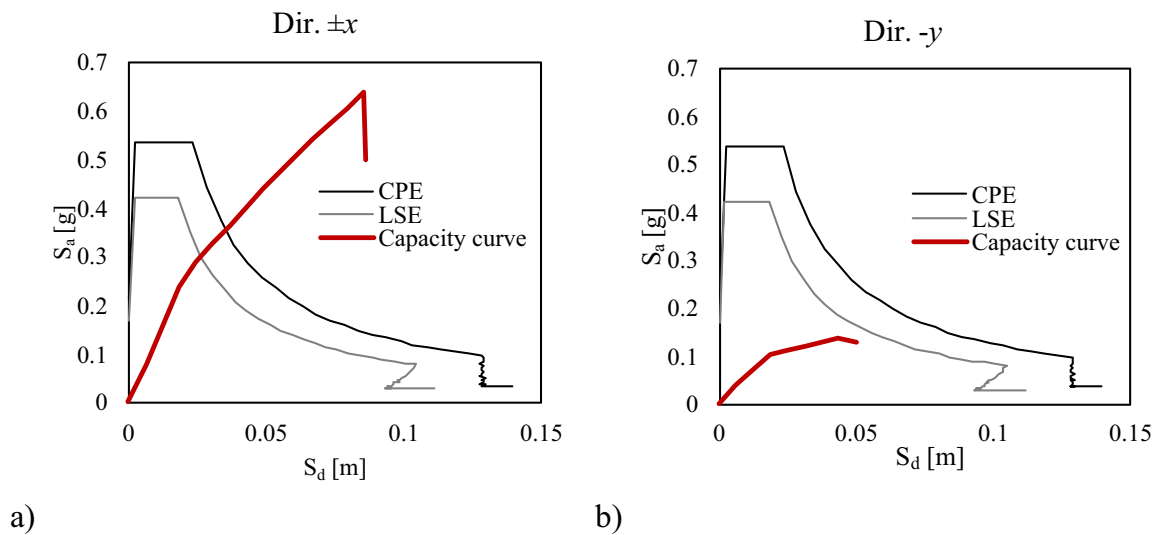
**Fig. 22** Capacity spectrum of the bell tower in the AS-IS conditions: direction  $x$  (a), and  $y$  (b). Note: LSE is the life safety earthquake; CPE is the collapse prevention earthquake

The ultimate displacement corresponds to the failure of the RC slab across the vertical discontinuity in the

cross-section of the bell tower,  $x$ -direction (Fig. 22a), and to the activation of the plastic hinge at the cracked 3rd level,  $y$ -direction (Fig. 22b). The LSLS and Collapse Prevention Limit State (CPLS) were defined based on the rotation reached in the lumped plastic hinges; in particular, the CPLS was set according to the ultimate rotational capacity of the flexural plastic hinges while LSLS limit was considered to be reached at 3/4 of such rotation capacity [23]. In the  $y$ -direction, since the activation of the plastic hinges representing the crack occurred earlier than the LSLS requirement, a structural retrofit was considered.

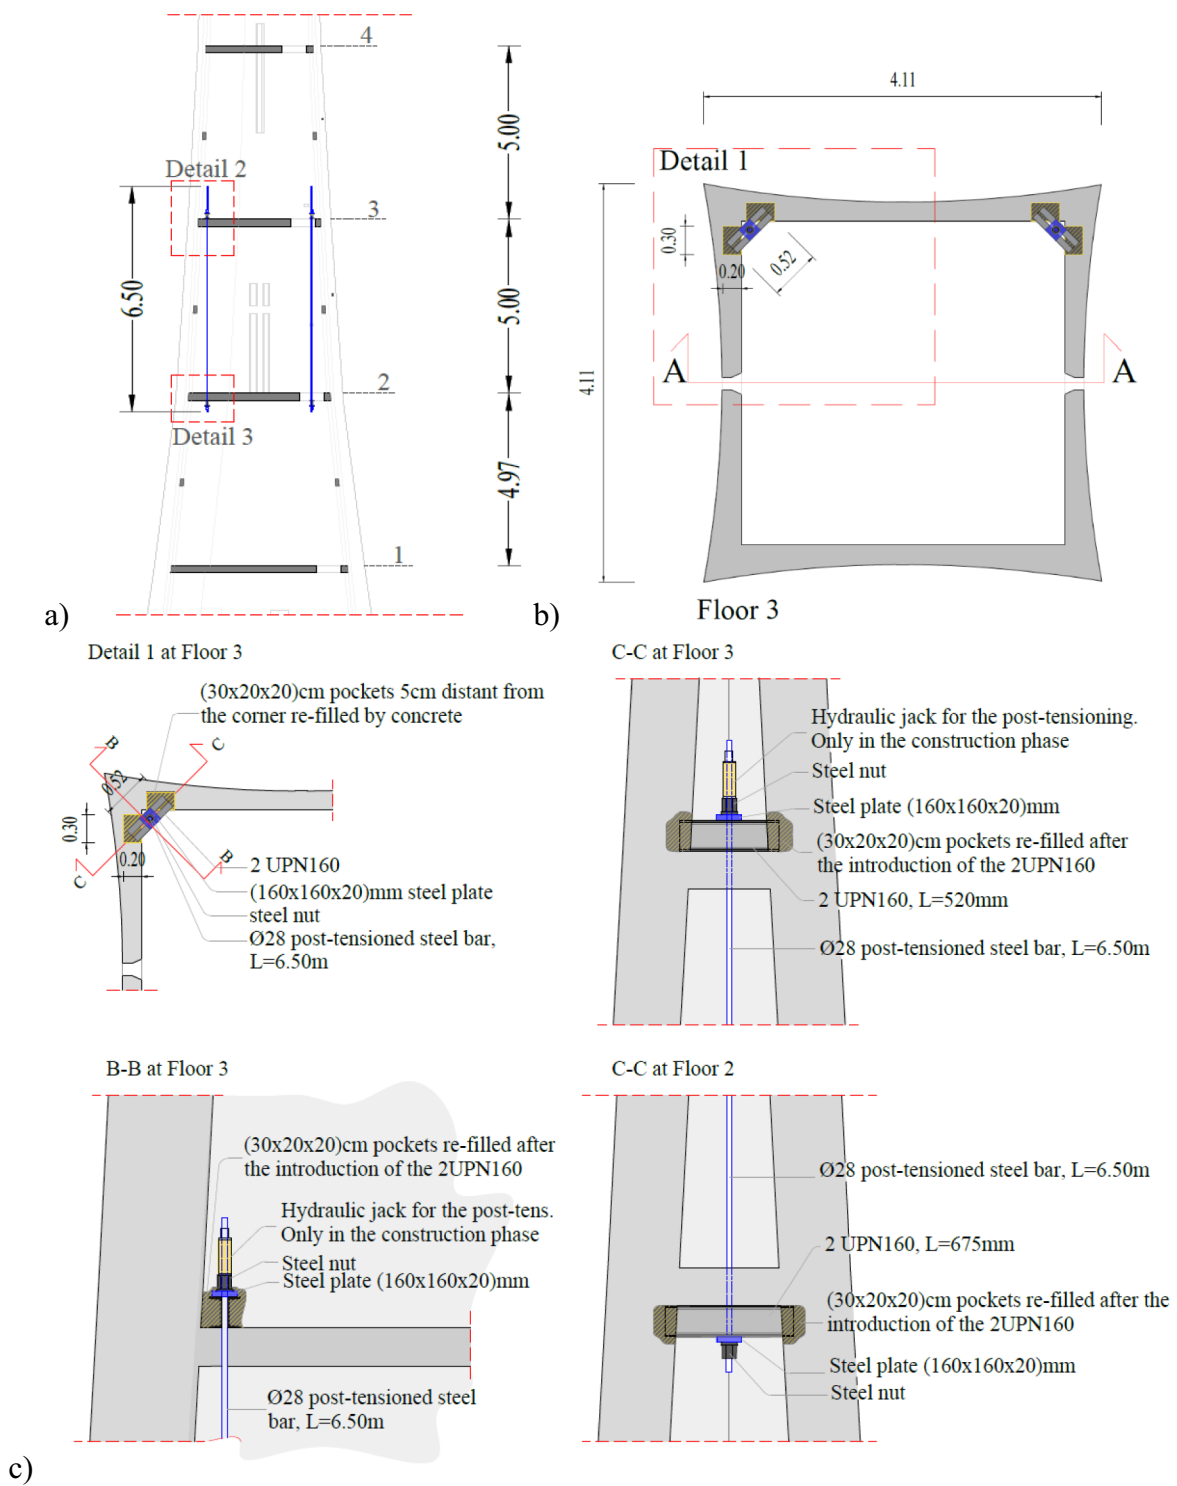
**Fig. 23** Drawings of the proposed local retrofit intervention: **a** vertical section and position of the retrofit intervention; **b** cross-section at the 3rd level; **c** details and description of the retrofit intervention

From a technological point of view, the proposed intervention was conceived as a set of two double S275 UPN160 profiles ( $L = 0.52$  m and 30 mm spaced) placed in pockets made in the walls of the bell tower, above and below the upper and lower decks close to the corners of the cracked façade (Fig. 23a, b). The double UPN, 32 mm spaced, allows the positioning of a  $\phi 28$  mm post-tensioning bar (Fig. 23c); as for Step 1 and Step 2, 224 kN and 616 kN are considered. It is worth noting that the stress increase which arises in the bell tower walls due to post-tensioning is negligible compared to the wall axial capacity.

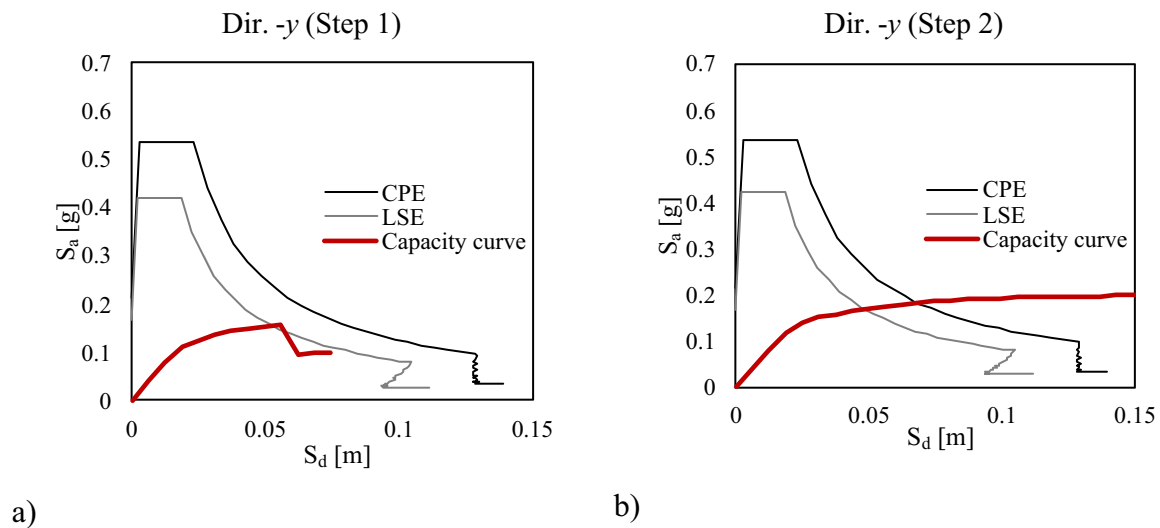
**Fig. 24** Capacity spectrum of the retrofitted bell tower in the weakest direction (negative y-direction): **a** Step 1; **b** Step 2

From the FE analysis point of view, the retrofitted area was modelled by replacing the plastic hinge introduced to model the damaged area with a new plastic hinge whose moment-rotation hysteresis was calibrated according to the applied post-tensioning. As in step 1, the preload was derived by considering a vertical load of 890 kN on the C-shaped element. The CPLS was determined at the activation of the plastic hinge in the damaged region (i.e., when the value of the post-tension was reached and a tensile stress state occurred in the damaged region); at the end of Step 1, a seismic safety index of 0.75 was obtained (Fig. 24).

In Step 2, the tensile stress that would develop in the 3rd level due to the overturning moment was evaluated and the prestressing was designed accordingly. A tensile force of 513 kN was determined in the cracked area. By multiplying this value by a safety factor of 1.20, the preload was defined and the plastic hinge hysteresis was calibrated. The capacity curve of the retrofitted bell tower along the  $y$ -direction is shown in Fig. 24. The intervention allows engaging a distributed plastic region along the bell tower height, the yield strength and ultimate strength of the plastic hinge are reached at the 4th level, respectively. A seismic safety index greater than 1 was obtained.
